Good practice guide for minimising impacts on the natural heritage during construction.

This guide shows examples of good and poor practice examples for hydro construction.

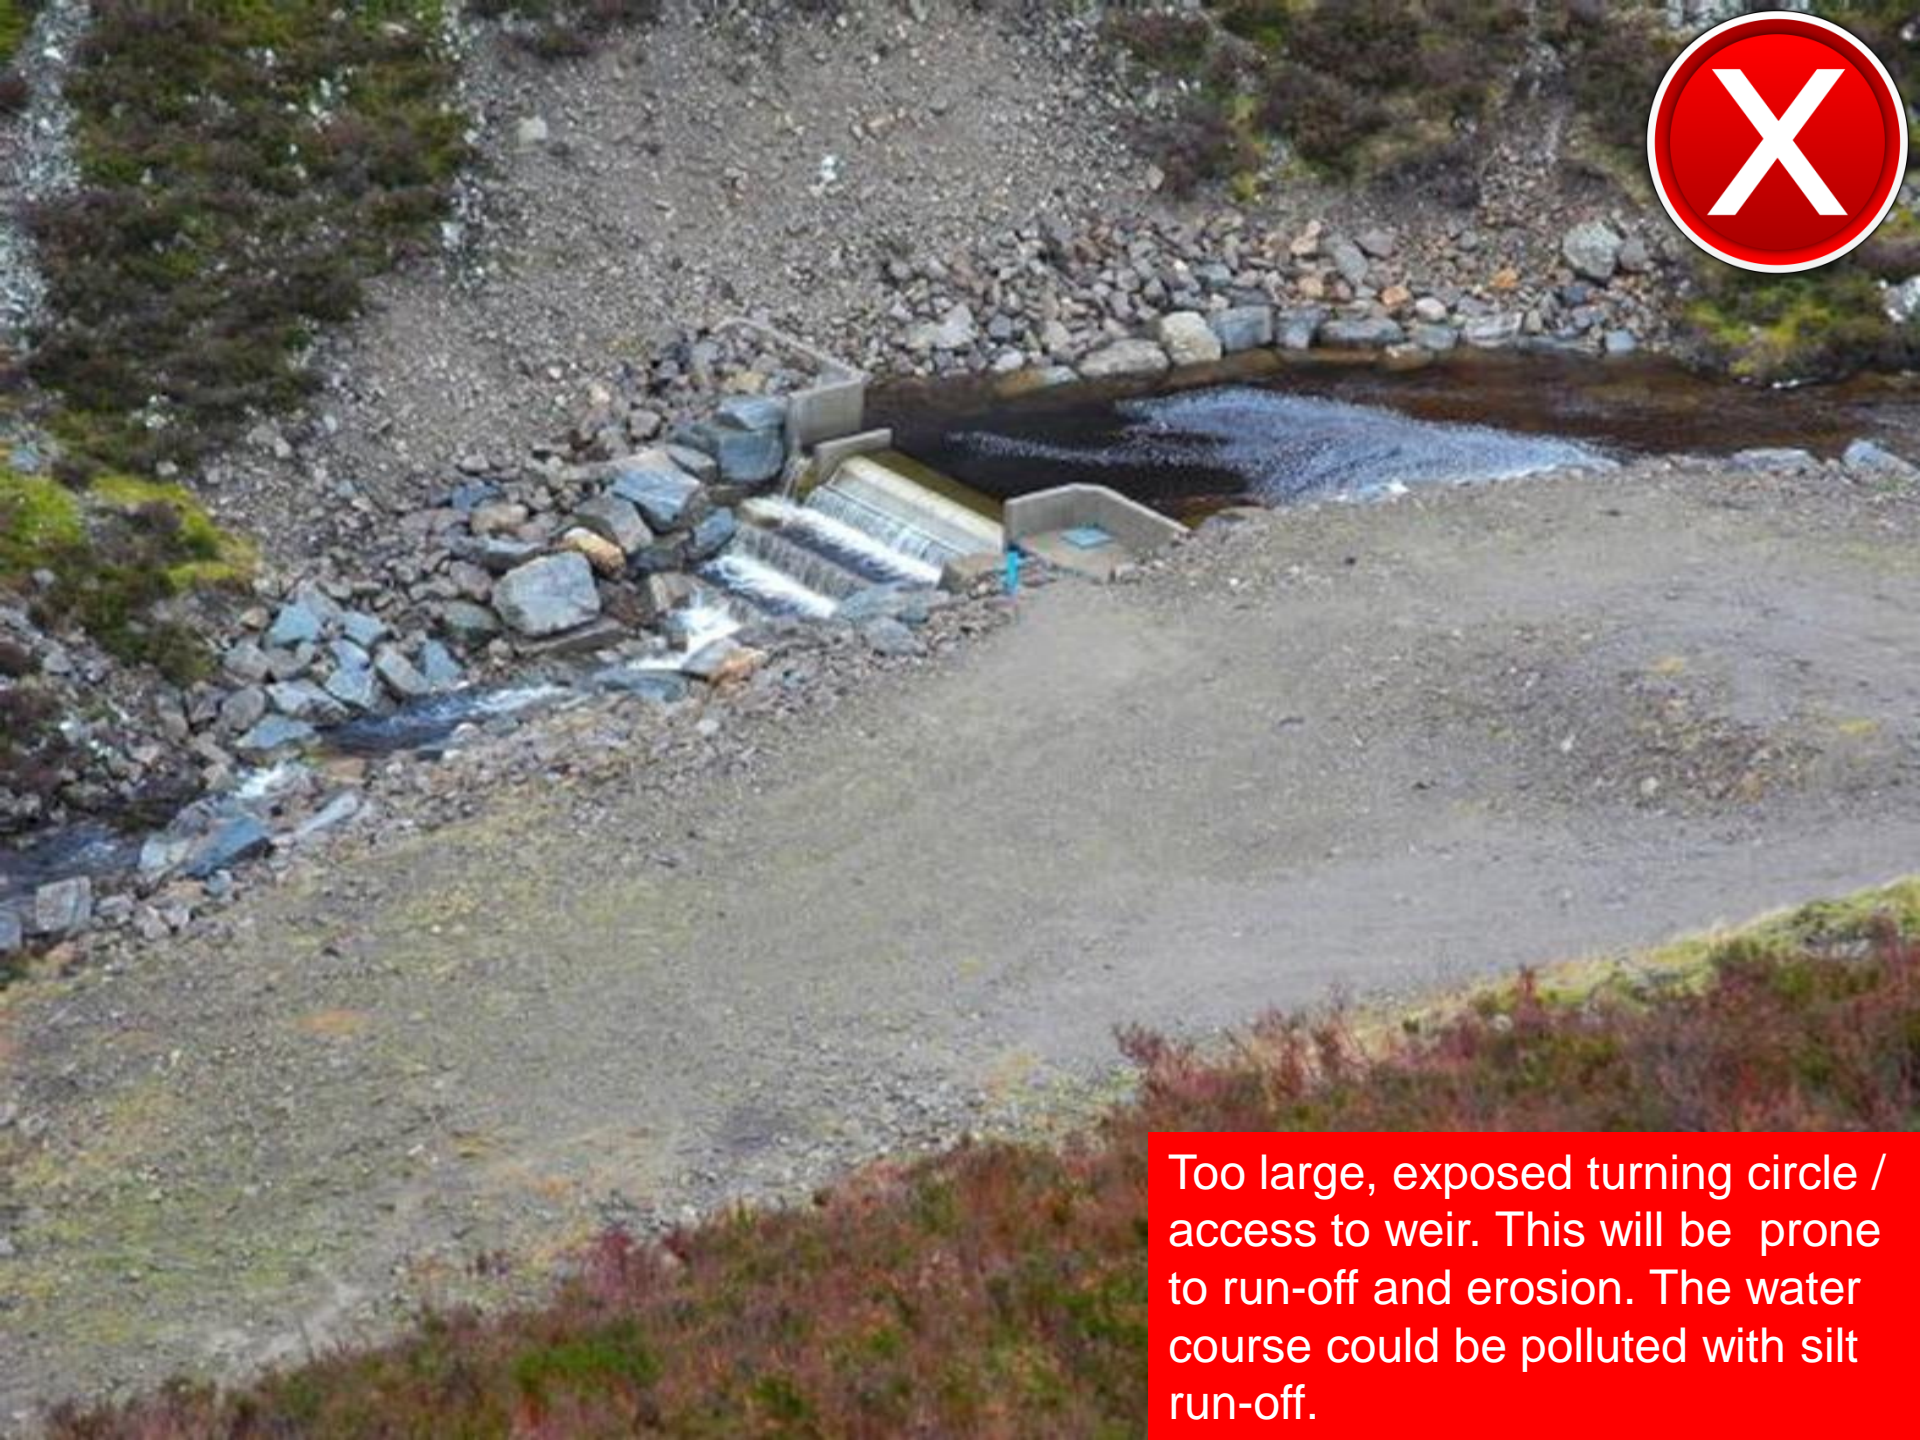
Difficult access to intake. High risk of erosion, and run-off to the watercourse.
The landscape will remain scarred for a long period of time, which can be bad for PR.

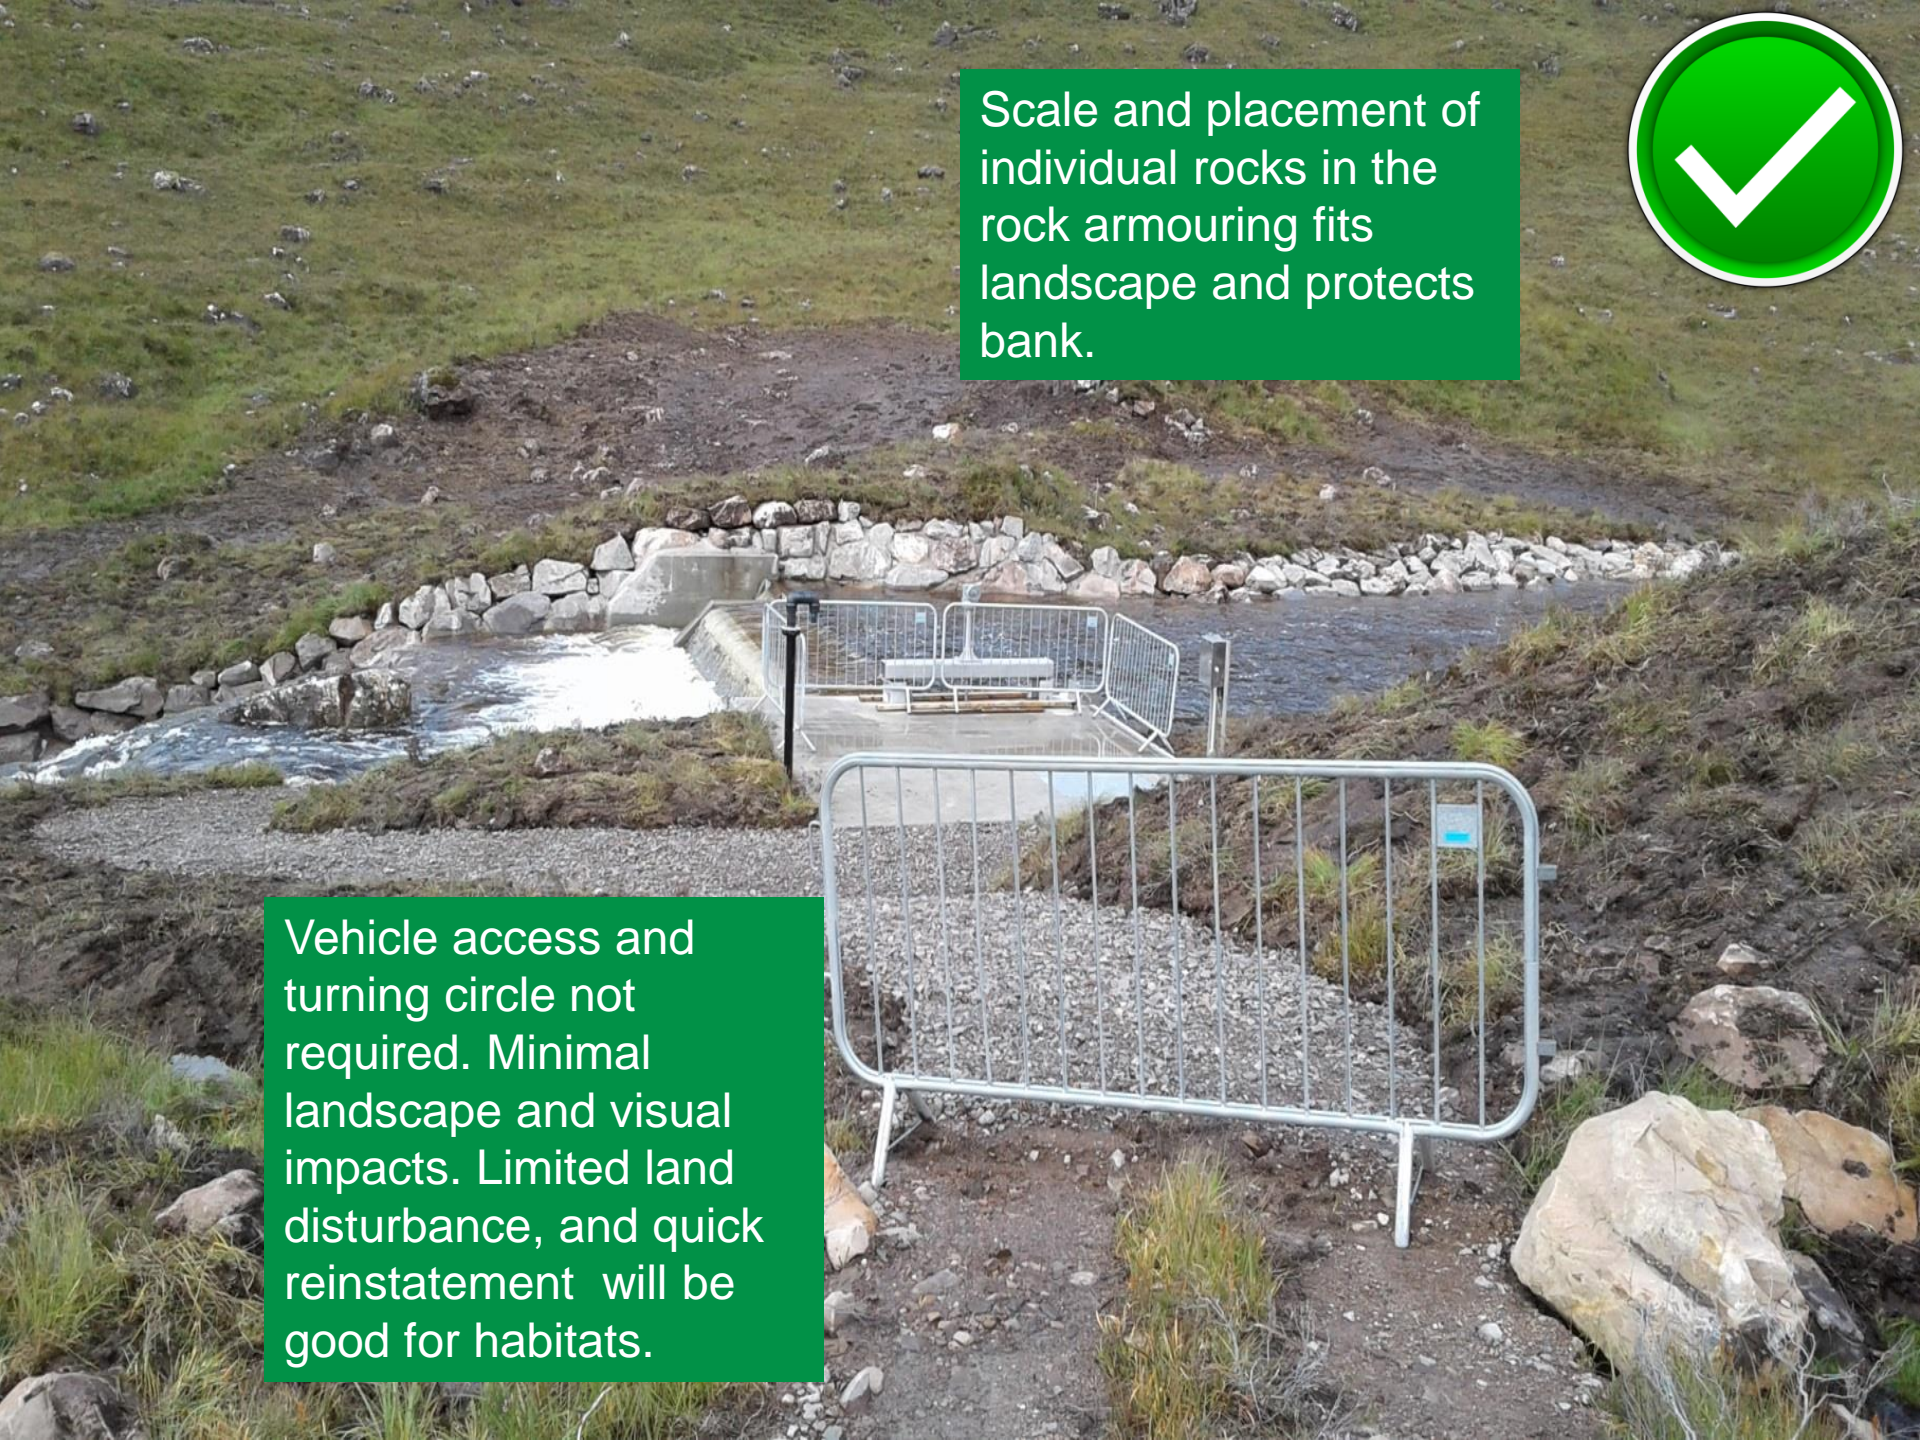
Vehicle access and turning circle not required. Minimal landscape and visual impacts. Limited land disturbance, and quick reinstatement will be good for habitats.

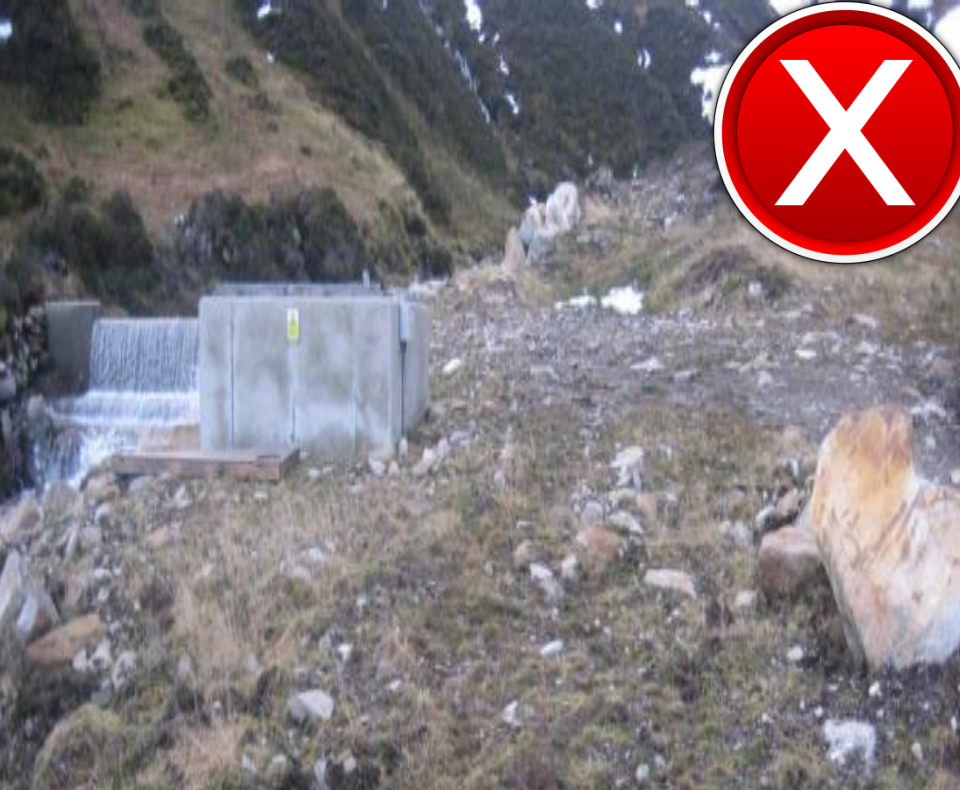
Infrastructure such as this concrete box can clutter the intake area, and increase visual impacts. Consider sensitive screening with soils and turves.

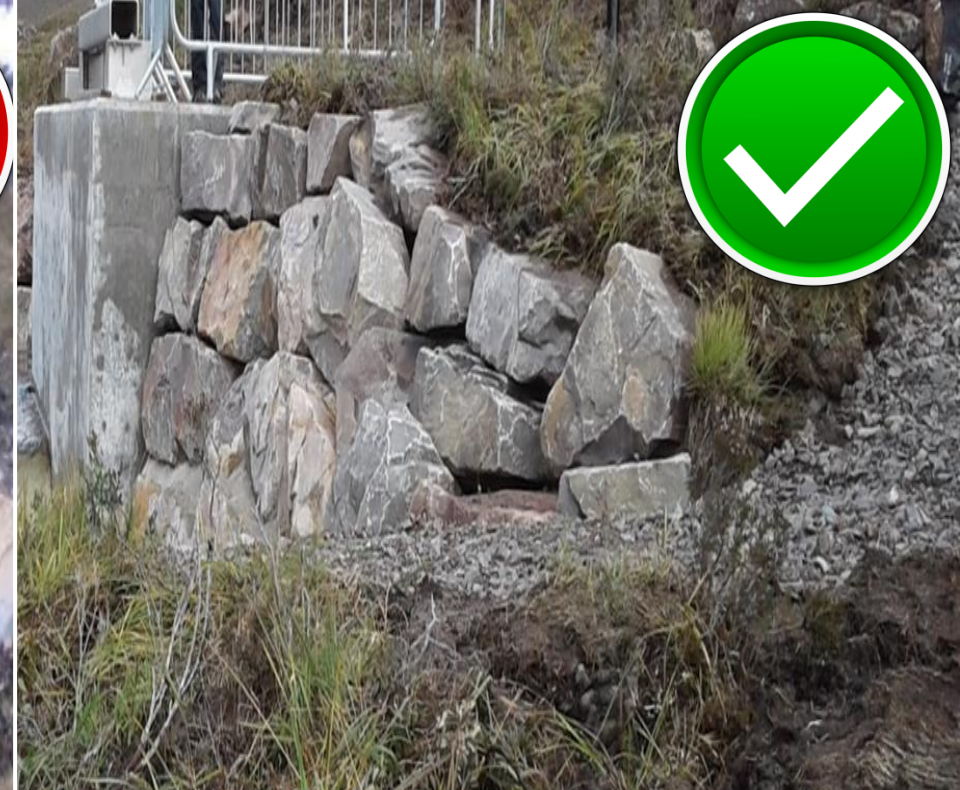
Rock armouring and well placed turves 'camouflaging' exposed wing walls.

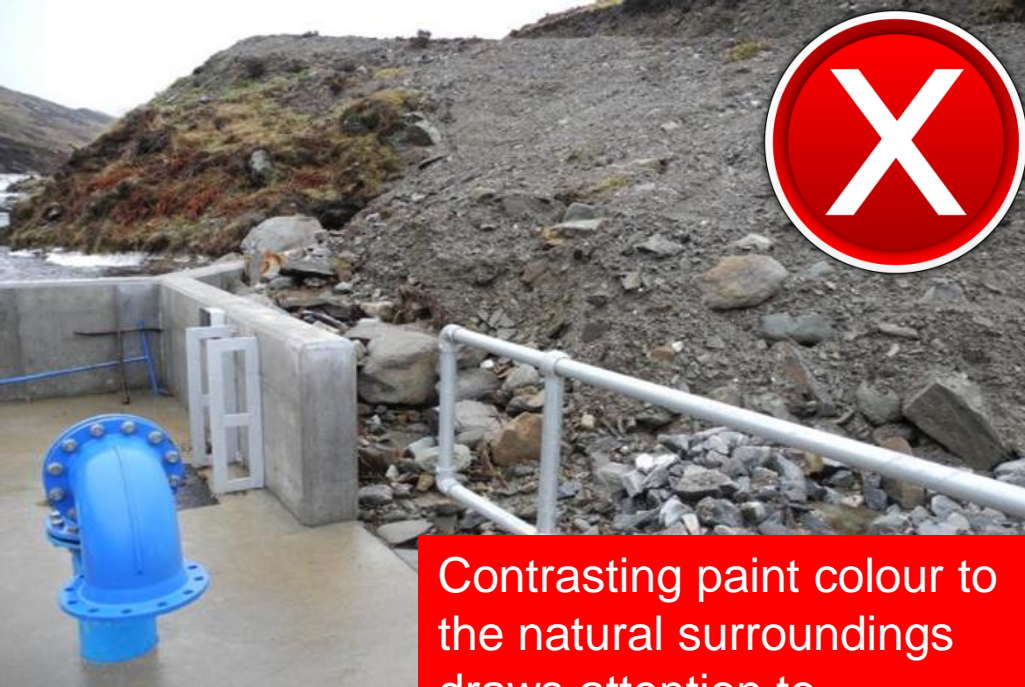
Contrasting paint colour to the natural surroundings draws attention to infrastructure and leads to landscape and visual impacts.

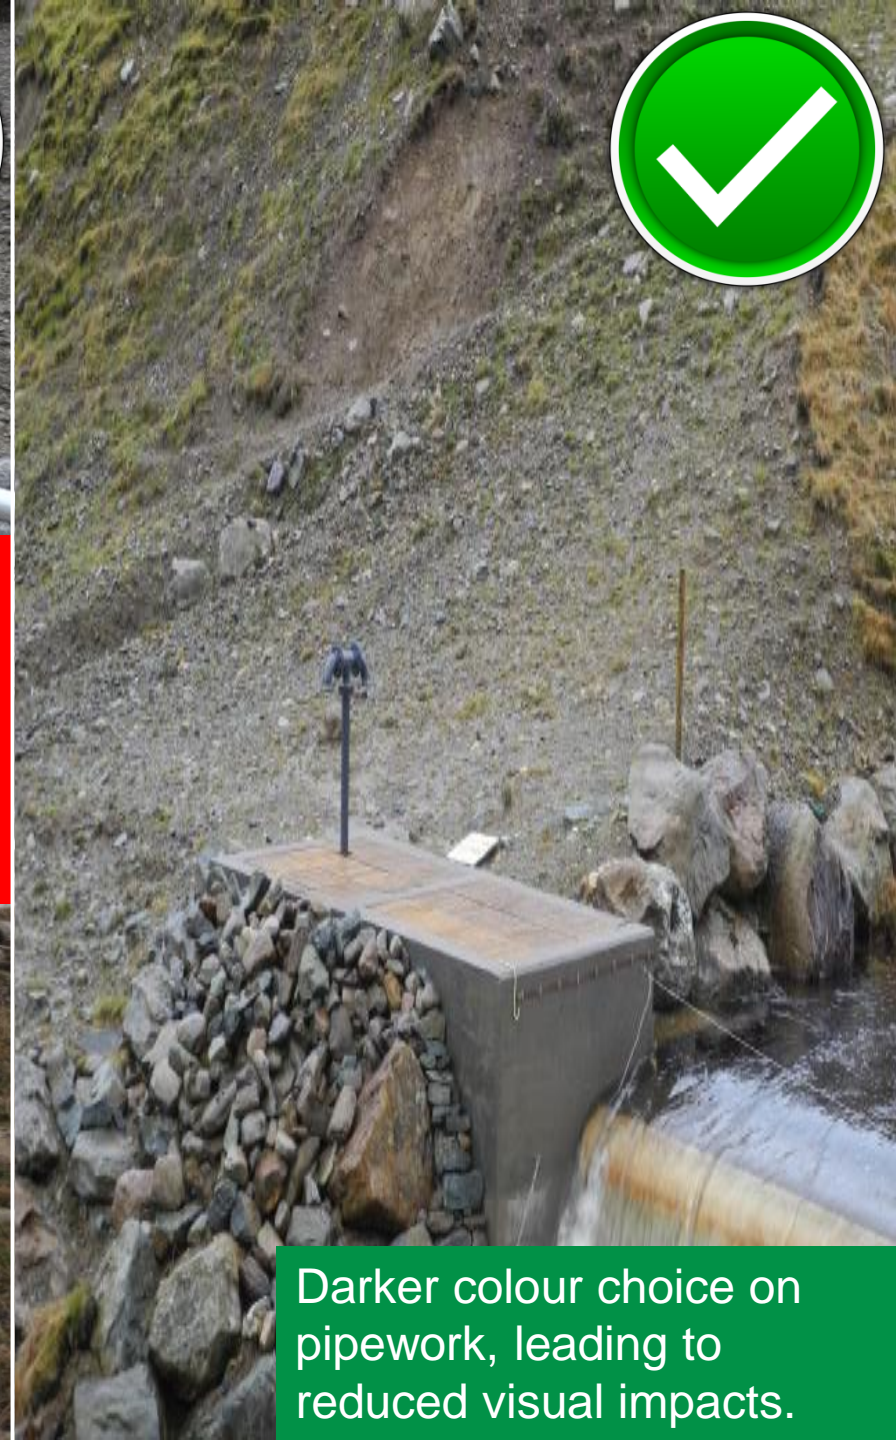
Darker colour choice on pipework, leading to reduced visual impacts.

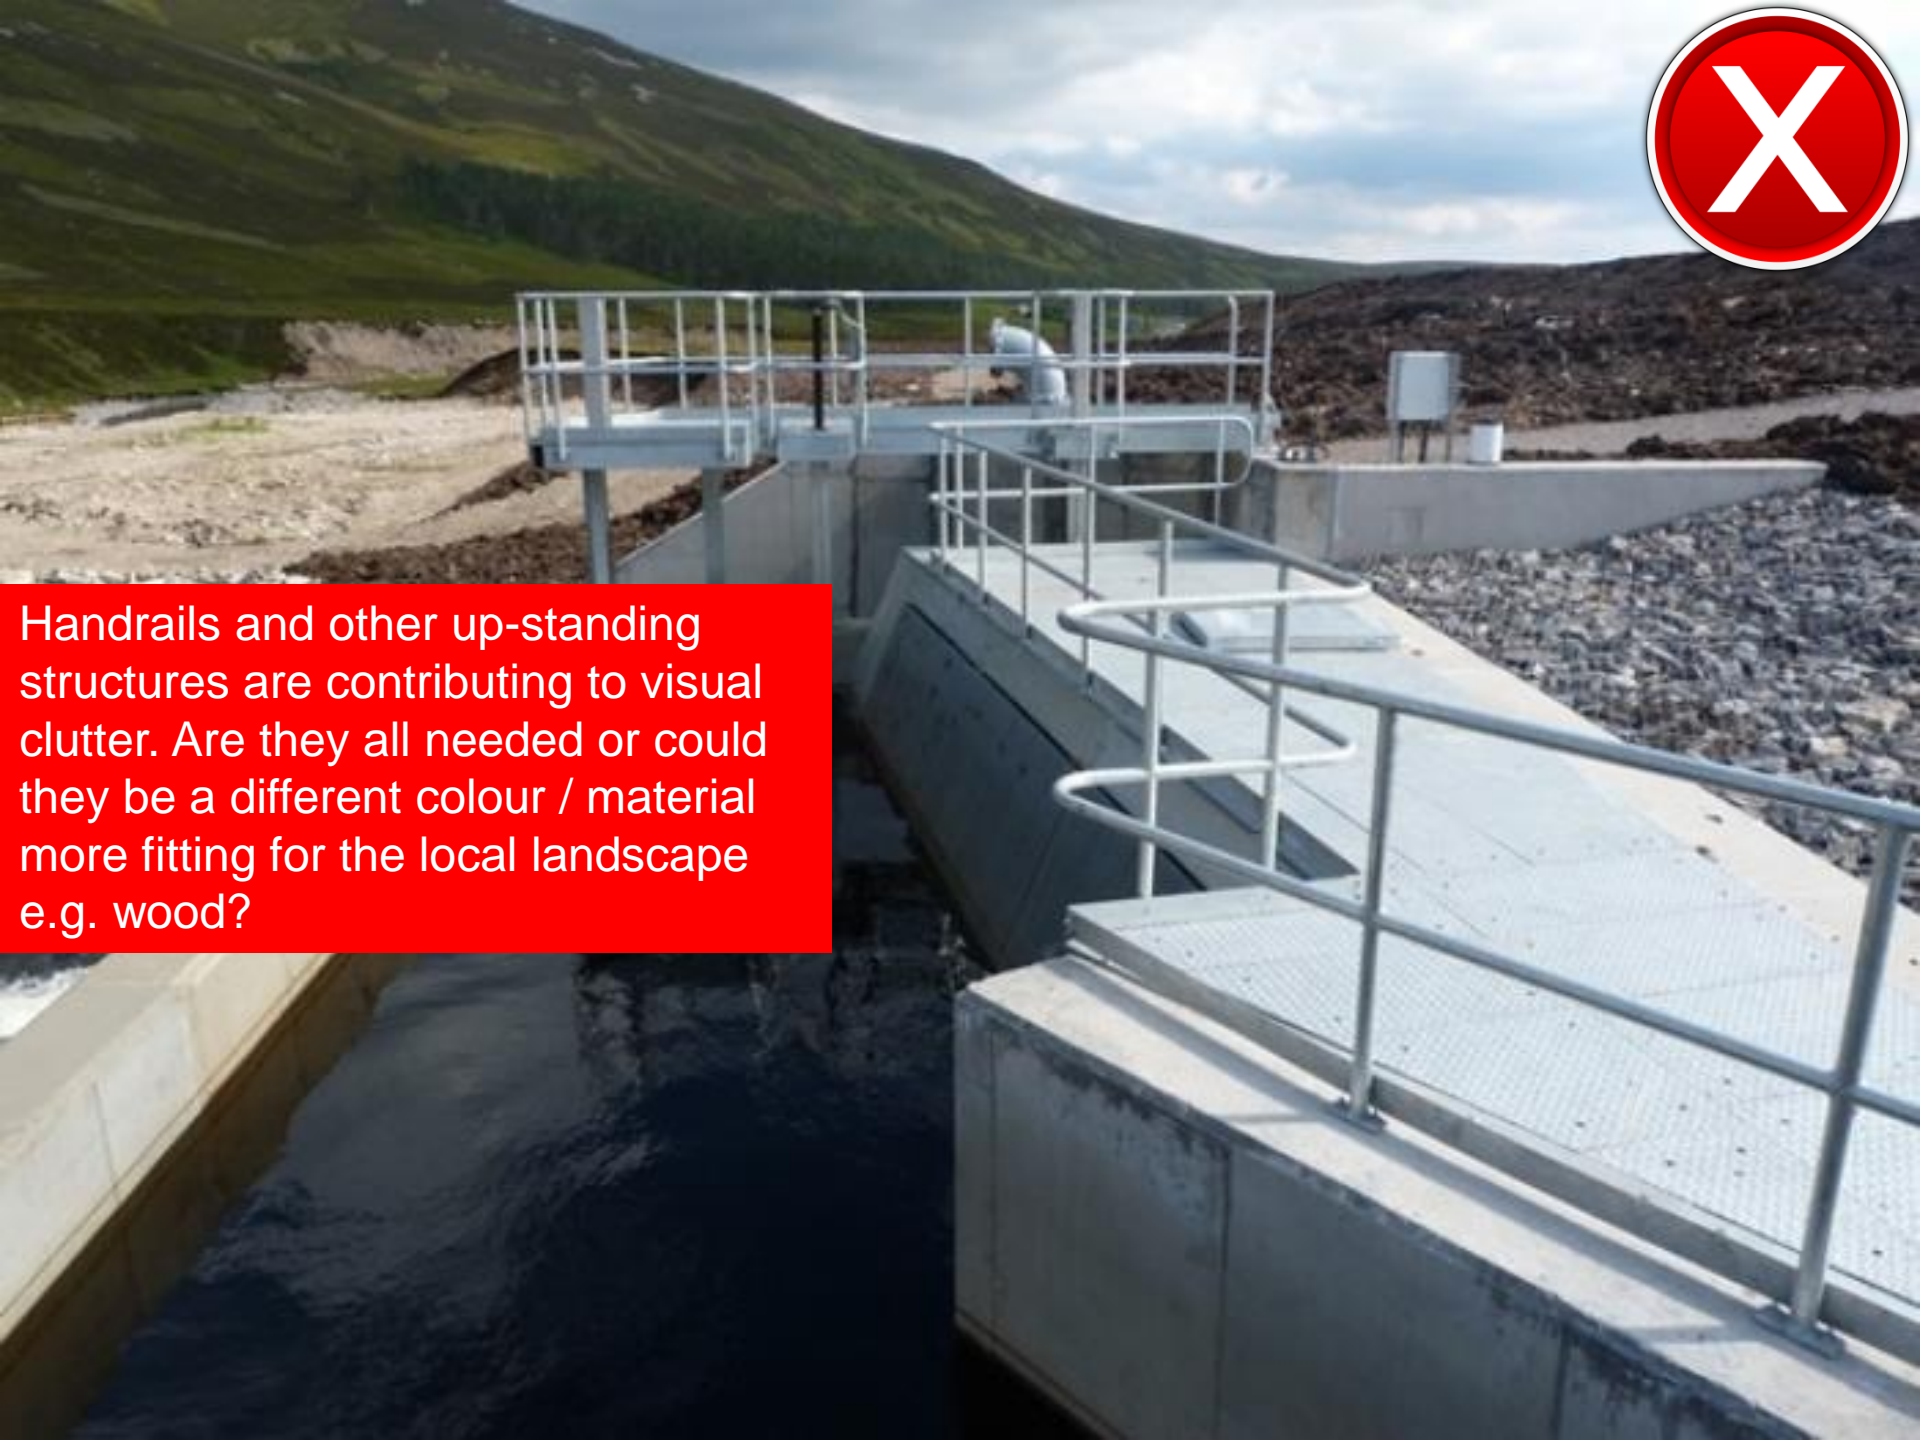
Handrails and other up-standing structures are contributing to visual clutter. Are they all needed or could they be a different colour / material more fitting for the local landscape e.g. wood?

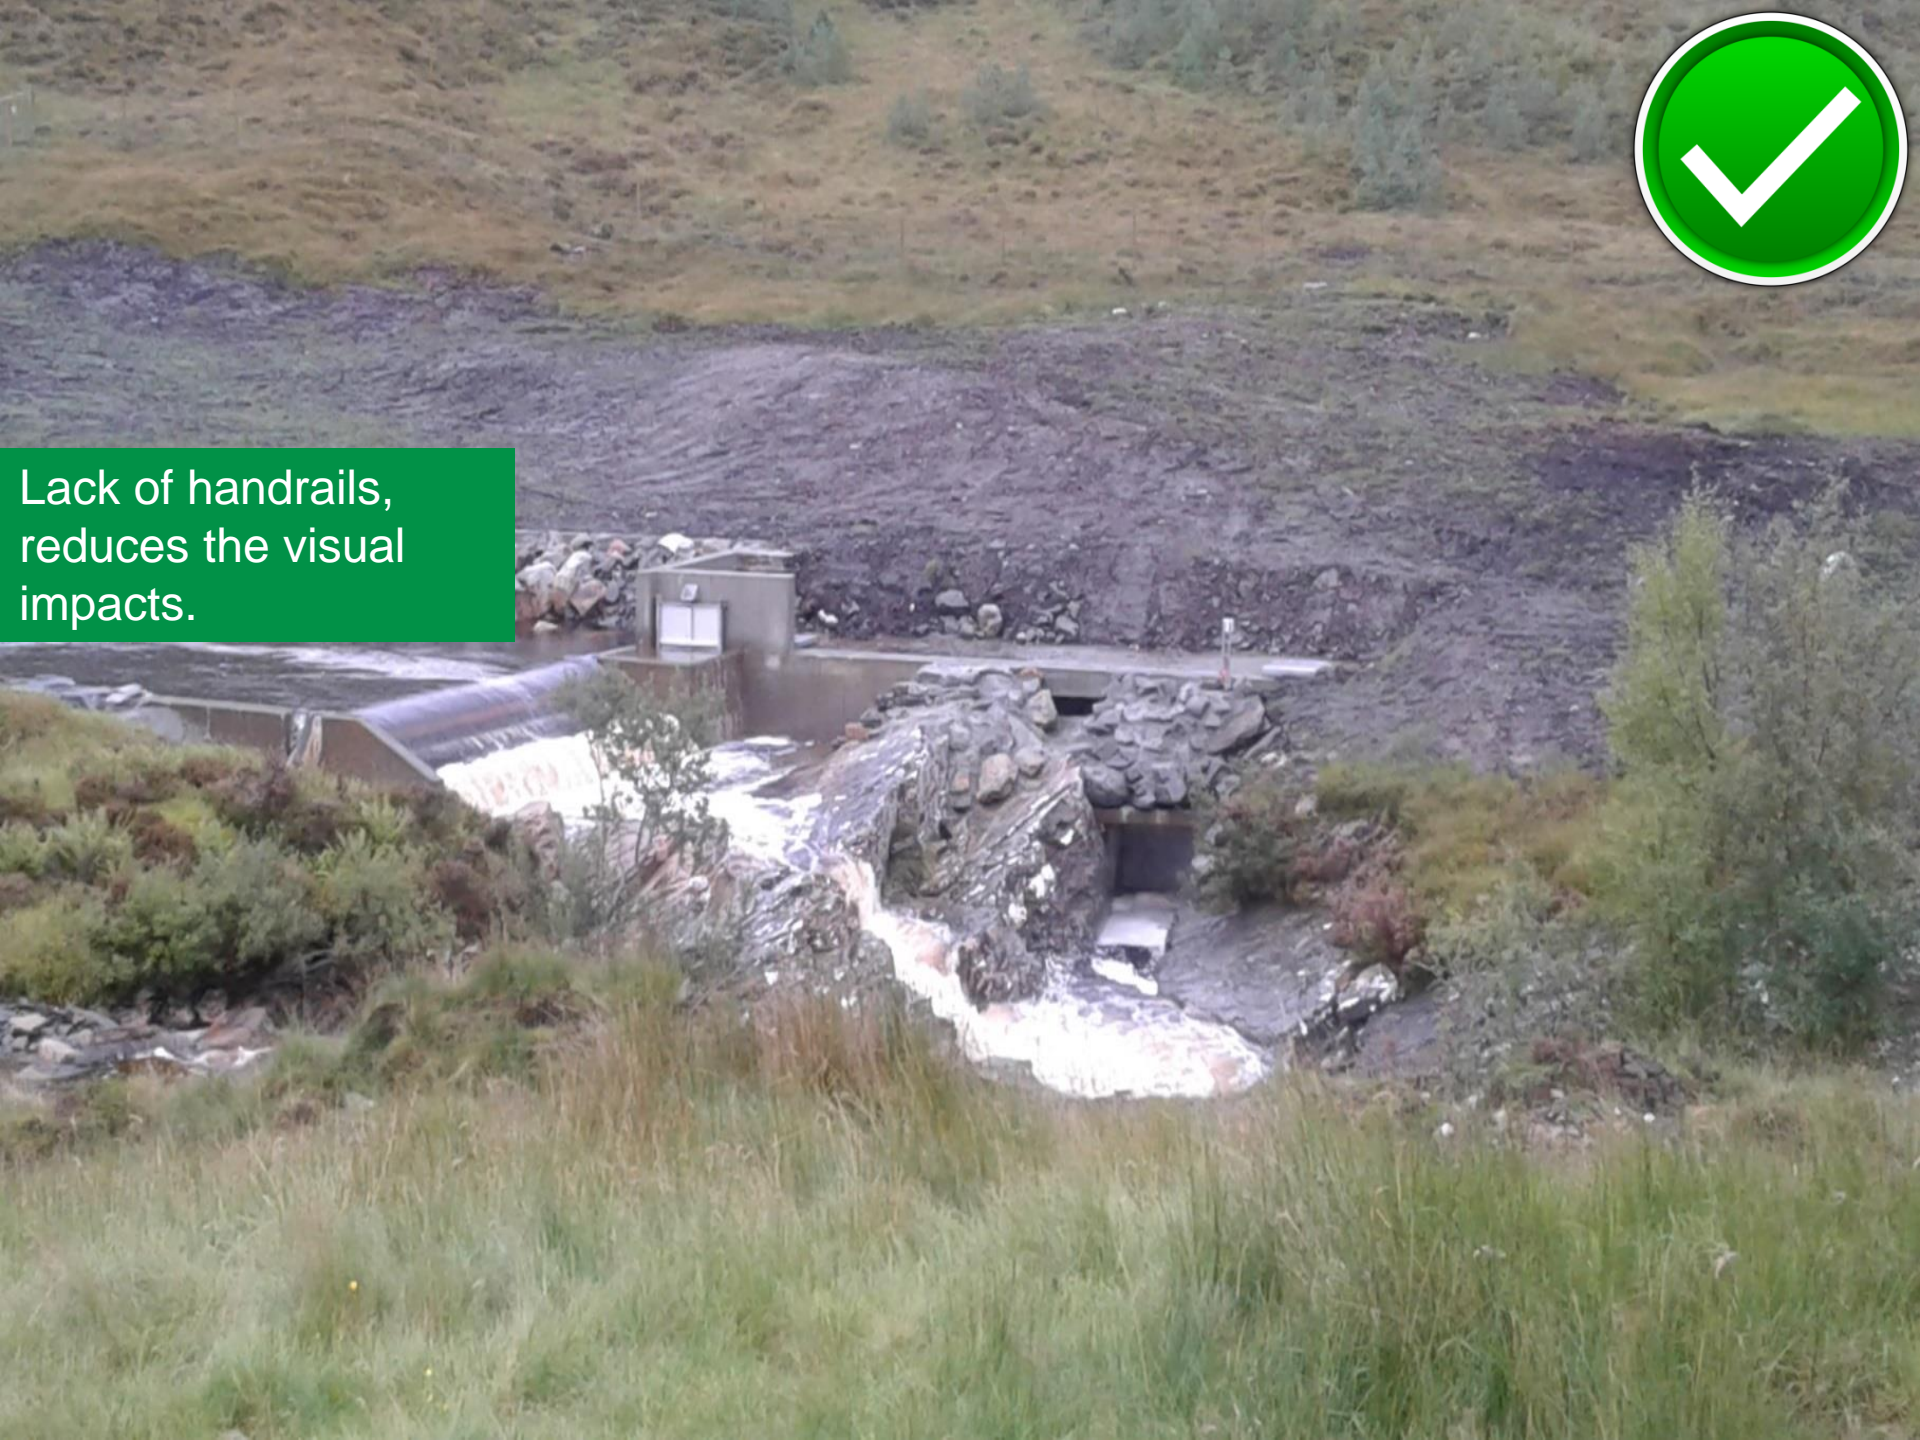
Lack of handrails,
reduces the visual
impacts.

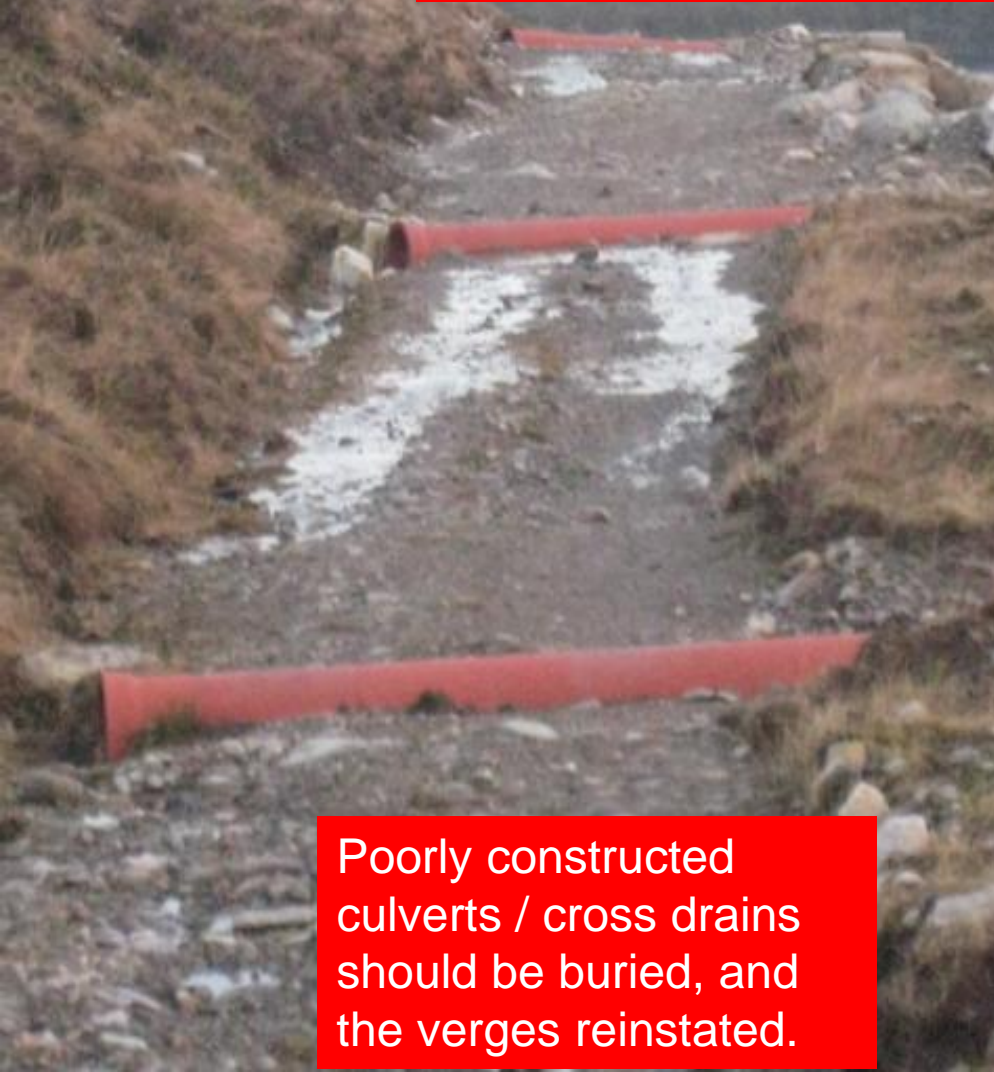
These red pipes are sitting proud of the track leading to visual impacts. Erosion of the path is likely in this poorly constructed state.

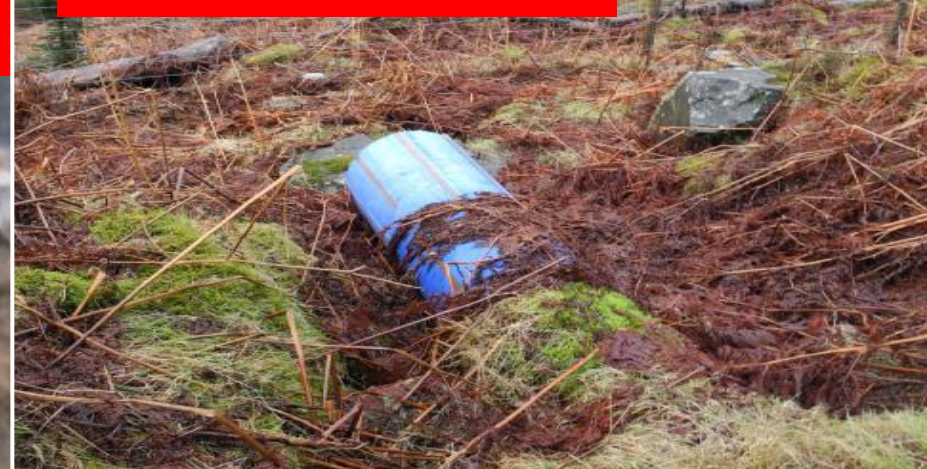
Poorly constructed culvert – protruding pipe is prominent. The discharge is likely to erode the habitat below.

Poorly constructed culvert – protruding pipe is very visible, and the habitat below the falling water is prone to erosion.

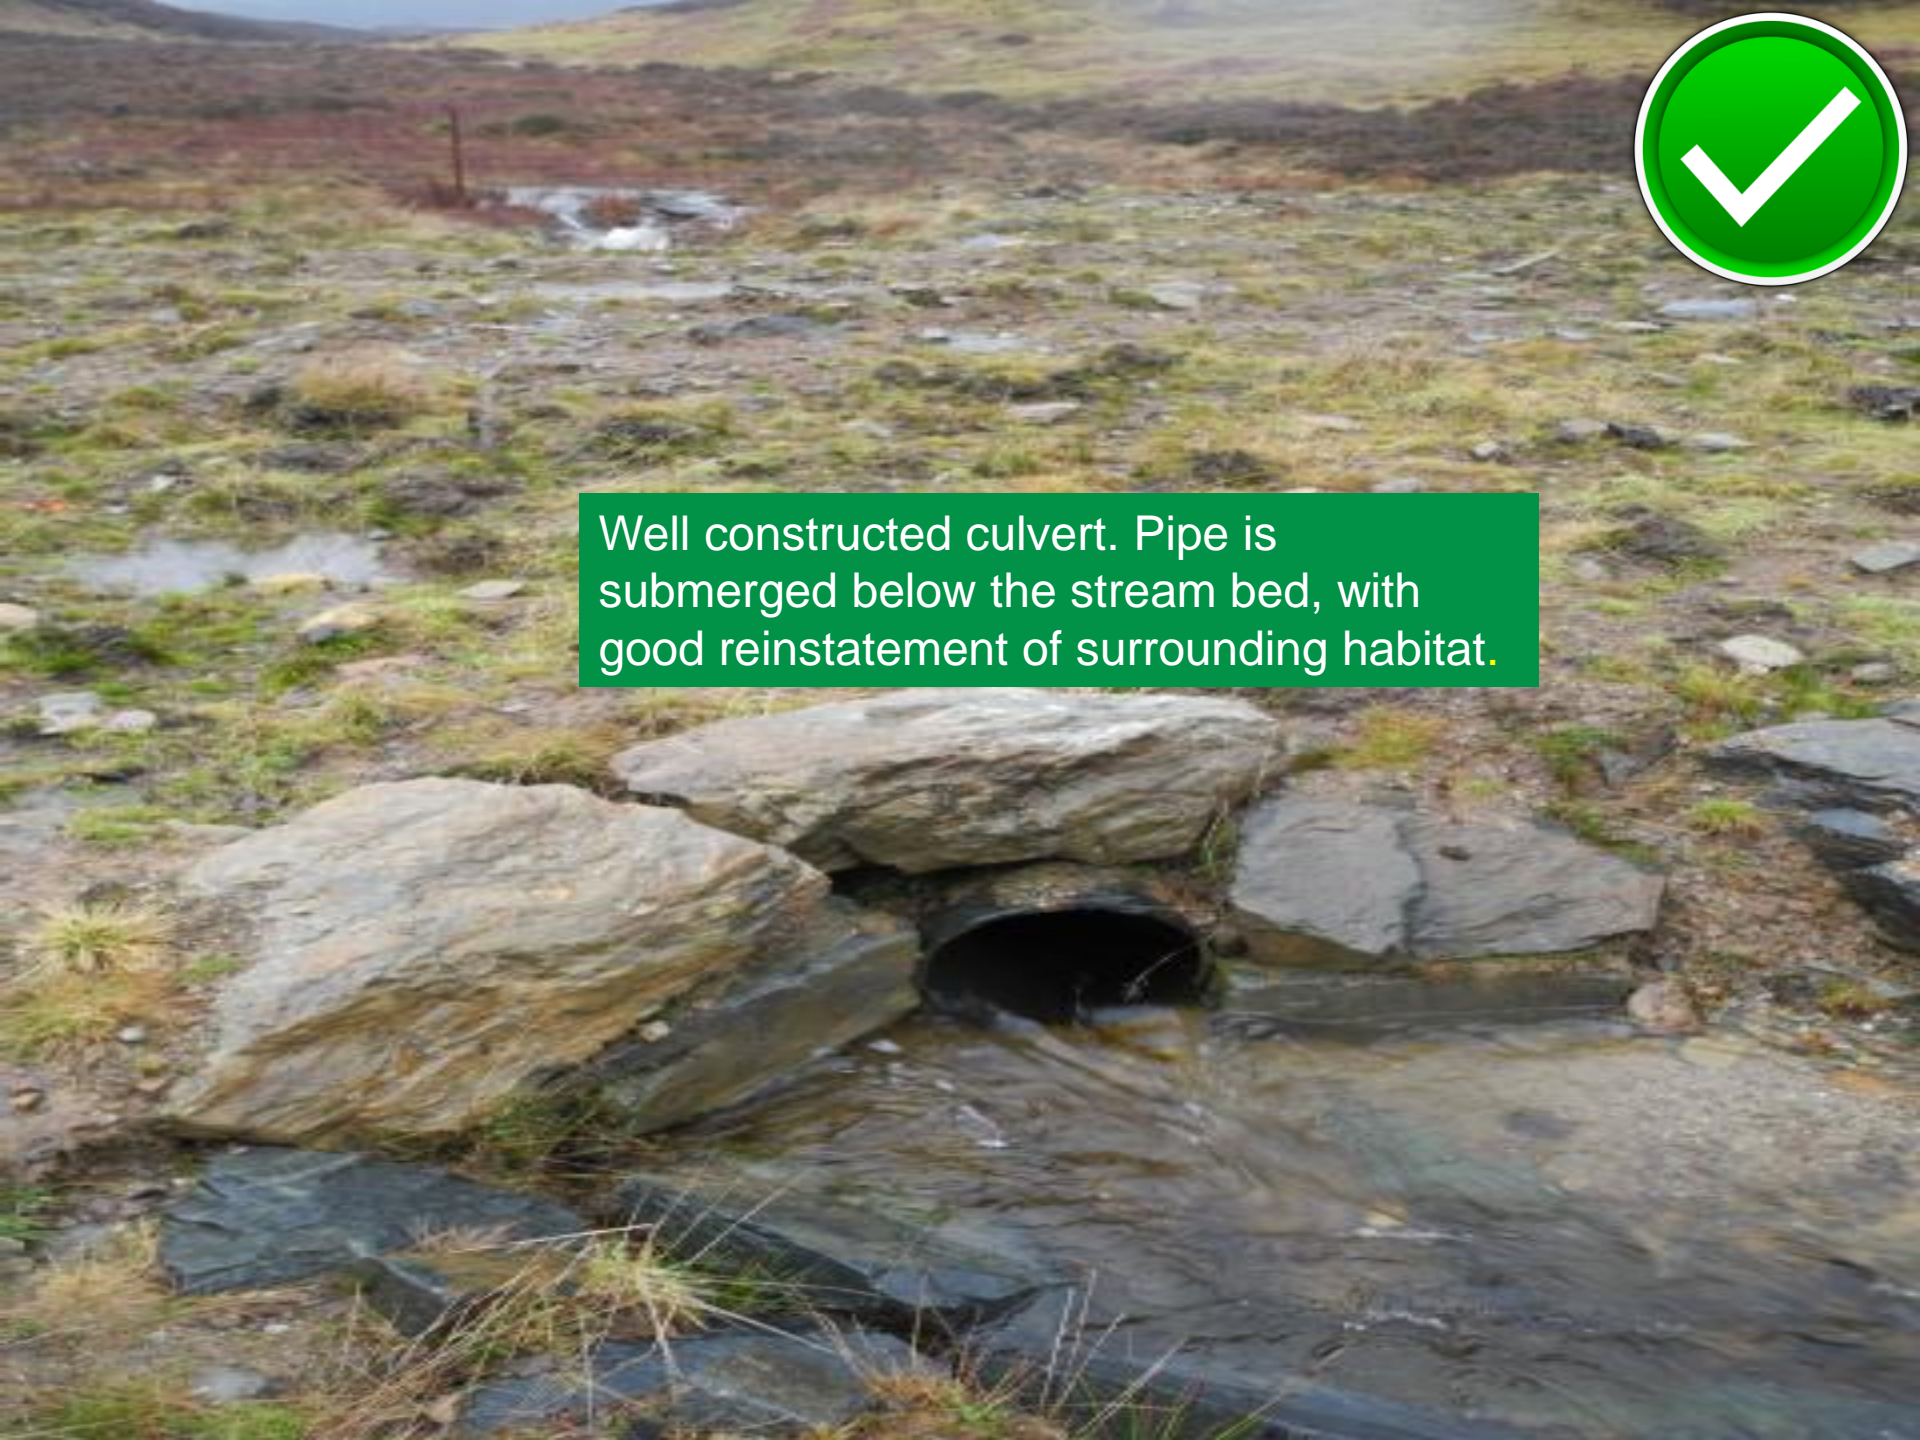
Well constructed culvert. Pipe is submerged below the stream bed, with good reinstatement of surrounding habitat.

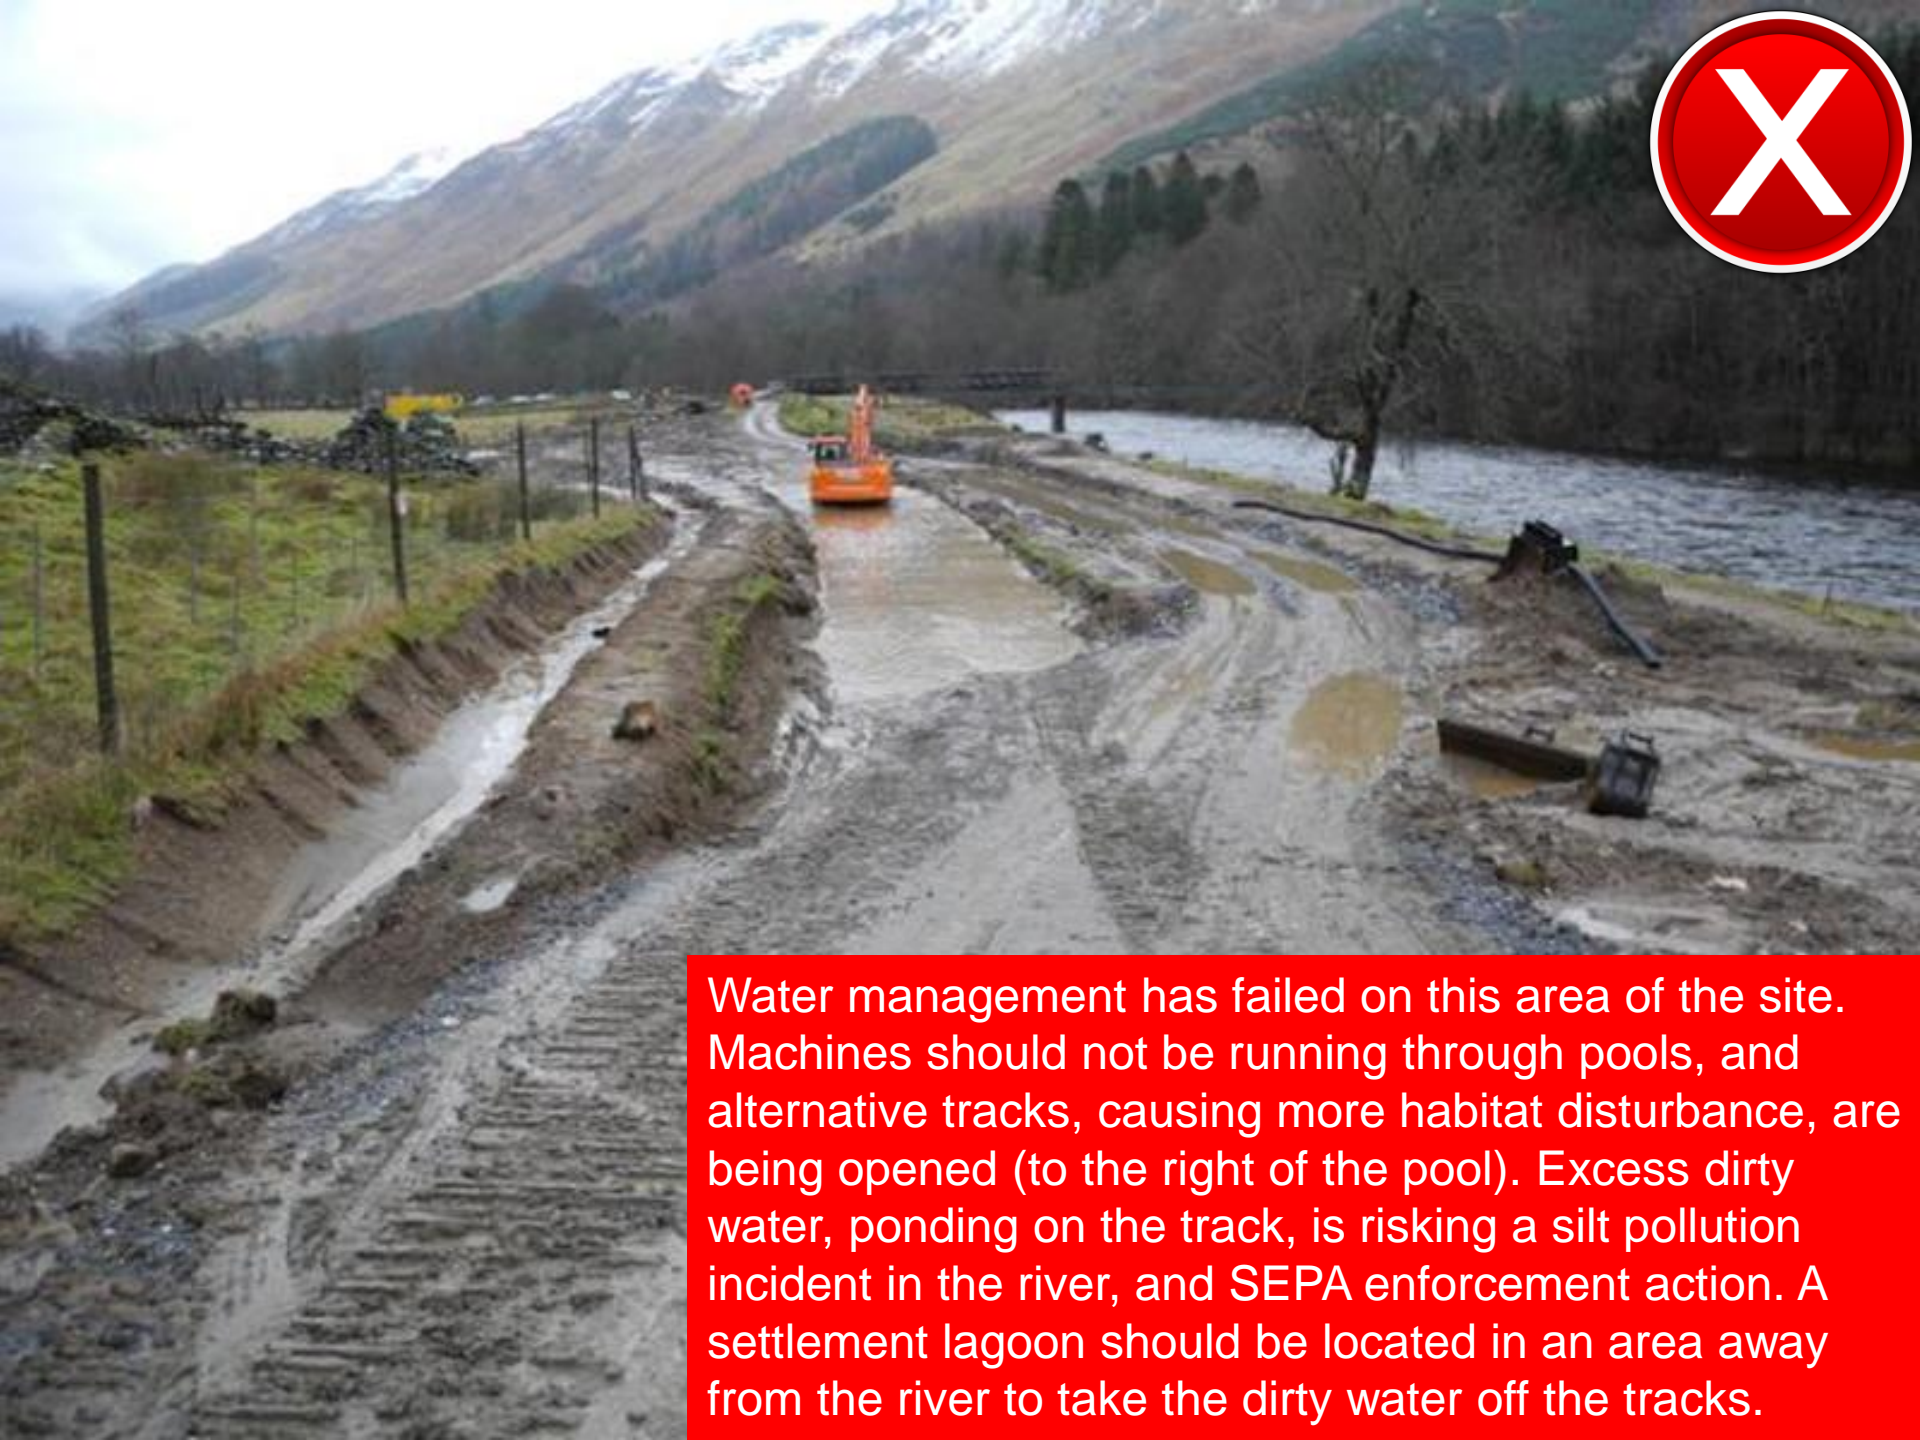
Water management has failed on this area of the site. Machines should not be running through pools, and alternative tracks, causing more habitat disturbance, are being opened (to the right of the pool). Excess dirty water, ponding on the track, is risking a silt pollution incident in the river, and SEPA enforcement action. A settlement lagoon should be located in an area away from the river to take the dirty water off the tracks.
