Good practice guide for minimising impacts on the natural heritage during construction.

This guide shows examples of good and poor practice examples for hydro construction.

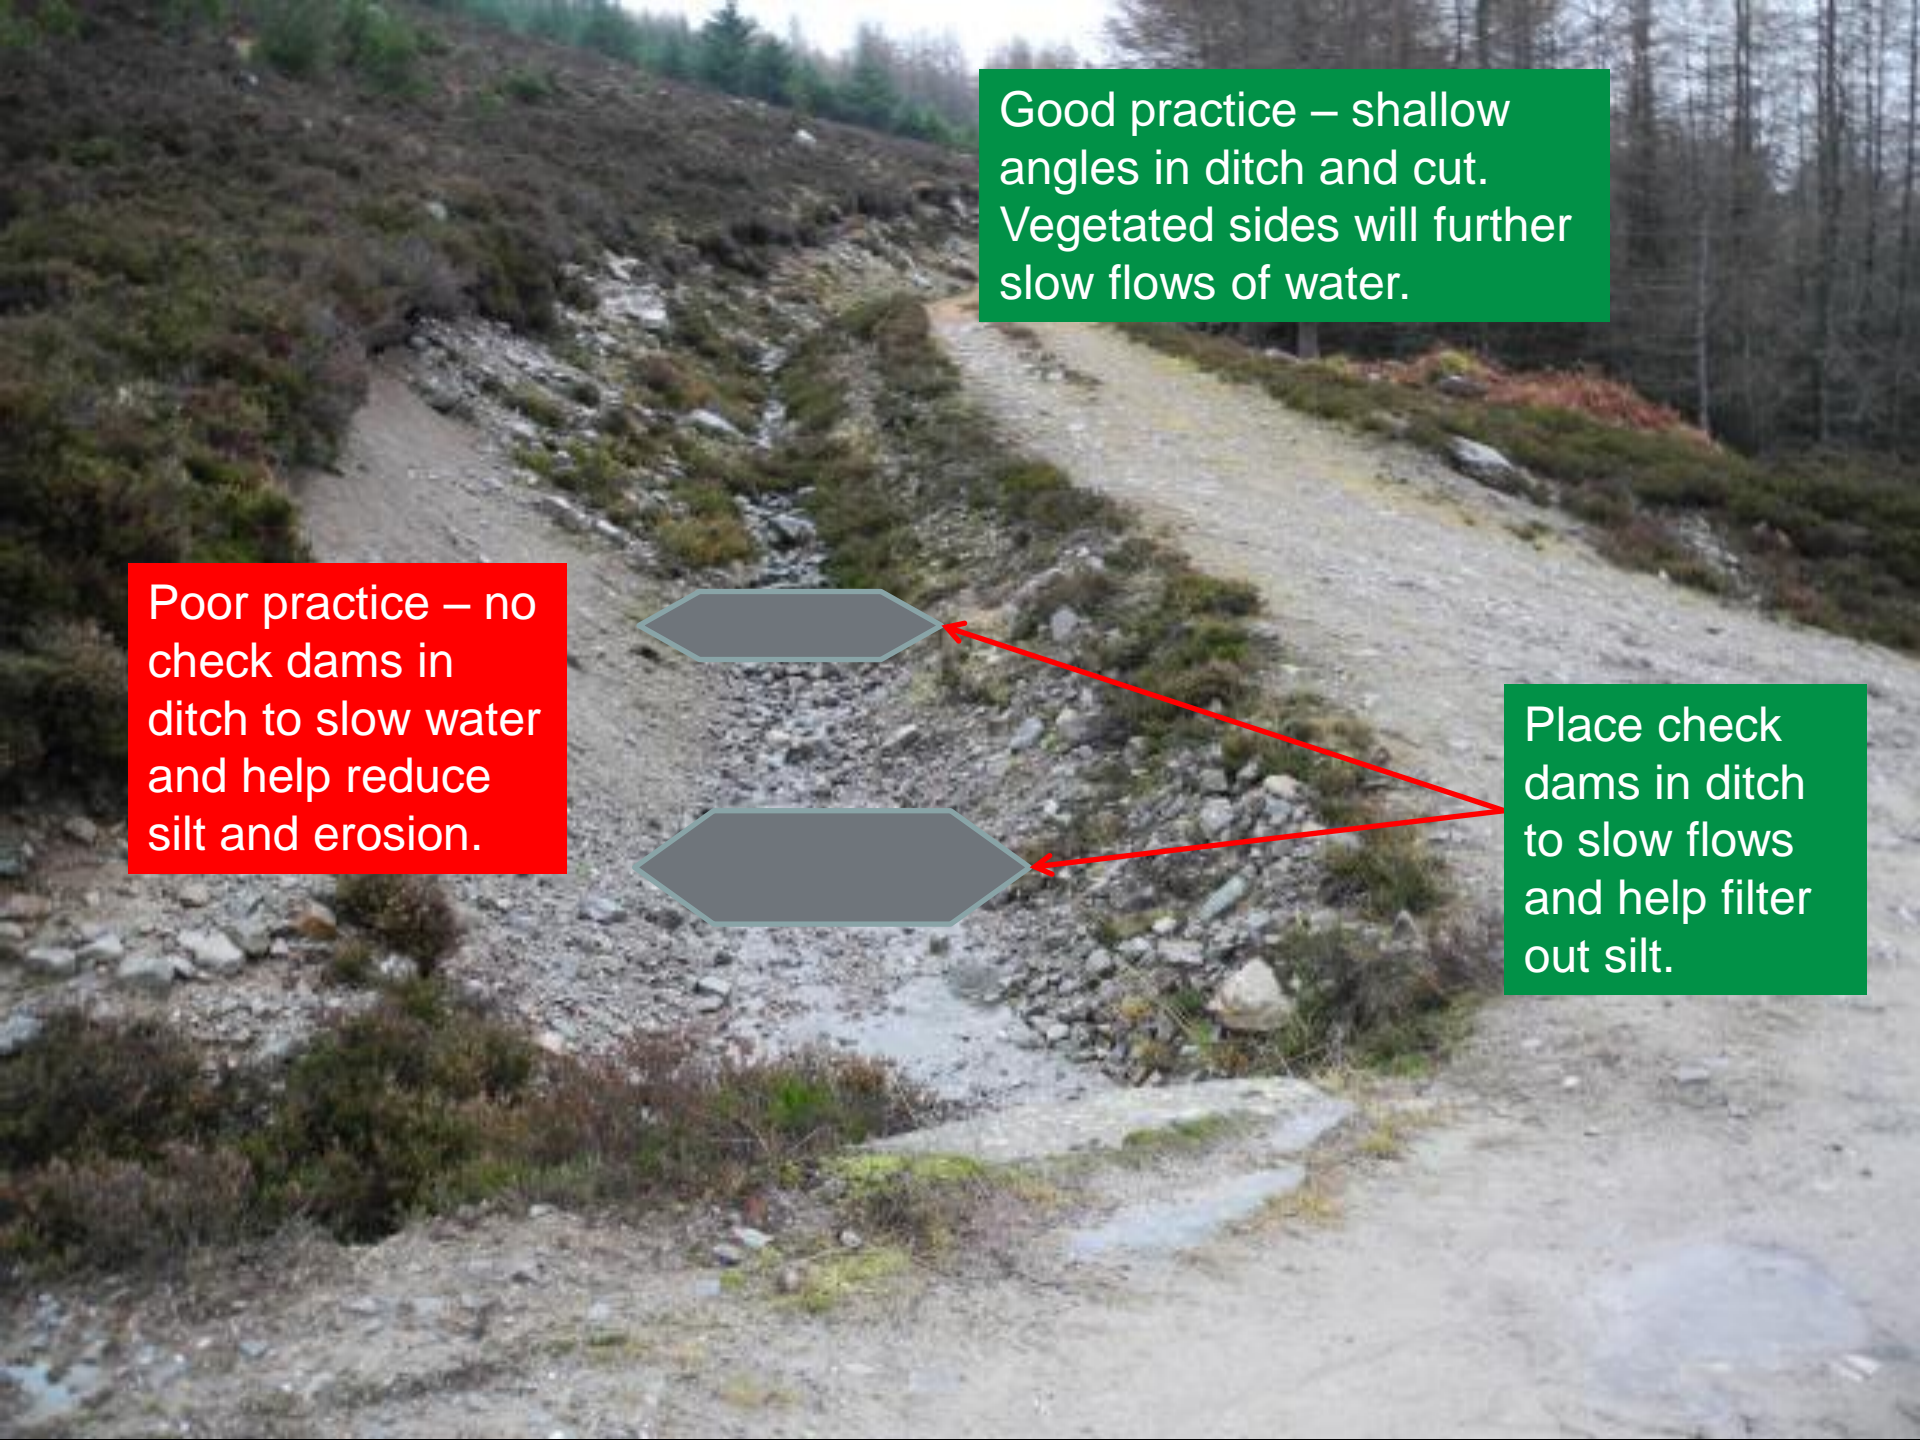
Poor road-side ditch construction under-cutting the vegetation above on this steep cut.

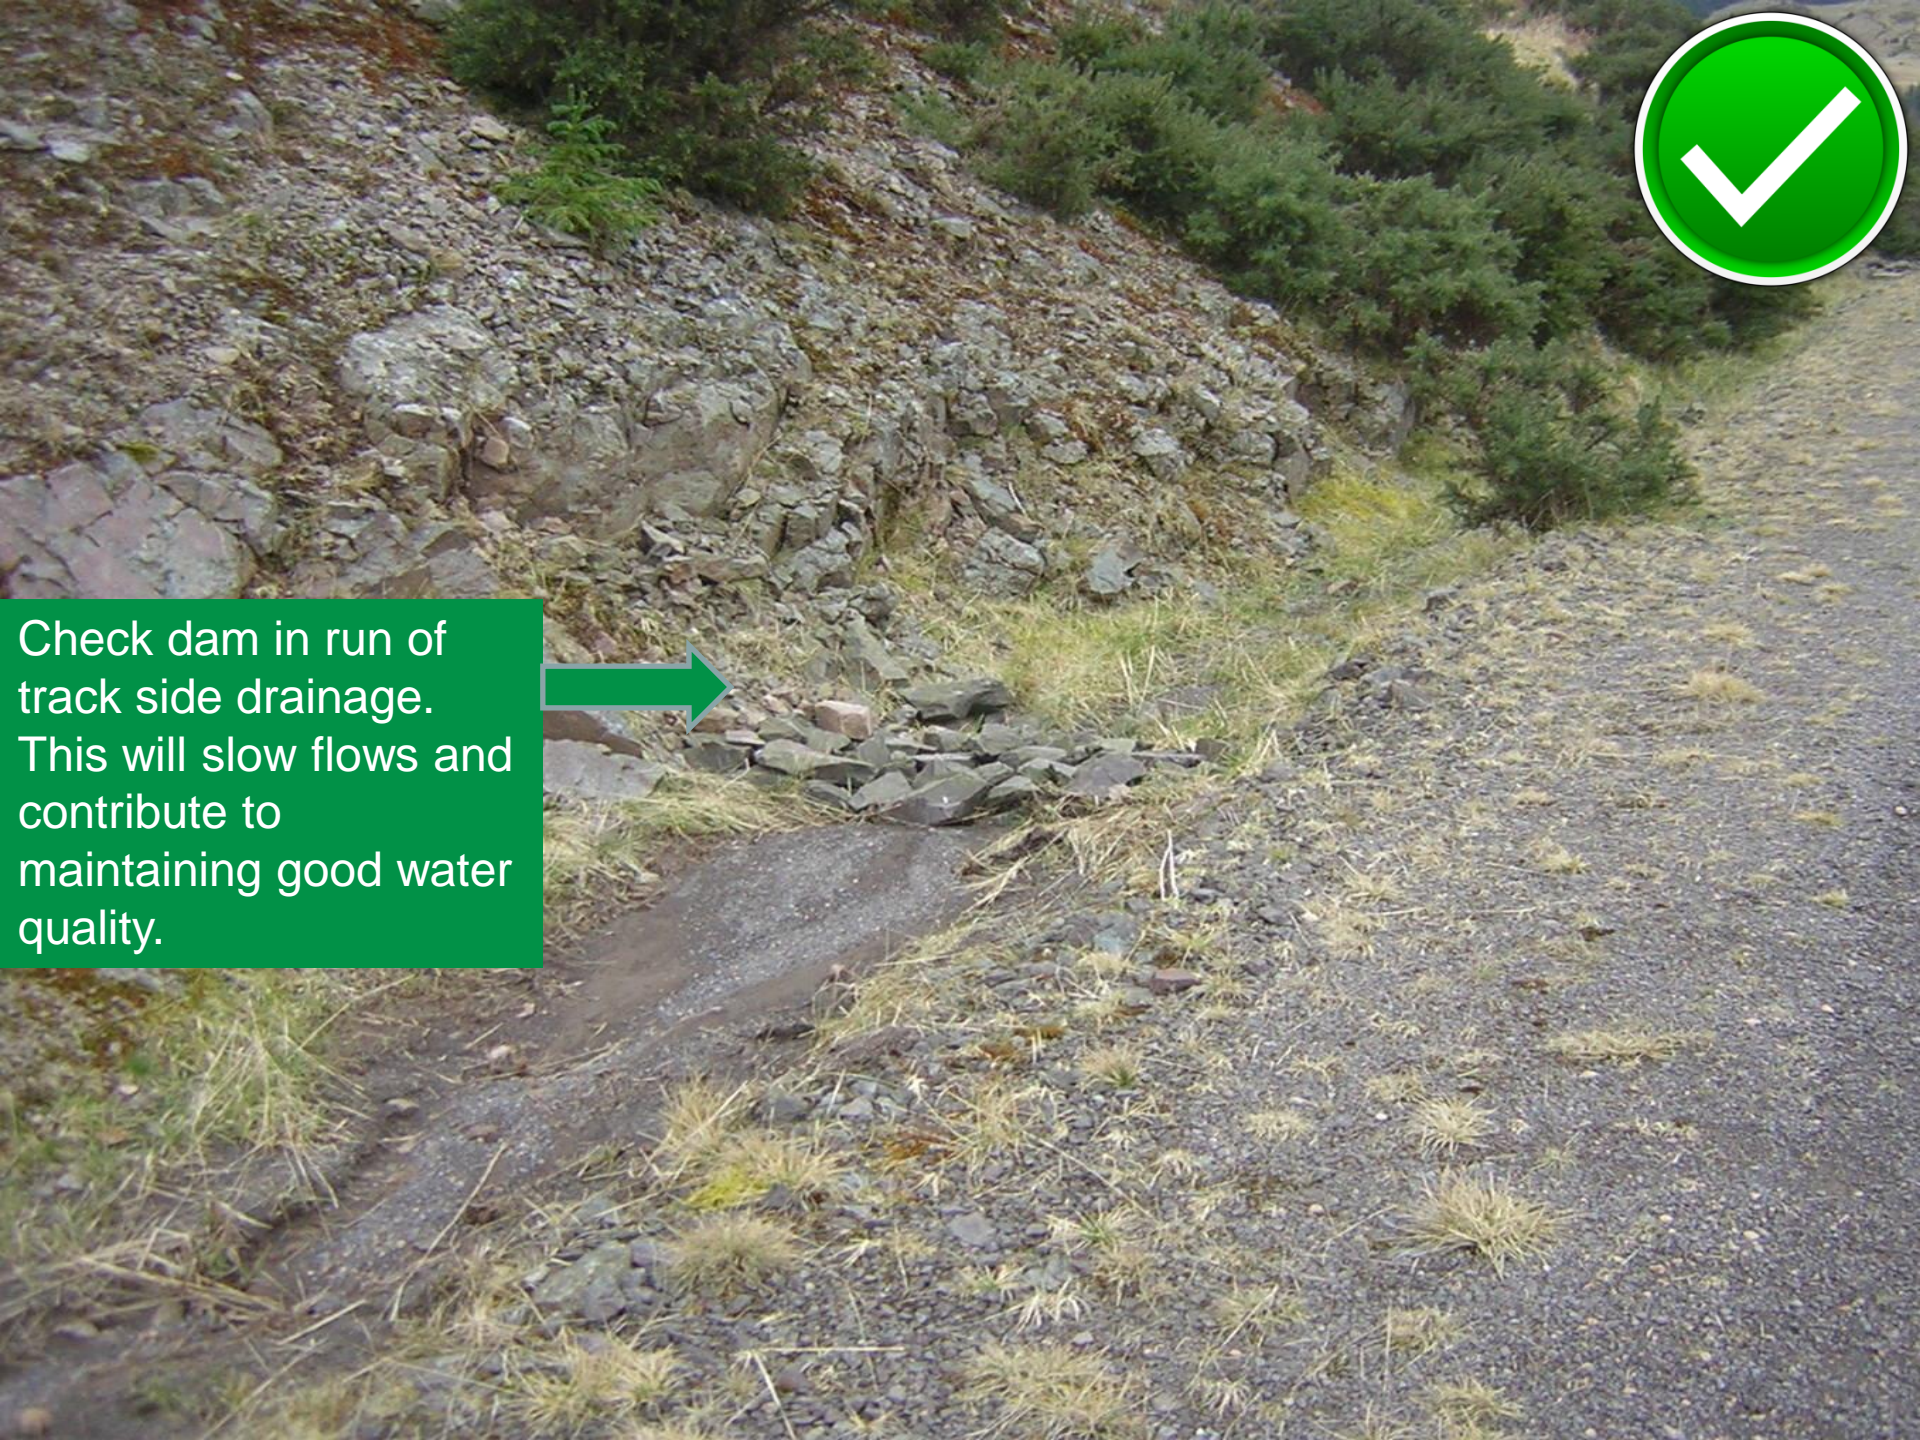
Check dam in run of track side drainage. This will slow flows and contribute to maintaining good water quality.

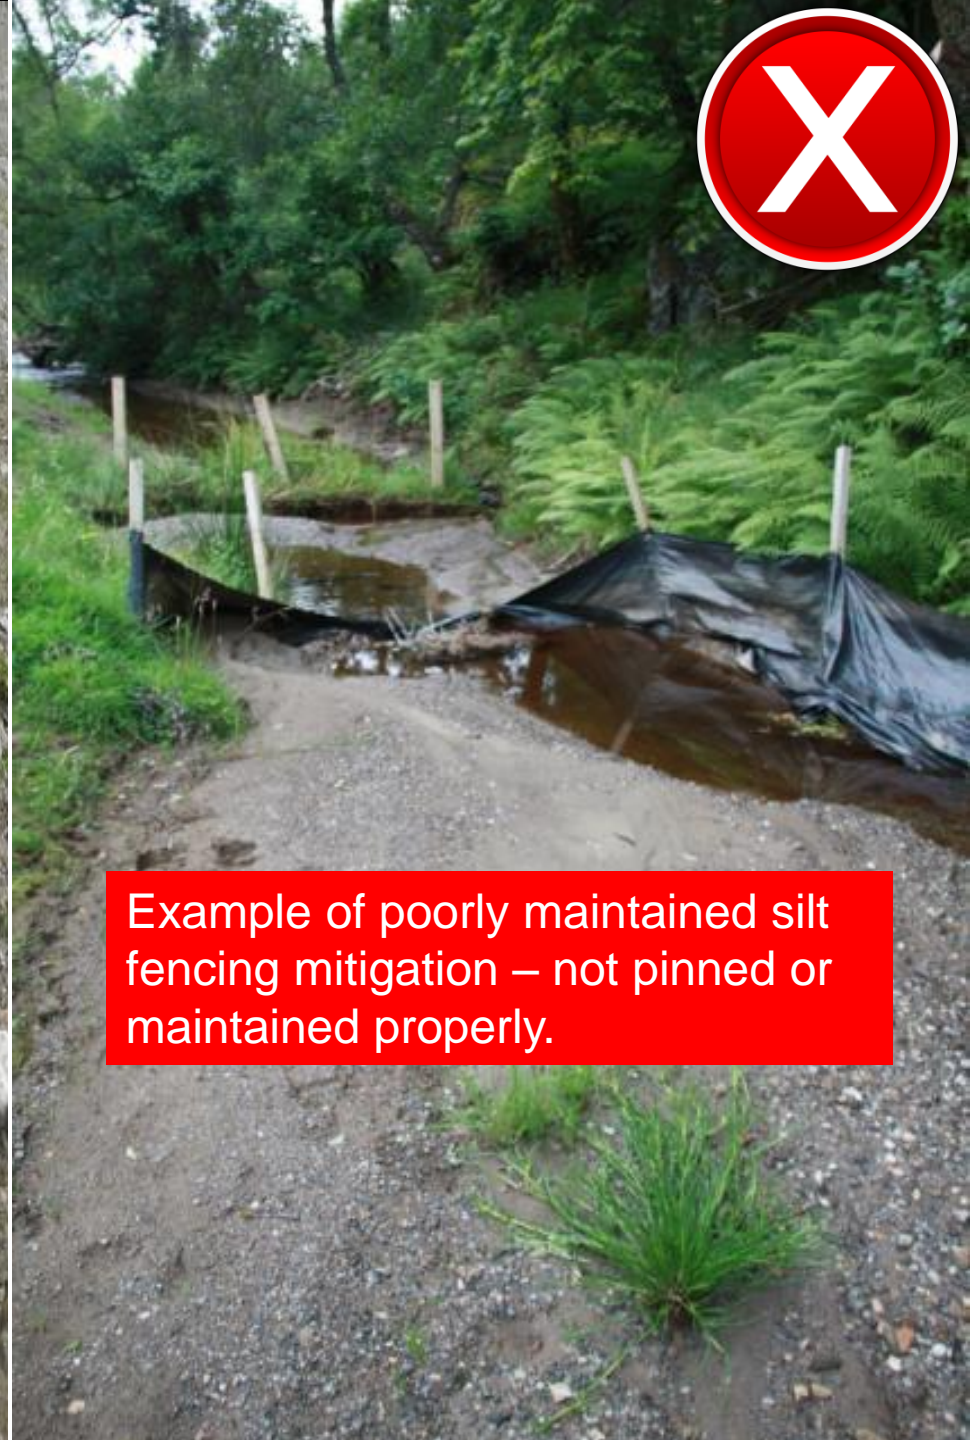
Example of poorly maintained silt fencing mitigation – not pinned or maintained properly.

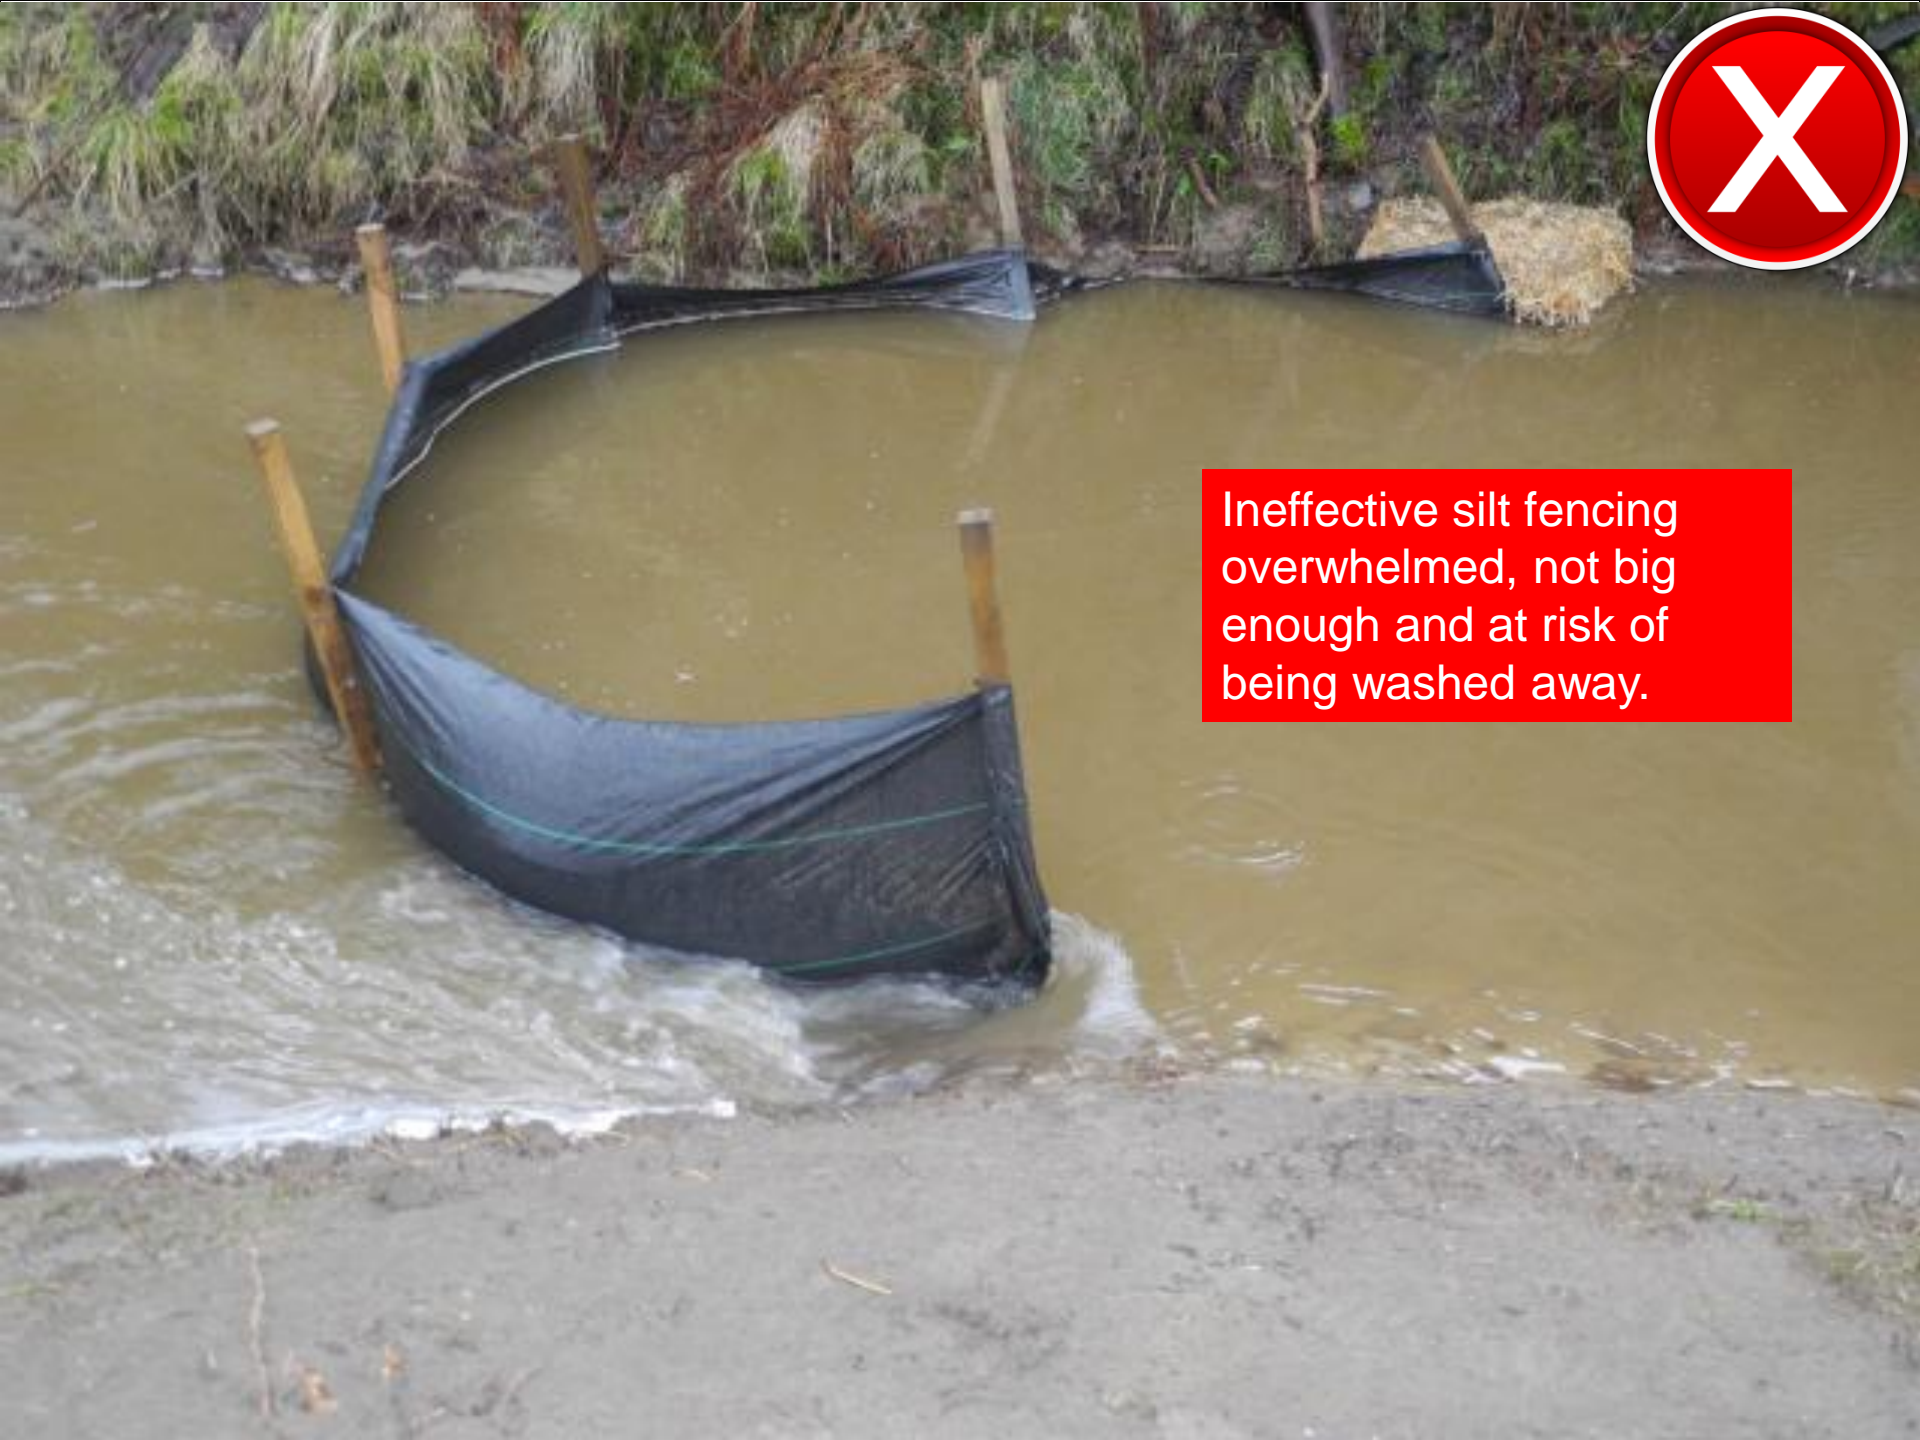
Ineffective silt fencing overwhelmed, not big enough and at risk of being washed away.

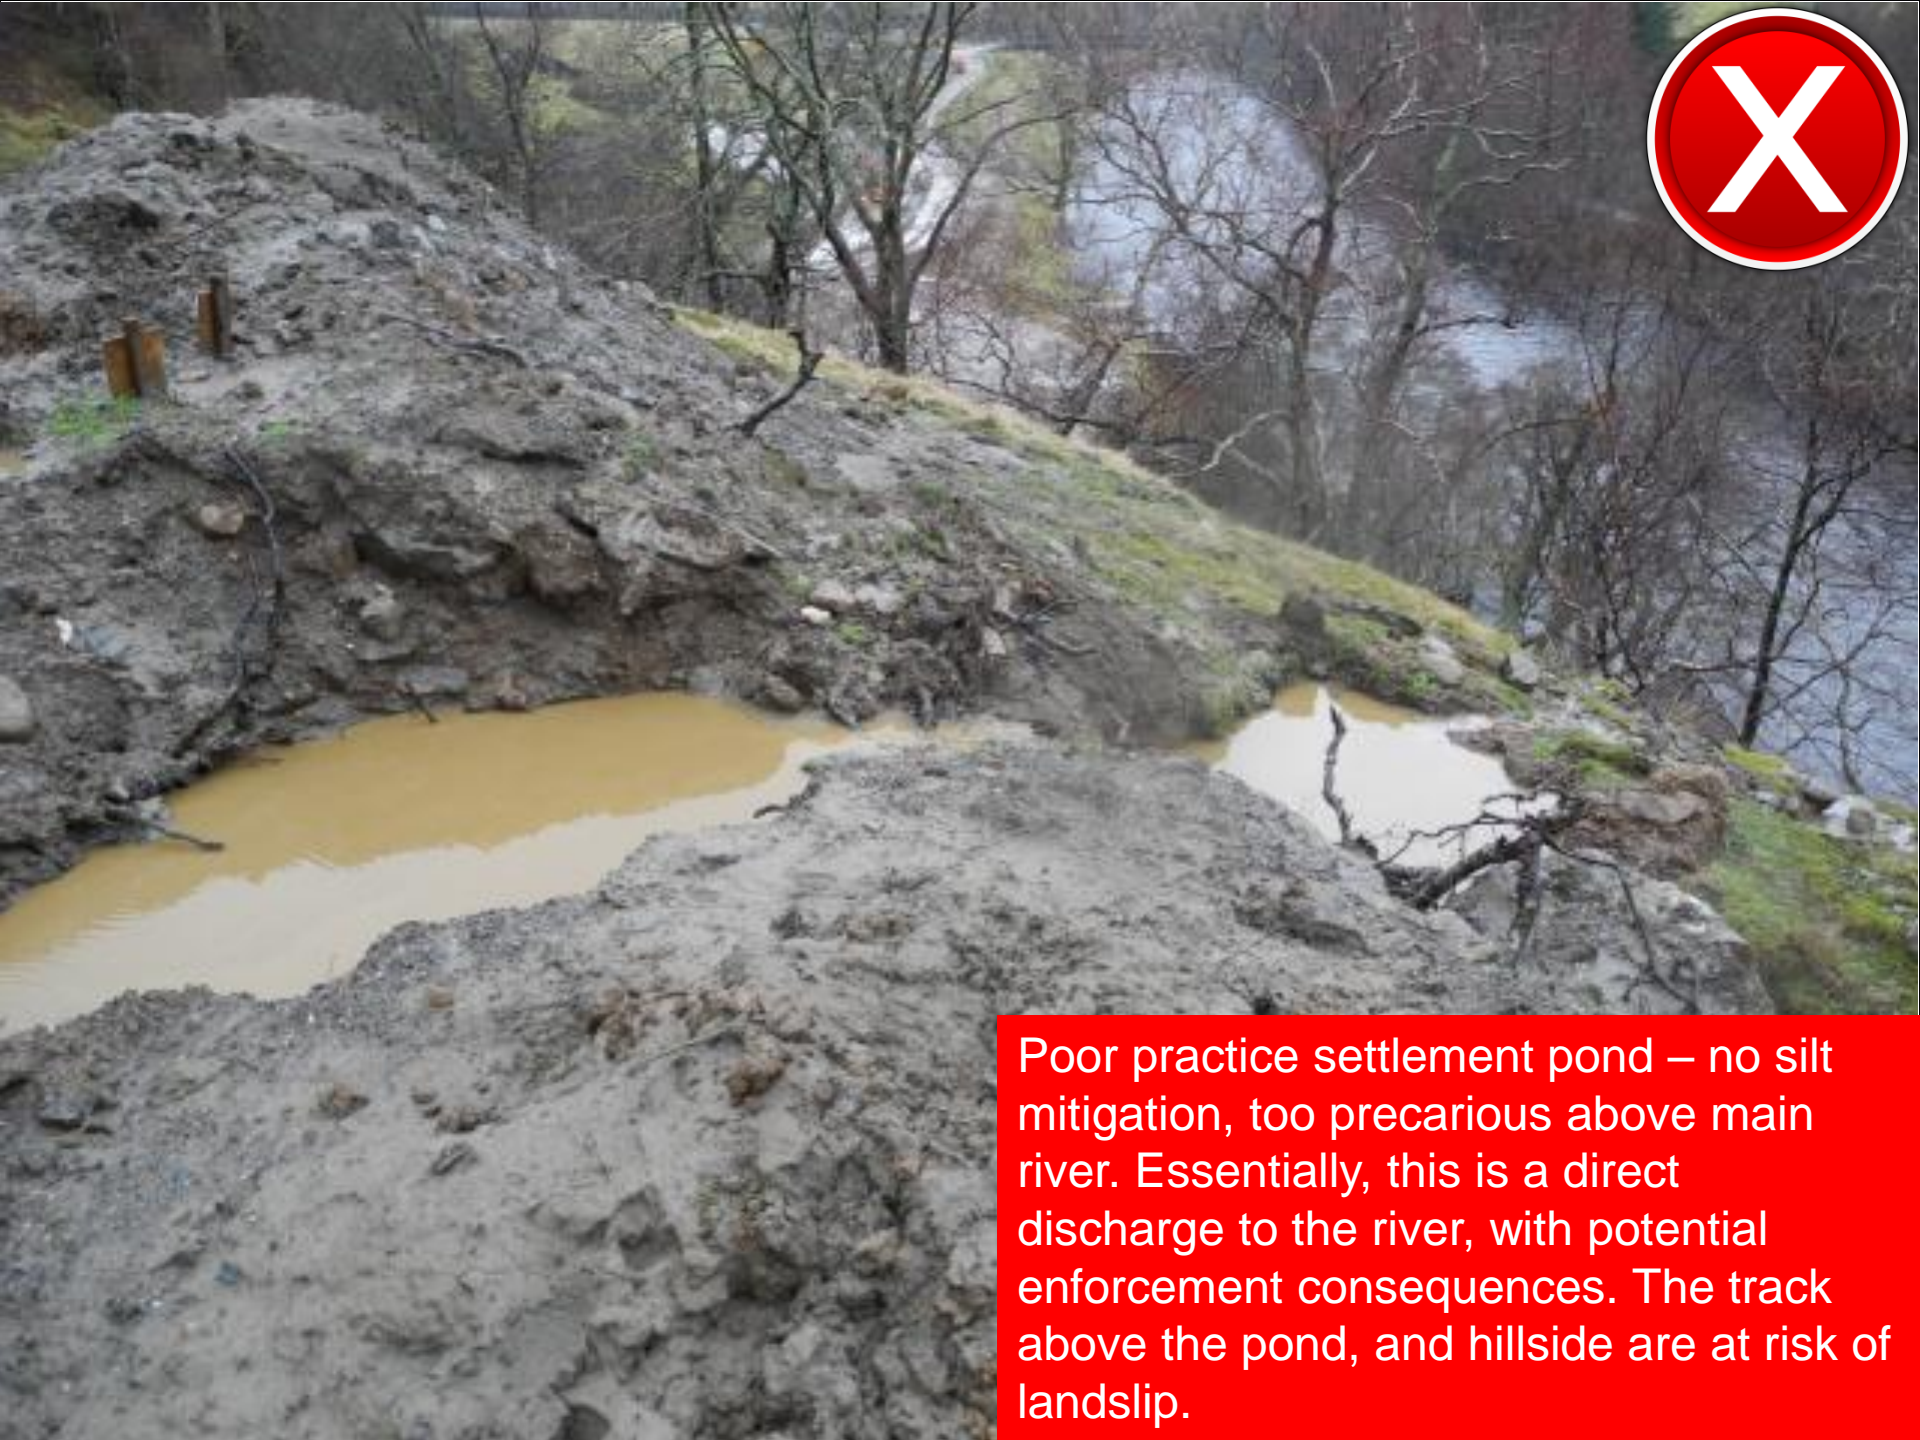
Poor practice settlement pond – no silt mitigation, too precarious above main river. Essentially, this is a direct discharge to the river, with potential enforcement consequences. The track above the pond, and hillside are at risk of landslip.

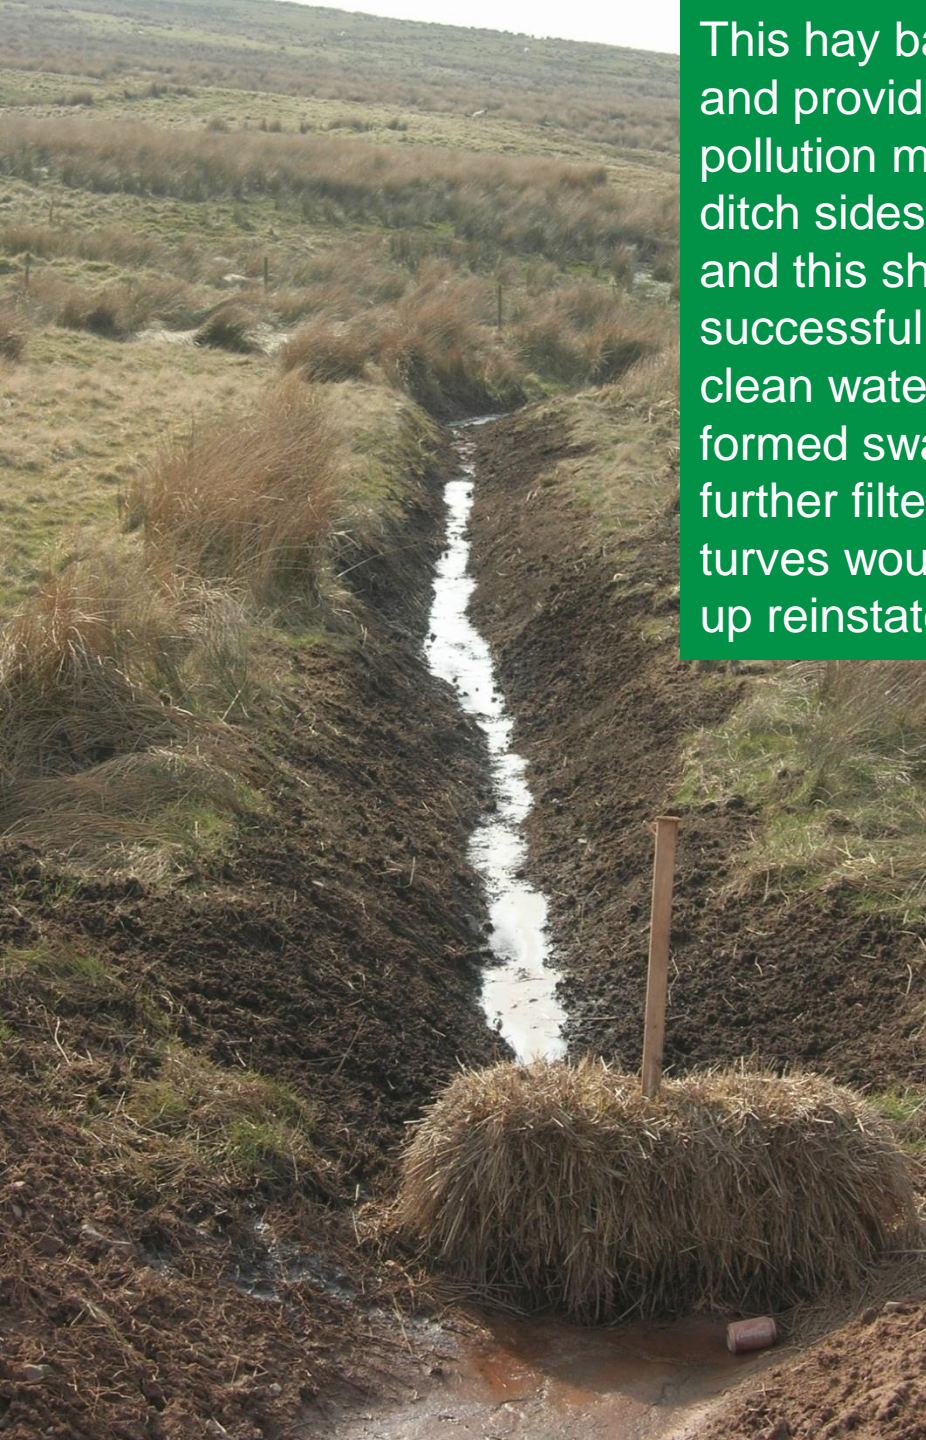
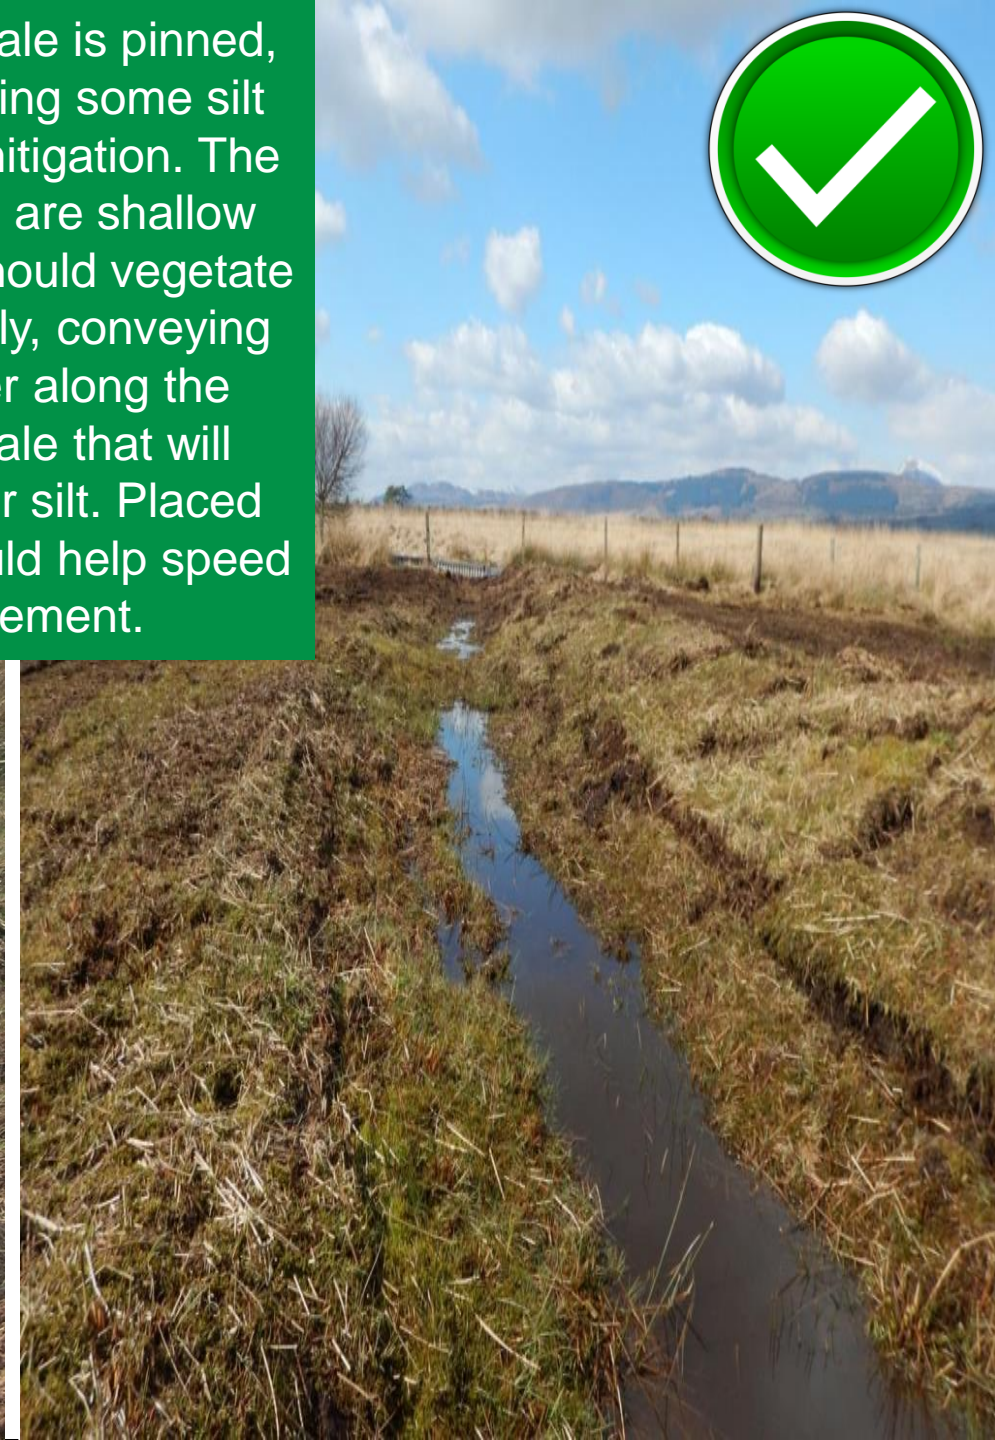
This hay bale is pinned, and providing some silt pollution mitigation. The ditch sides are shallow and this should vegetate successfully, conveying clean water along the formed swale that will further filter silt. Placed turves would help speed up reinstatement.

Too much peat exposure, leading to drying out and loss of carbon.

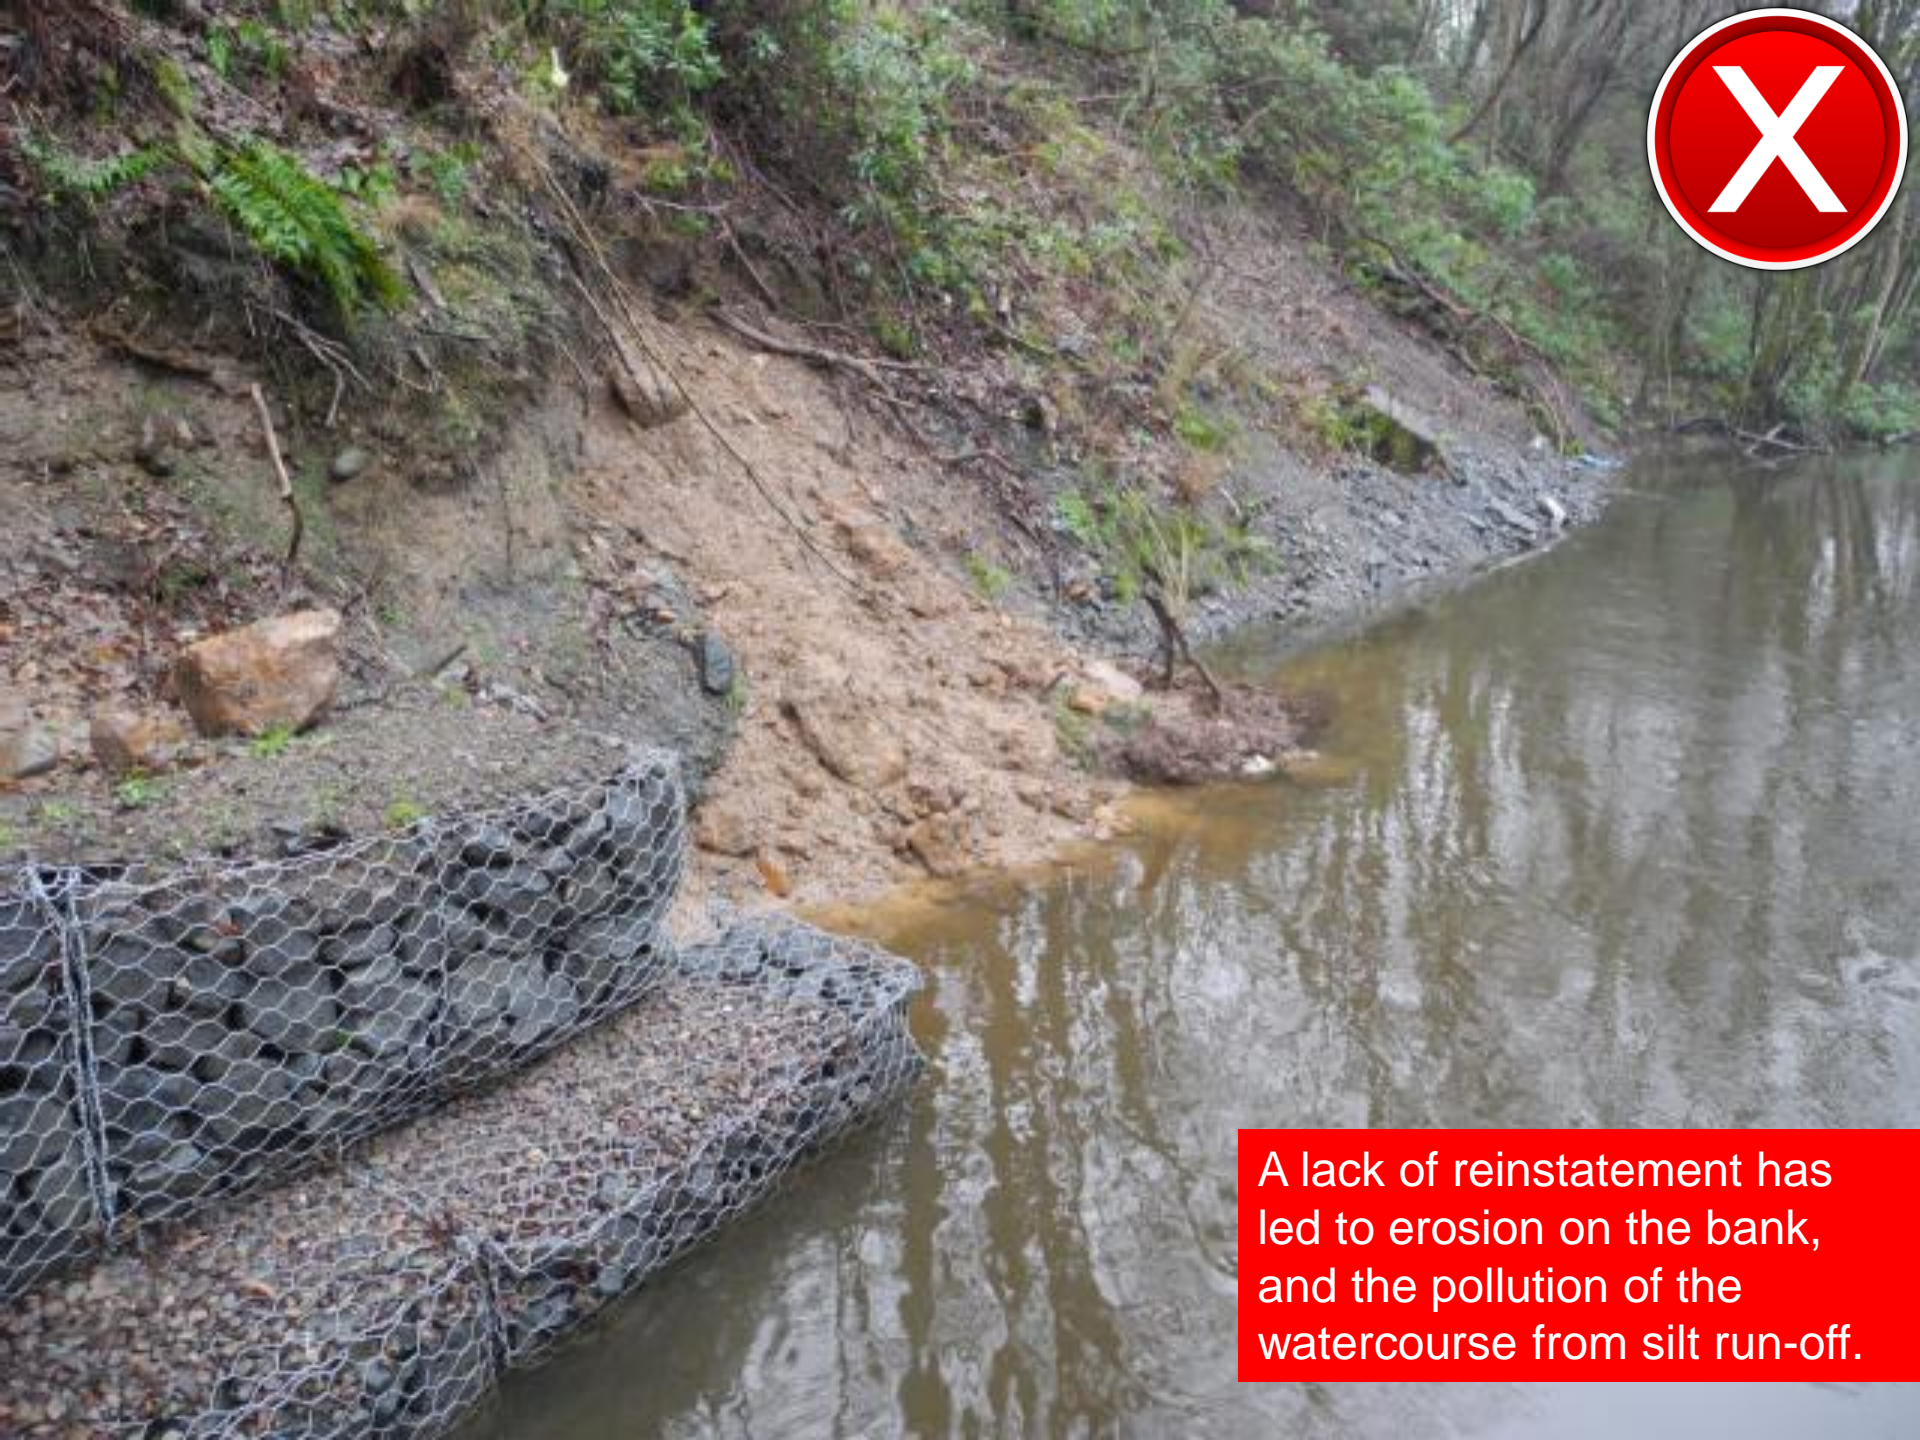
Verges have been reduced, drainage ditch restored (now acting as a swale).

A central vegetation strip is beginning to re-establish here that will further reduce the visual impact of the track.

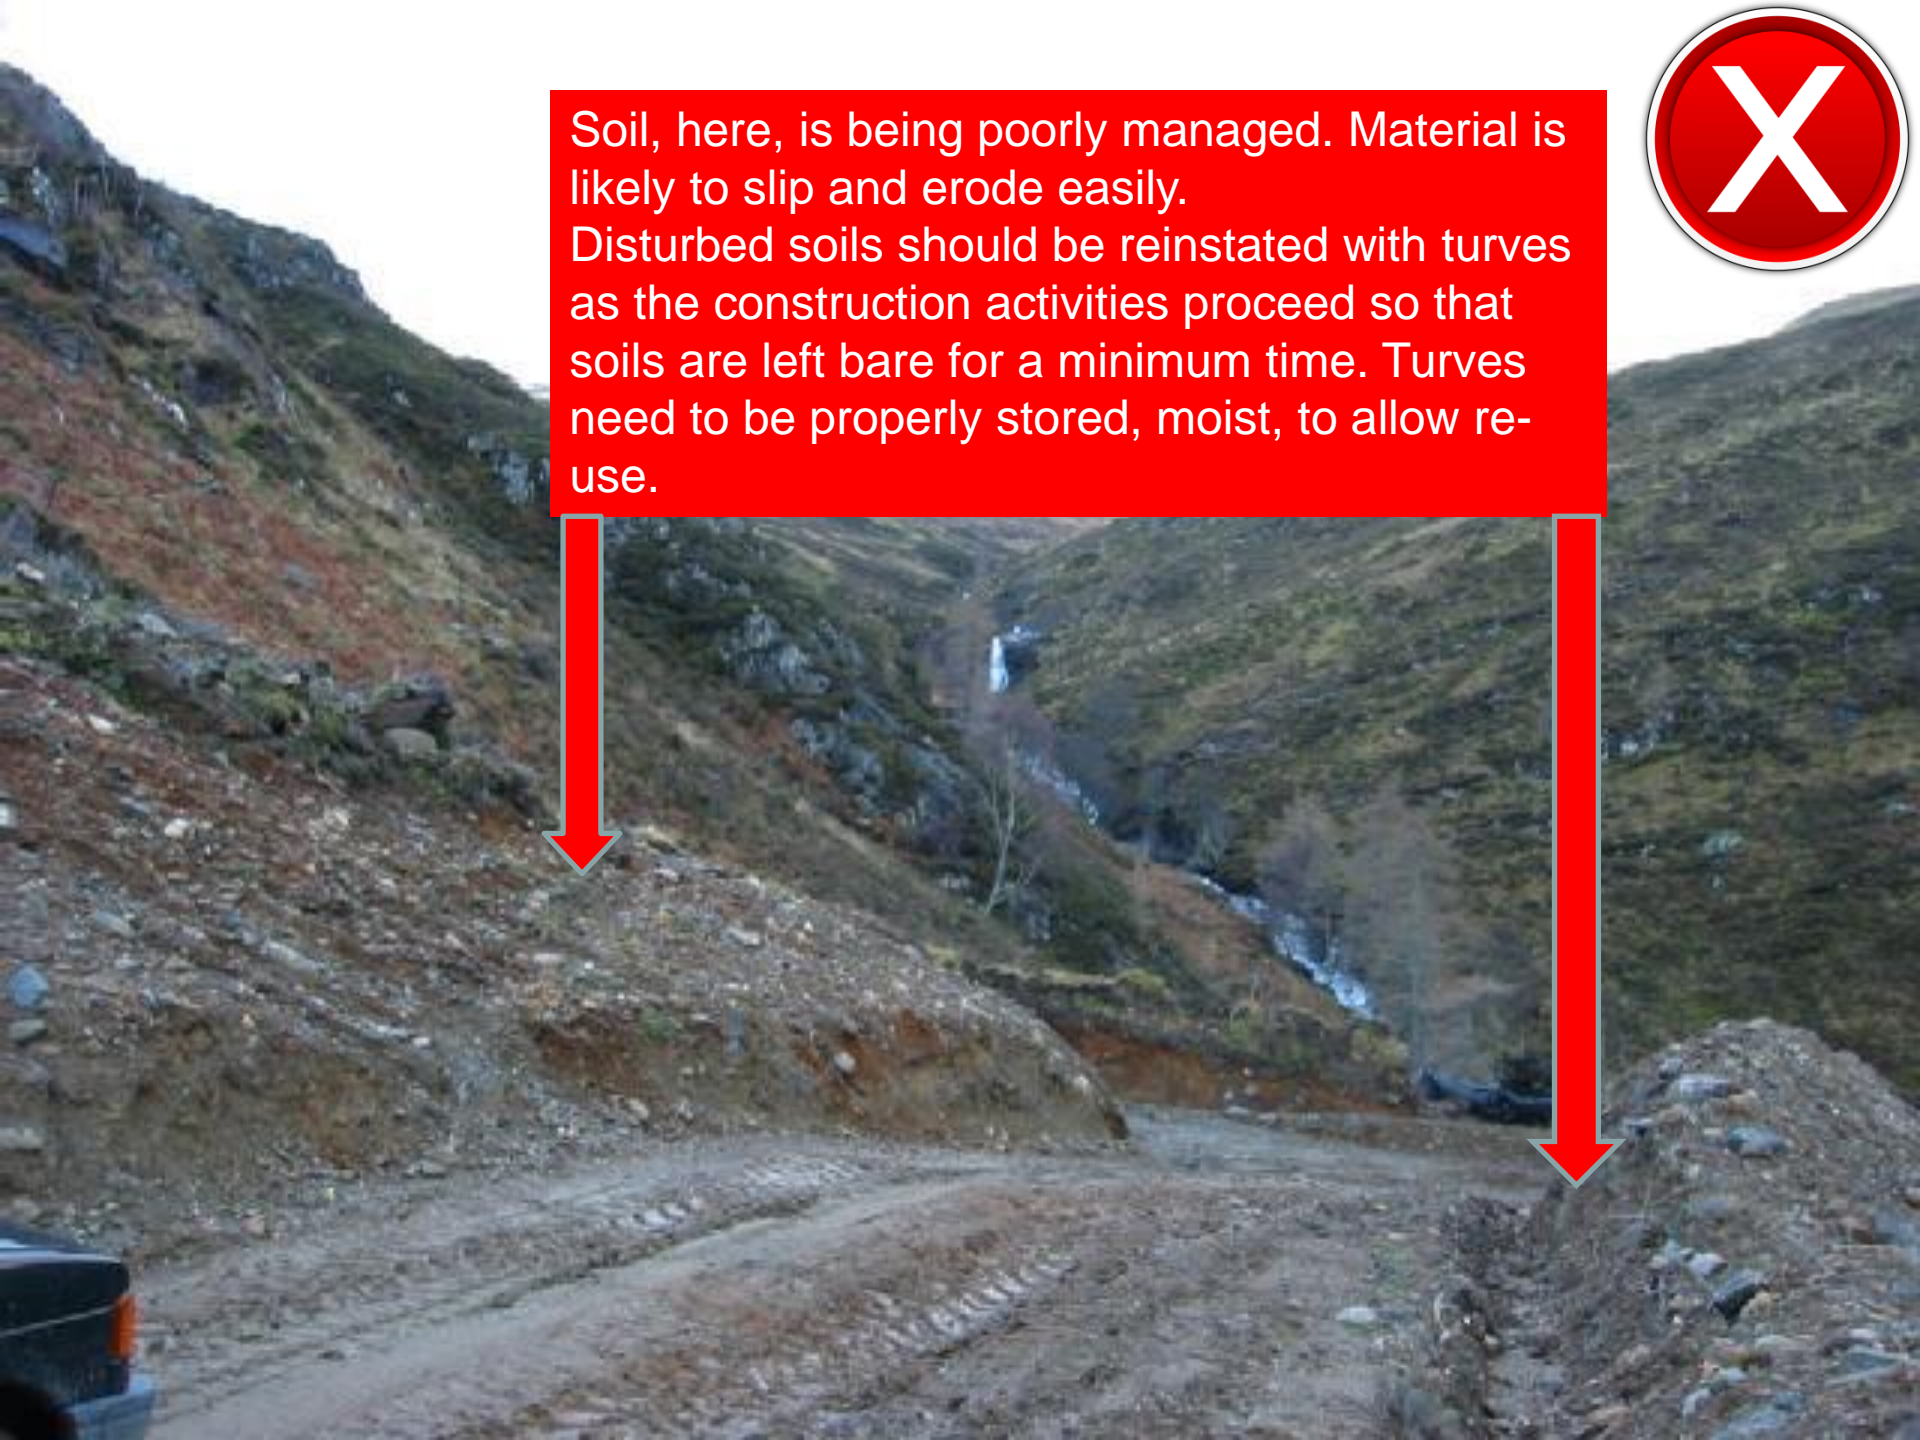
Soil, here, is being poorly managed. Material is likely to slip and erode easily. Disturbed soils should be reinstated with turves as the construction activities proceed so that soils are left bare for a minimum time. Turves need to be properly stored, moist, to allow re-use.

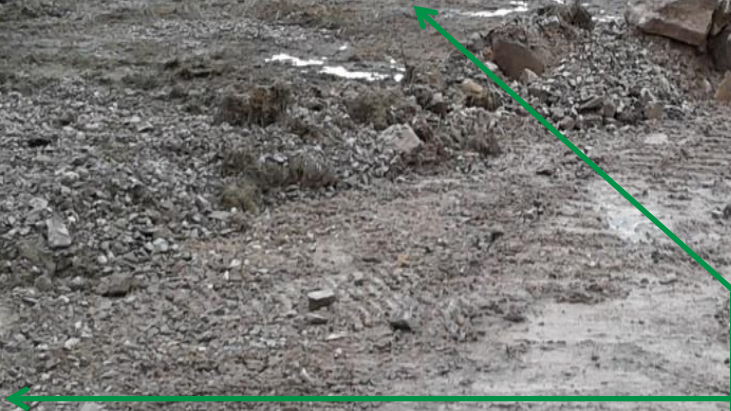
Peat soil will dry out, and material likely to slip and erode easily. Difficult to reinstate these verges to achieve good habitat.
