Good practice guide for minimising impacts on the natural heritage during construction.

This guide shows examples of good and poor practice examples for hydro construction.

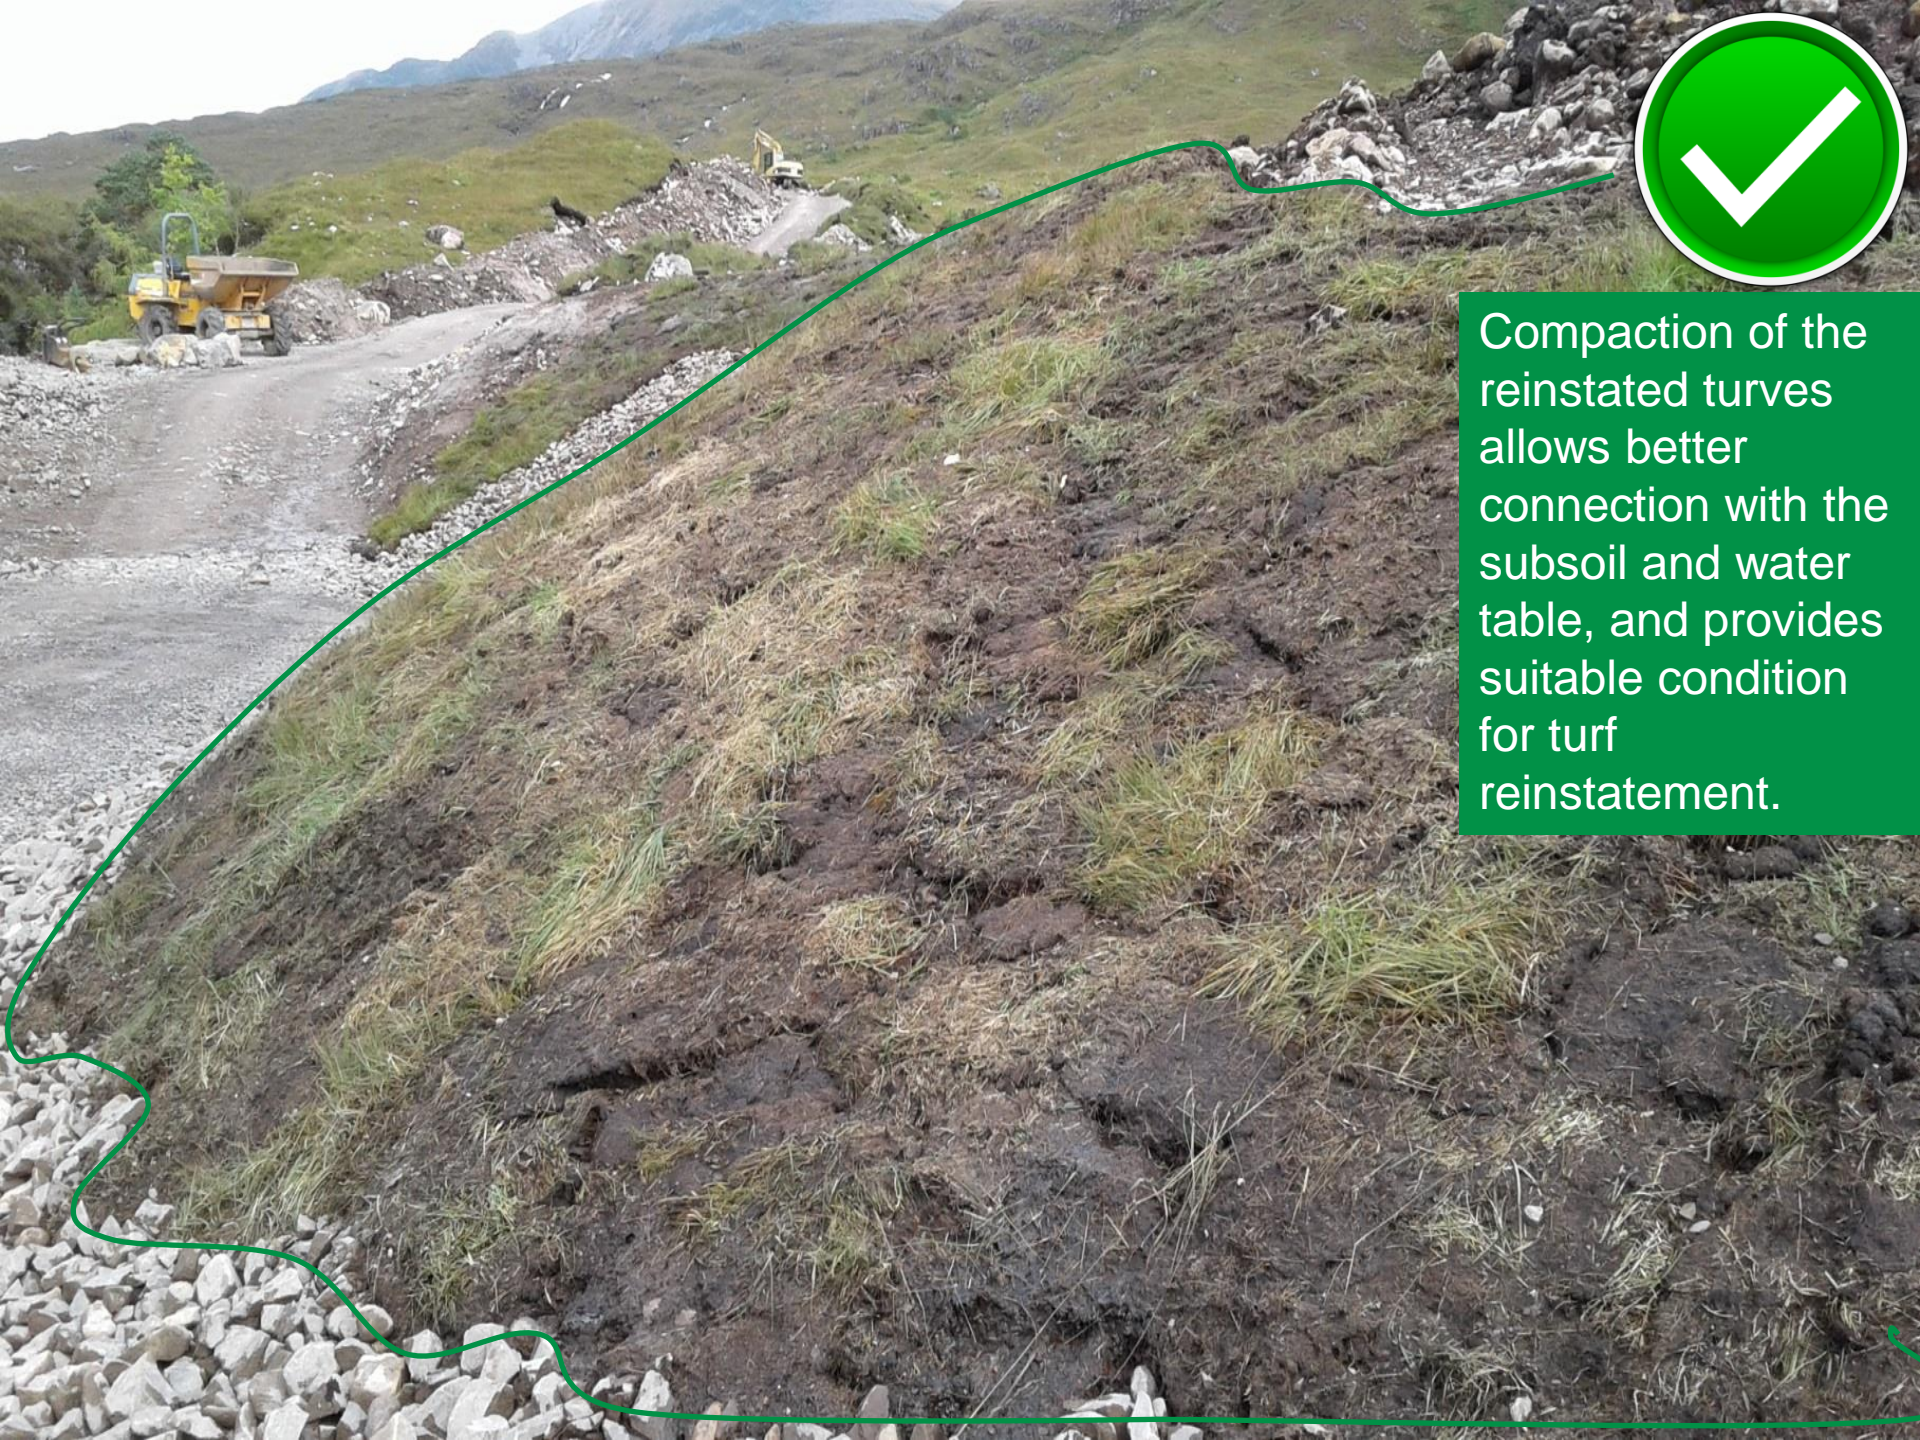
This cut face is too steep and reinstatement attempts will prove very difficult. Turves will be unlikely to take on this slope. This face will be prone to a large amount of erosion.

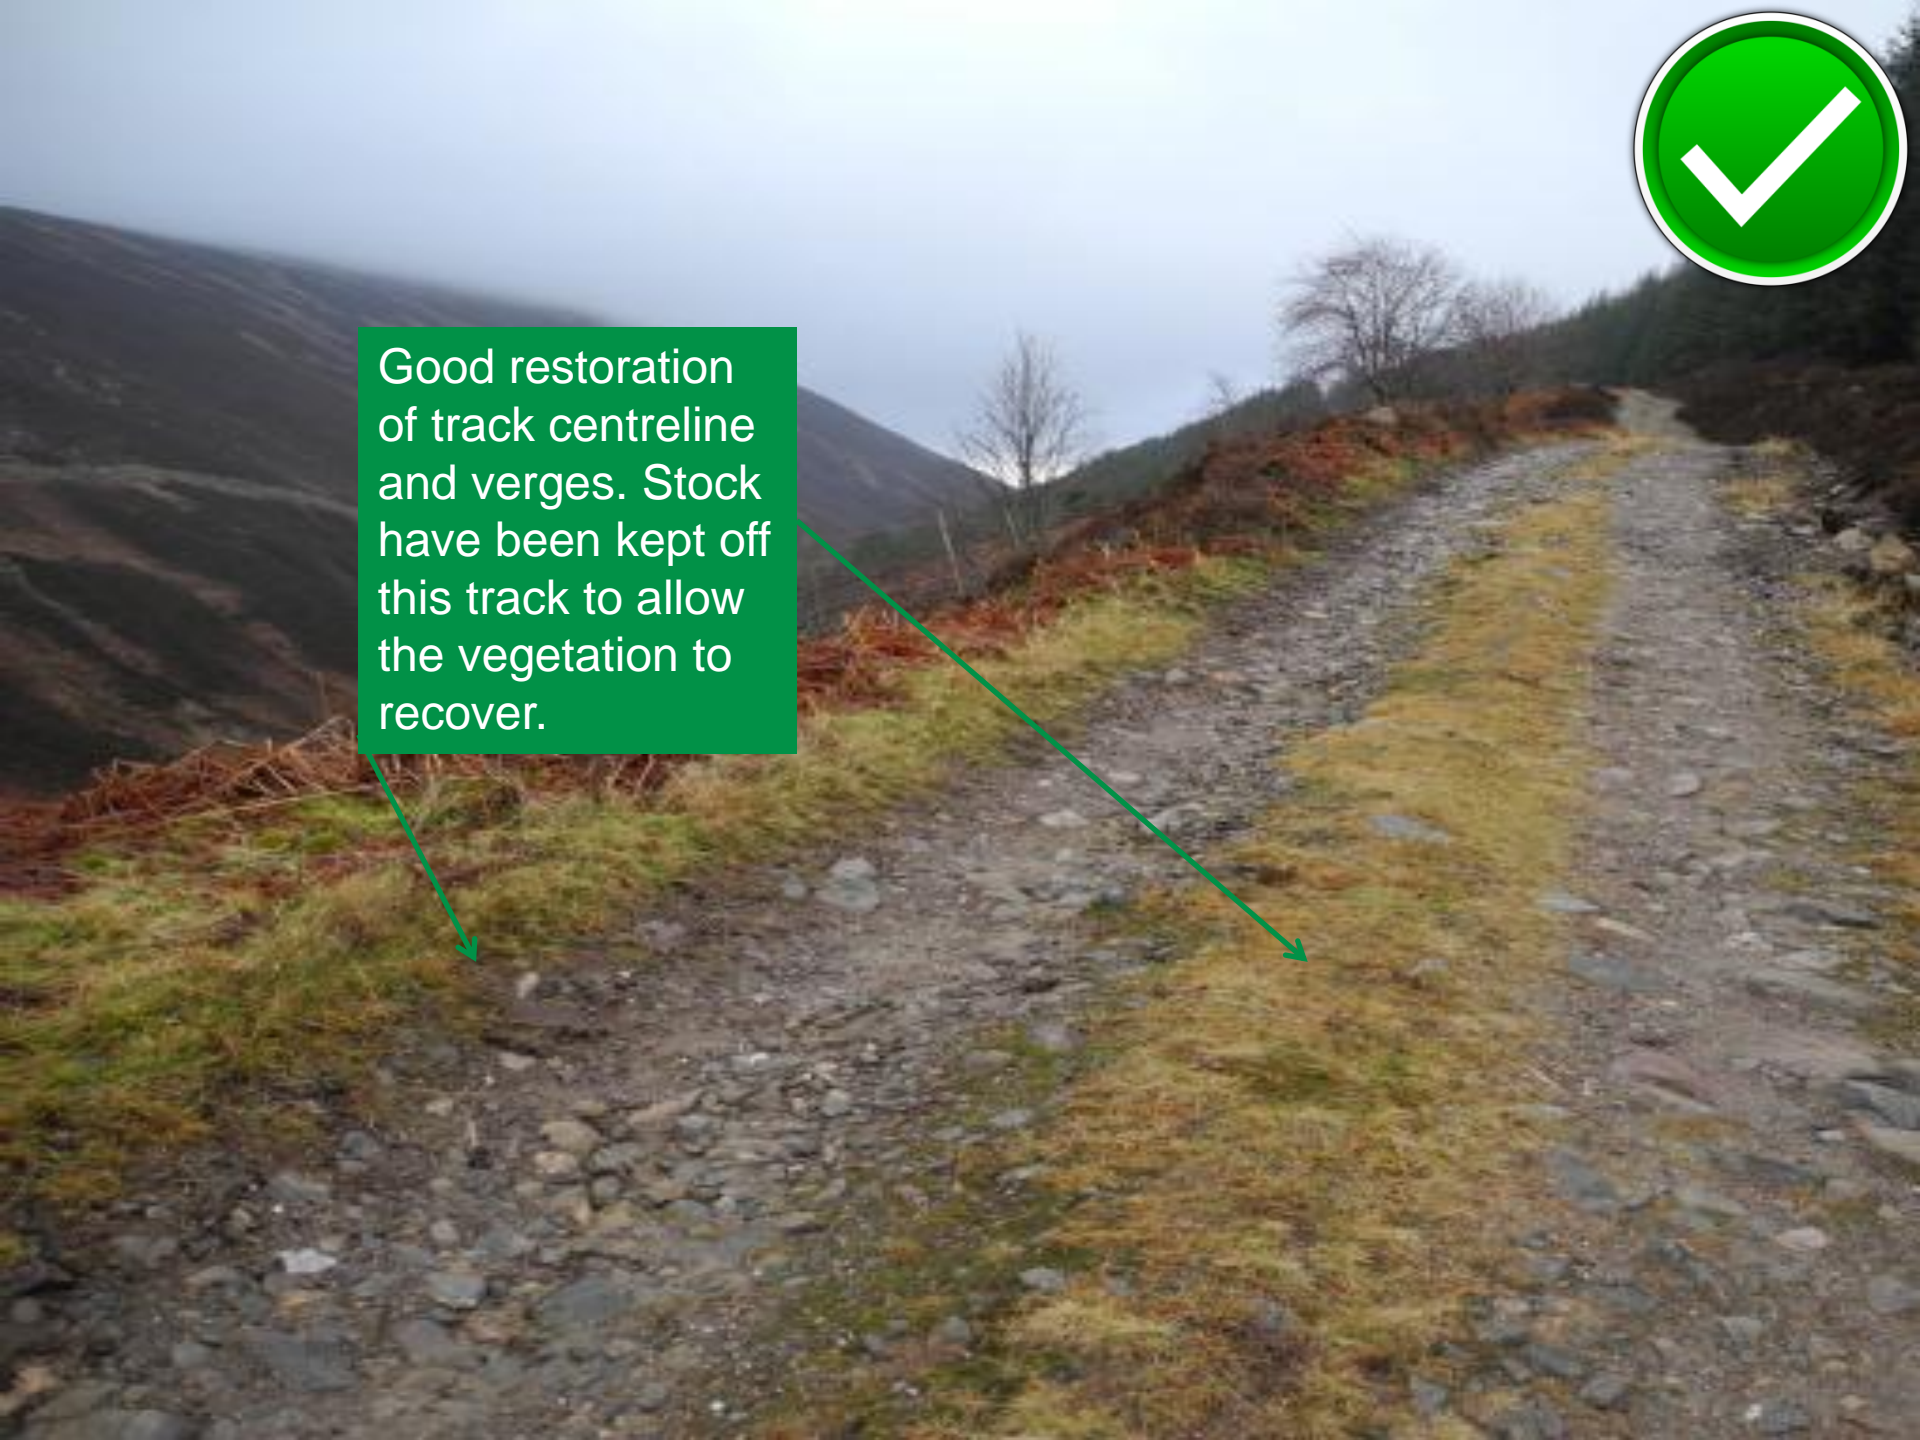
Good restoration
of track centreline
and verges. Stock
have been kept off
this track to allow
the vegetation to
recover.

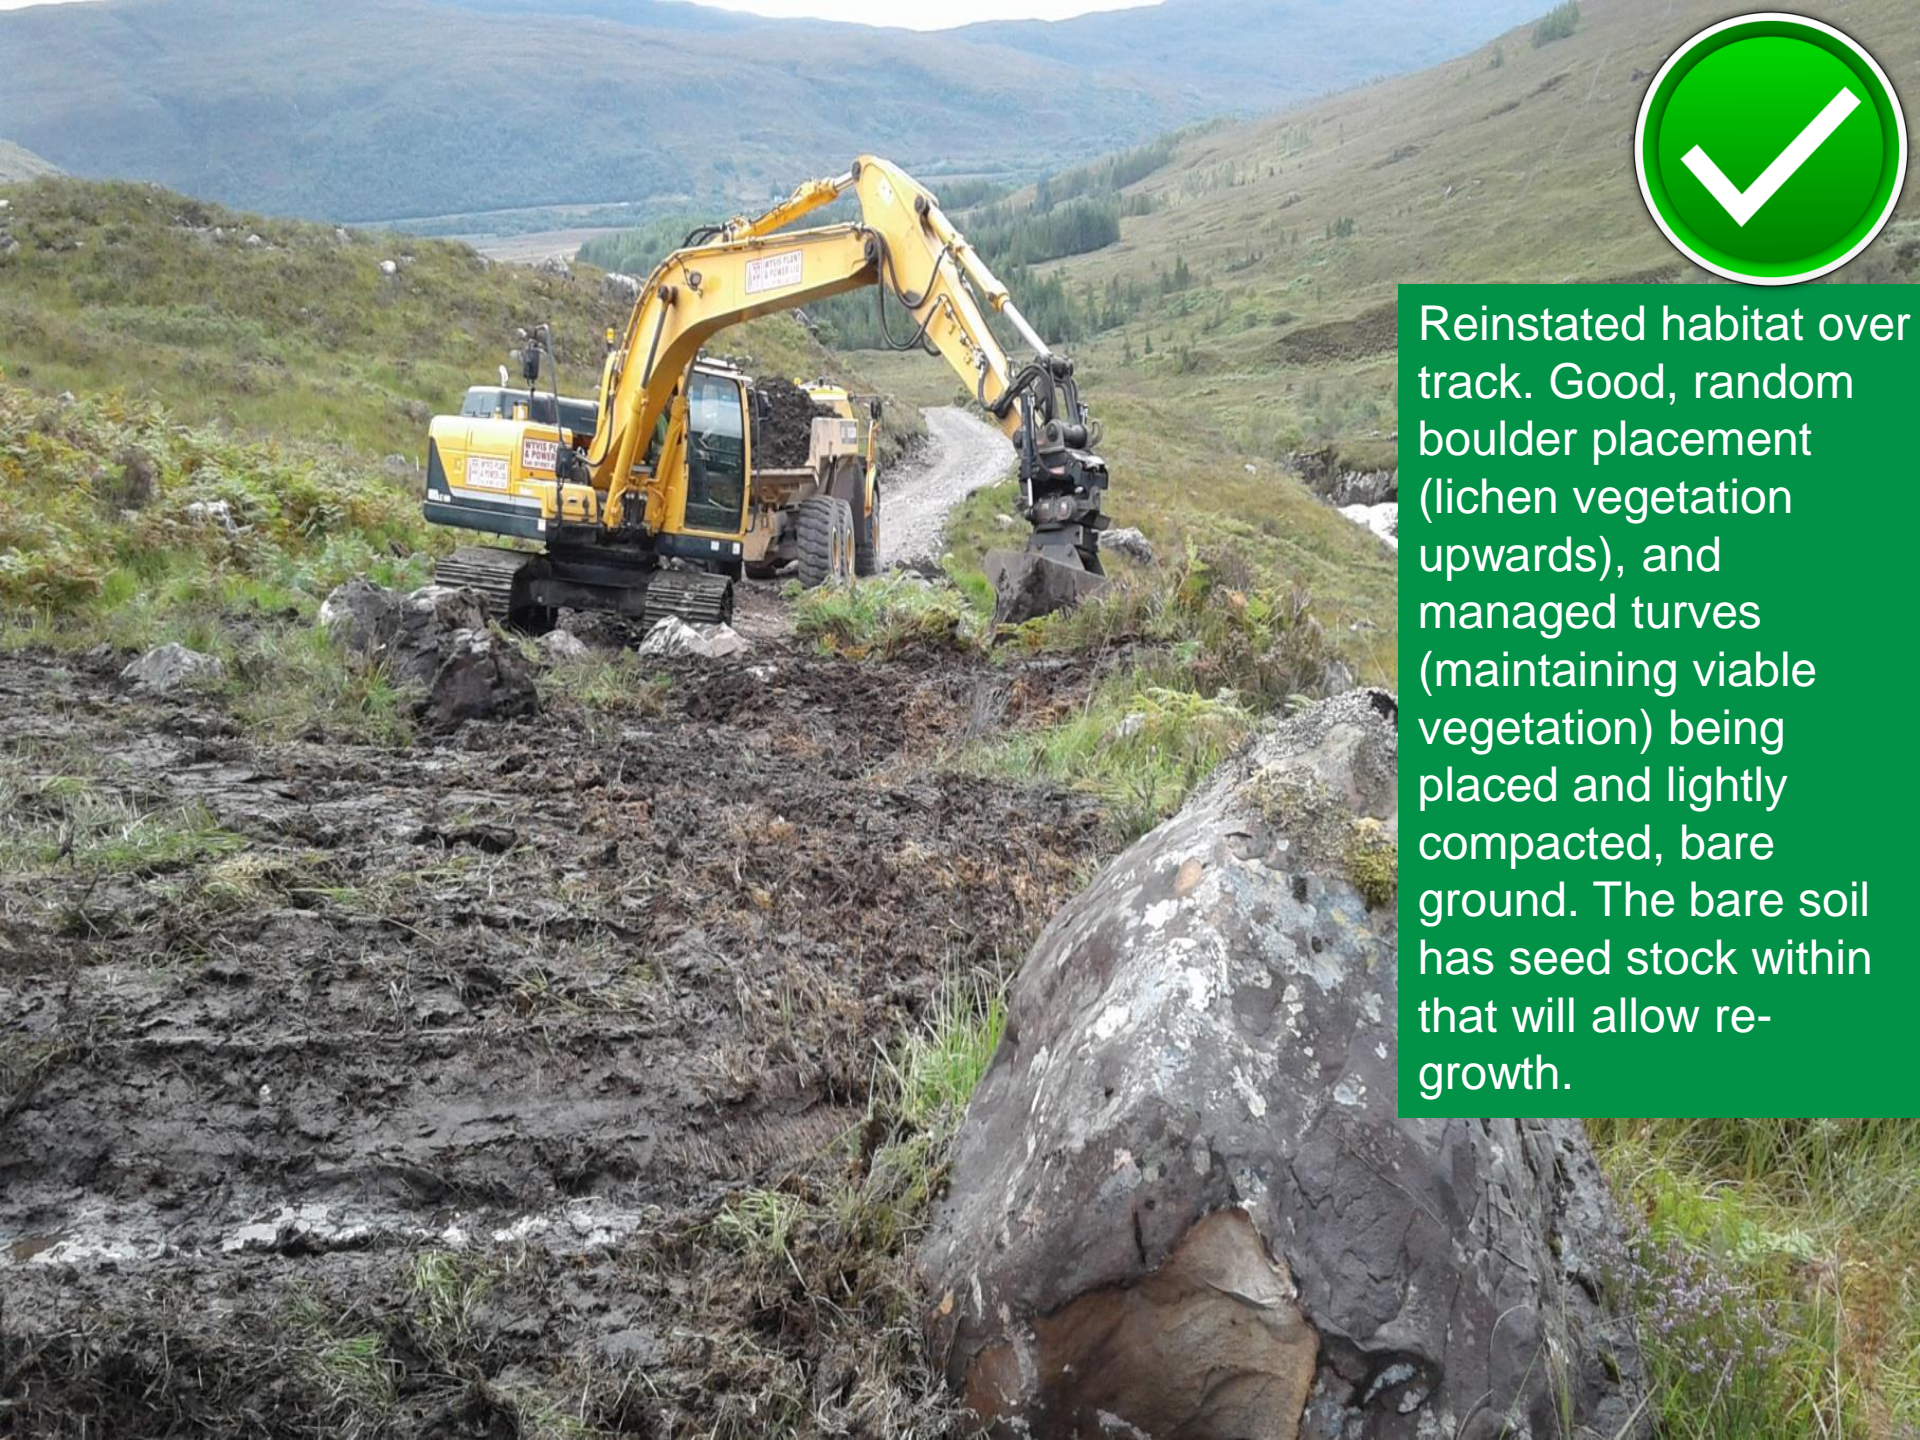
Reinstated habitat over track. Good, random boulder placement (lichen vegetation upwards), and managed turves (maintaining viable vegetation) being placed and lightly compacted, bare ground. The bare soil has seed stock within that will allow re-growth.

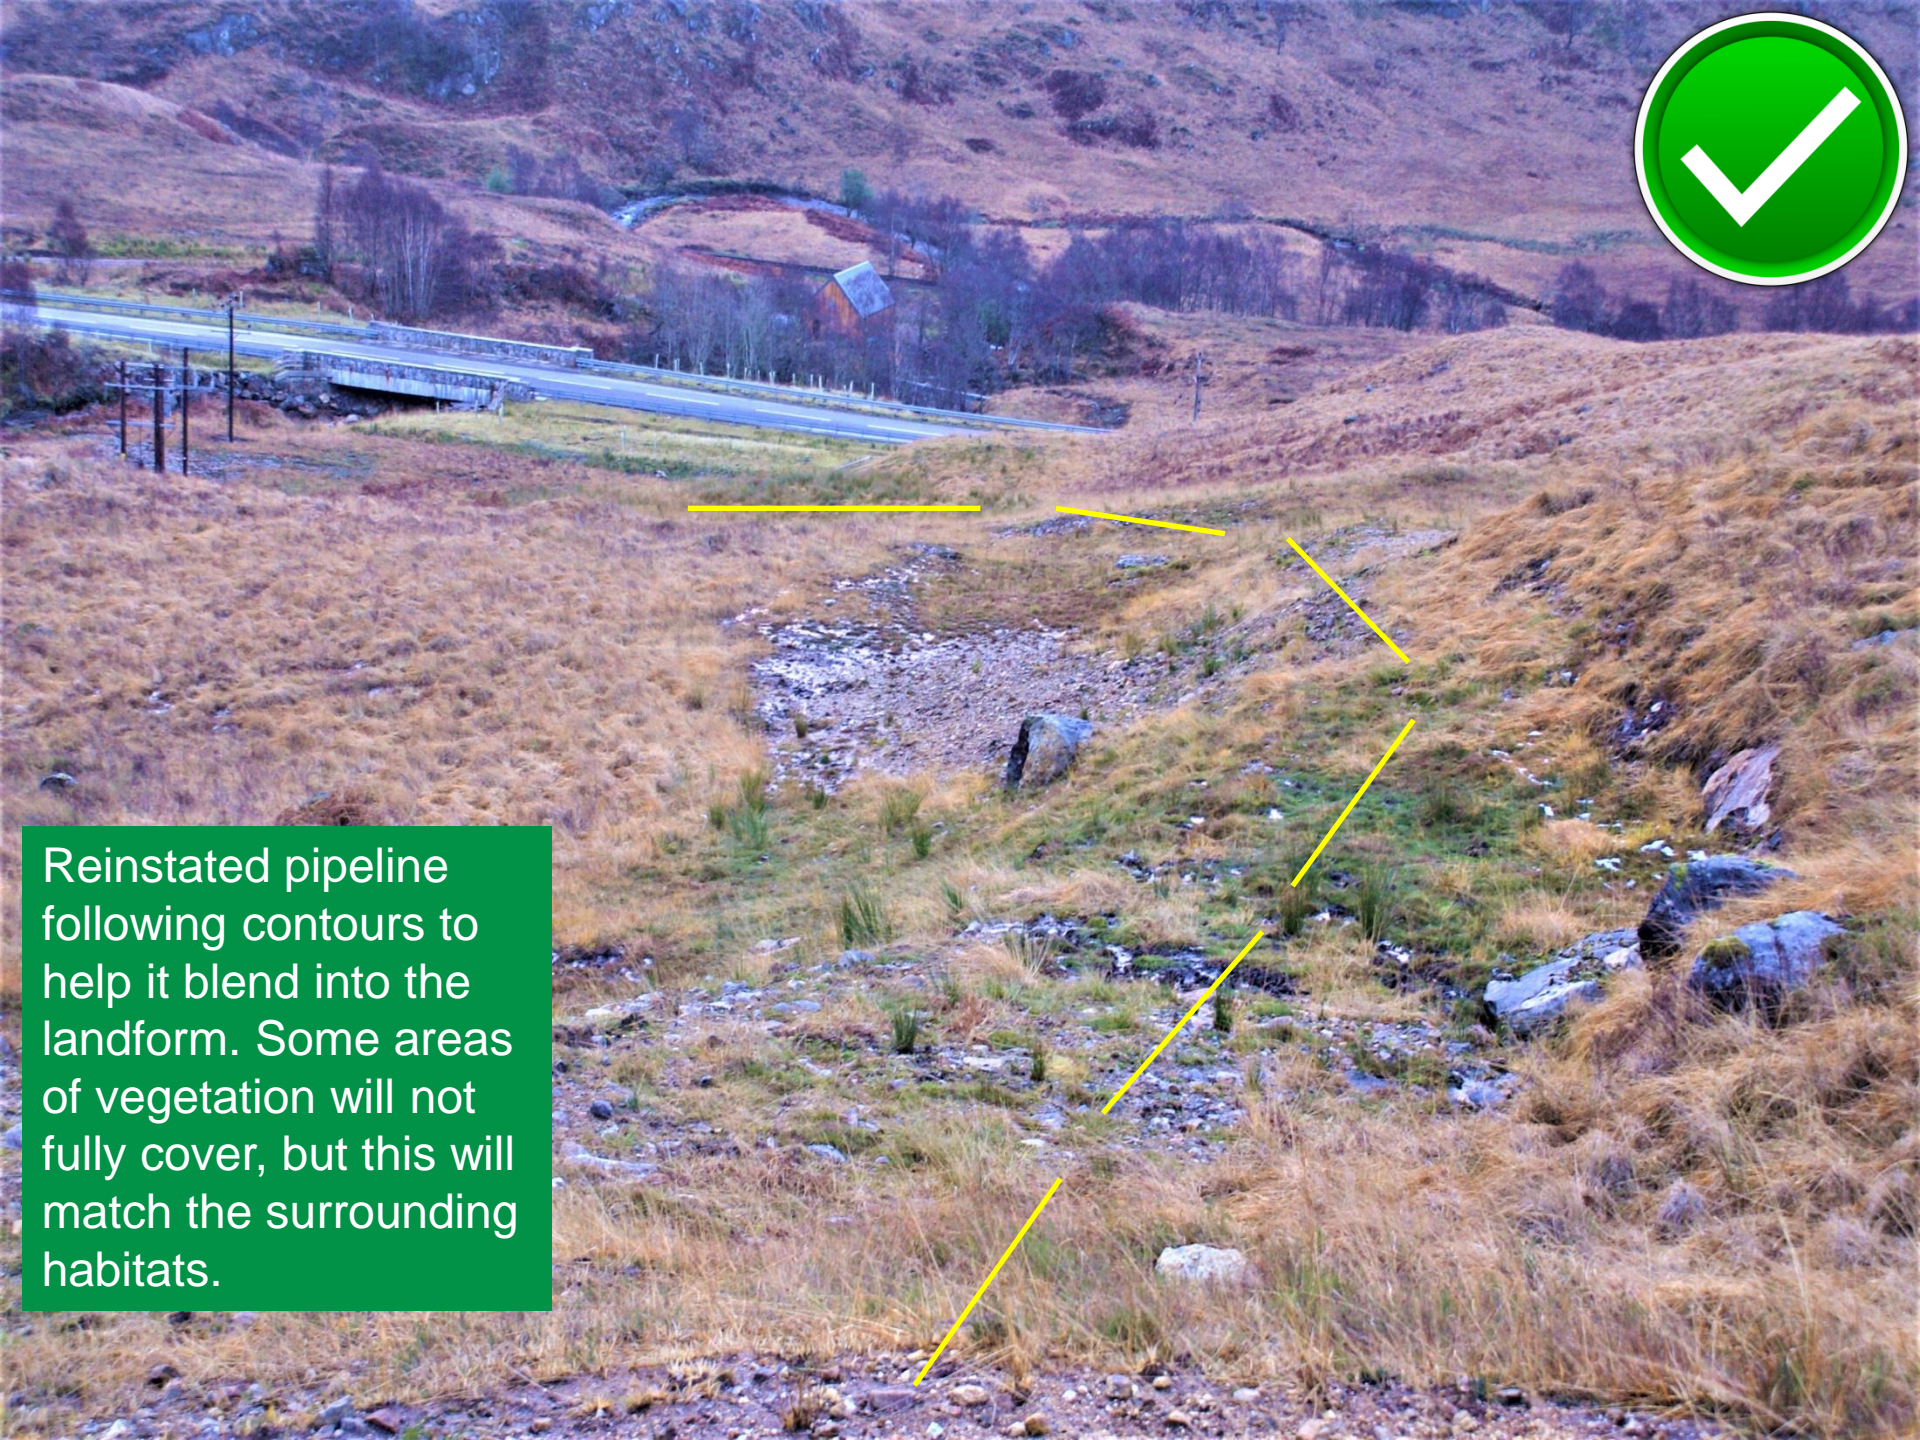
Reinstated pipeline following contours to help it blend into the landform. Some areas of vegetation will not fully cover, but this will match the surrounding habitats.

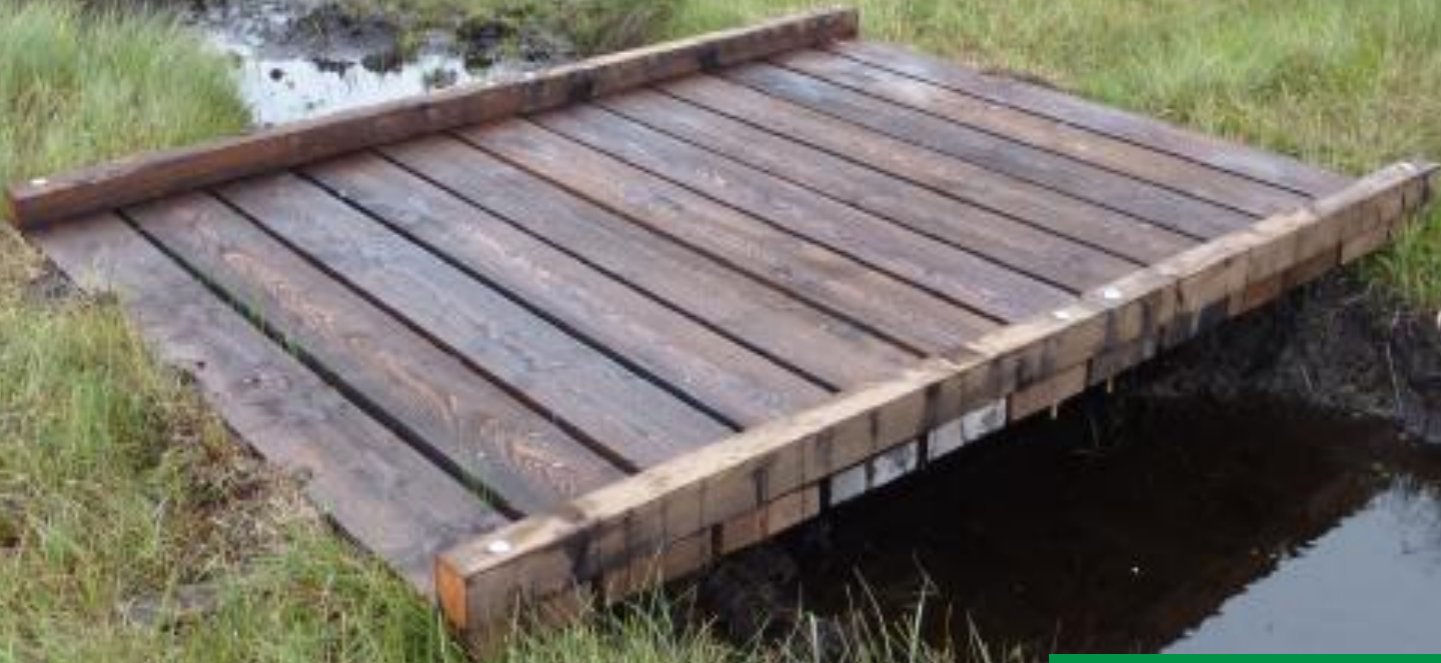
Good practice would have placed the penstock under the bridge to be less visible.

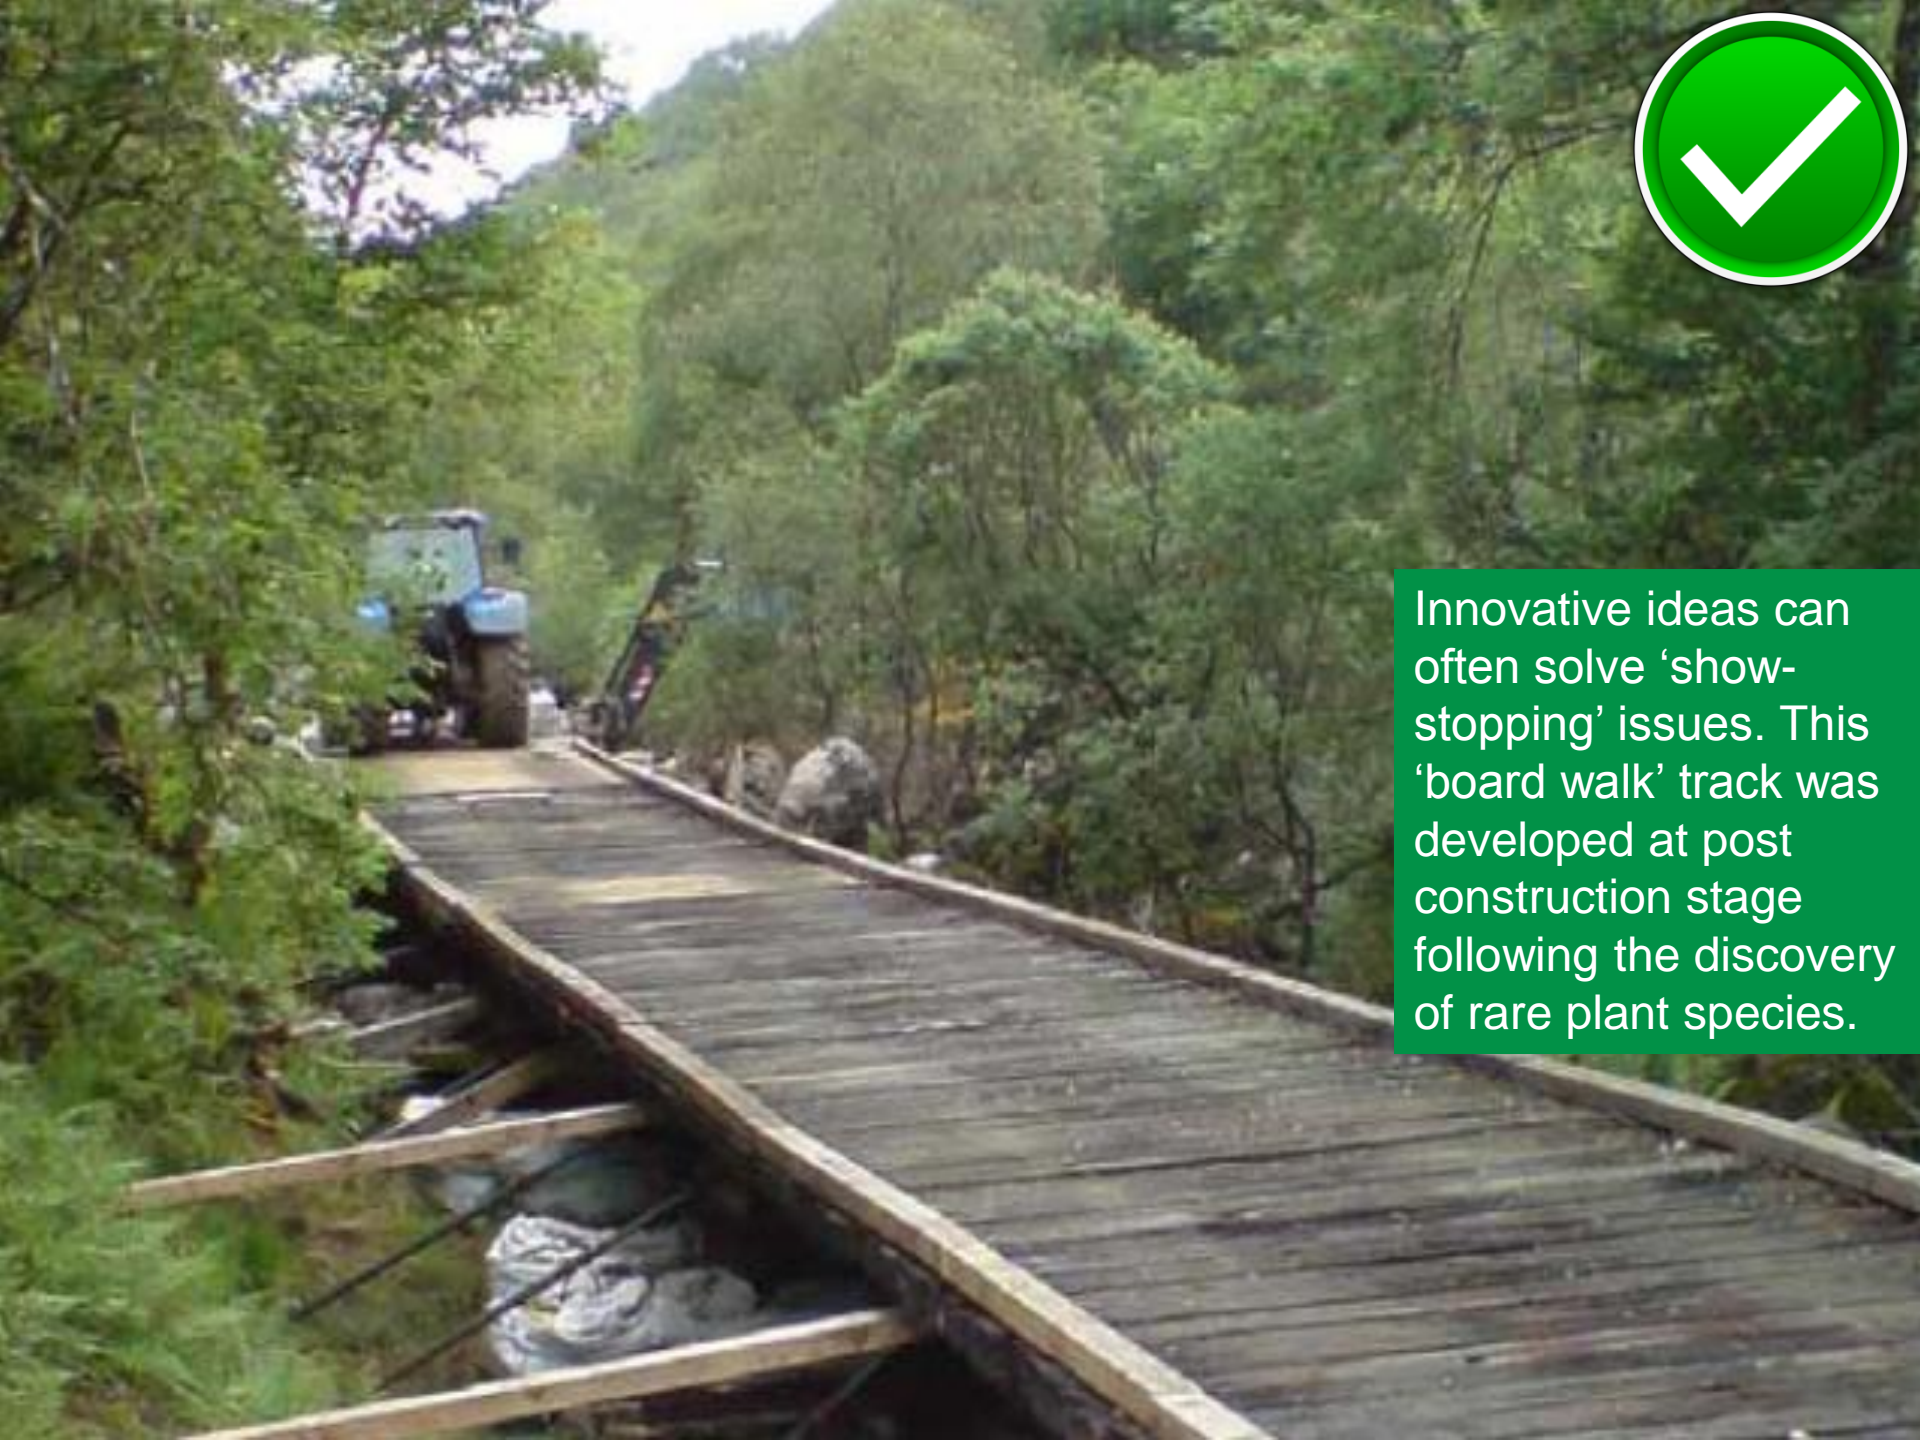
Innovative ideas can often solve 'show-stopping' issues. This 'board walk' track was developed at post construction stage following the discovery of rare plant species.

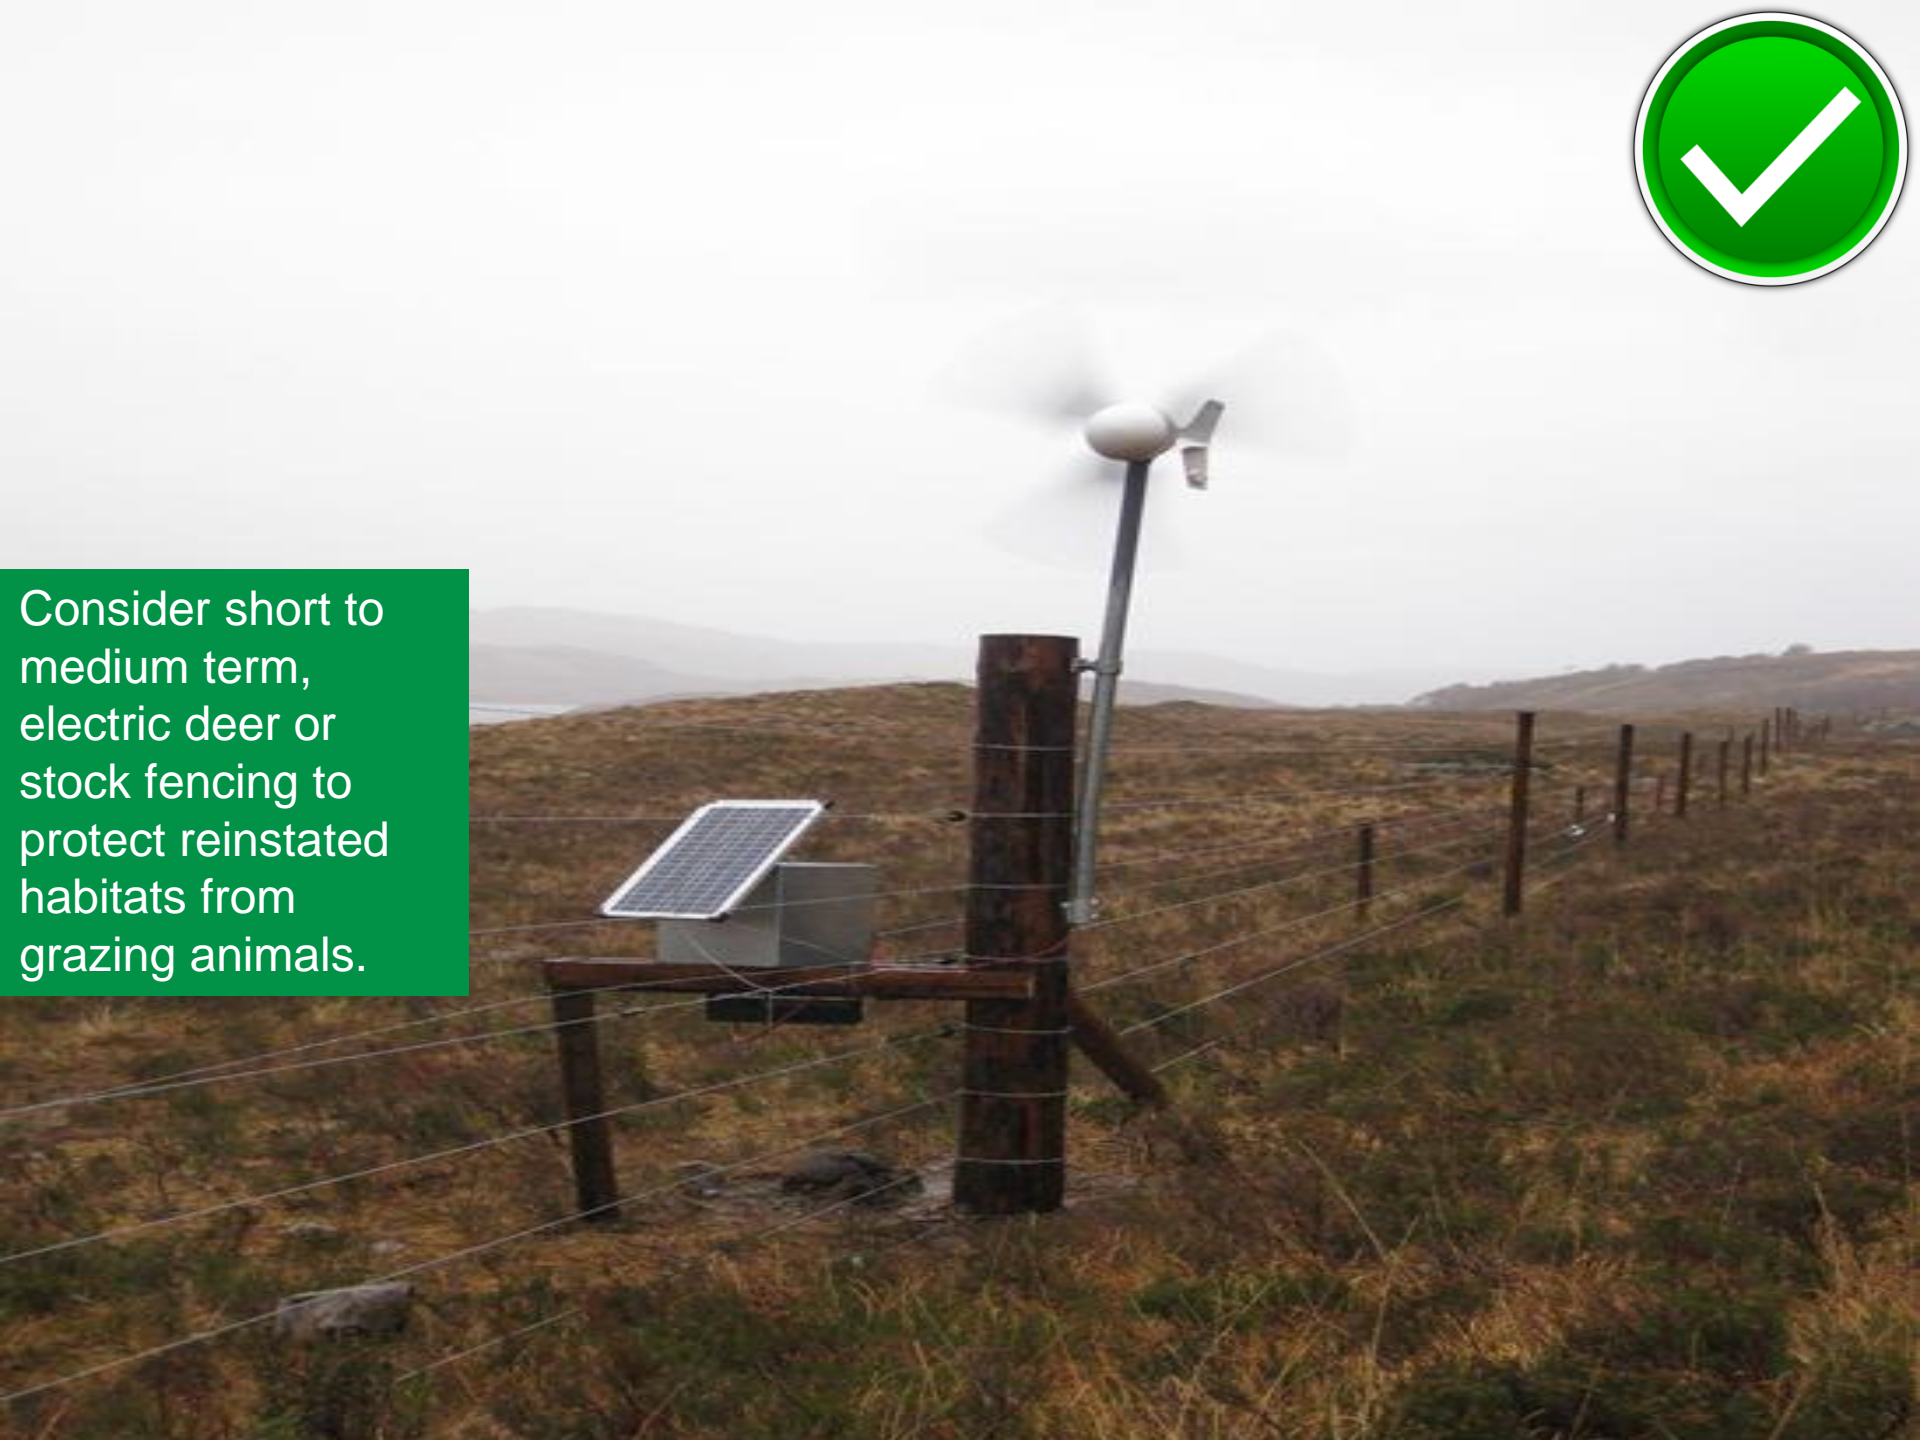
Consider short to medium term, electric deer or stock fencing to protect reinstated habitats from grazing animals.

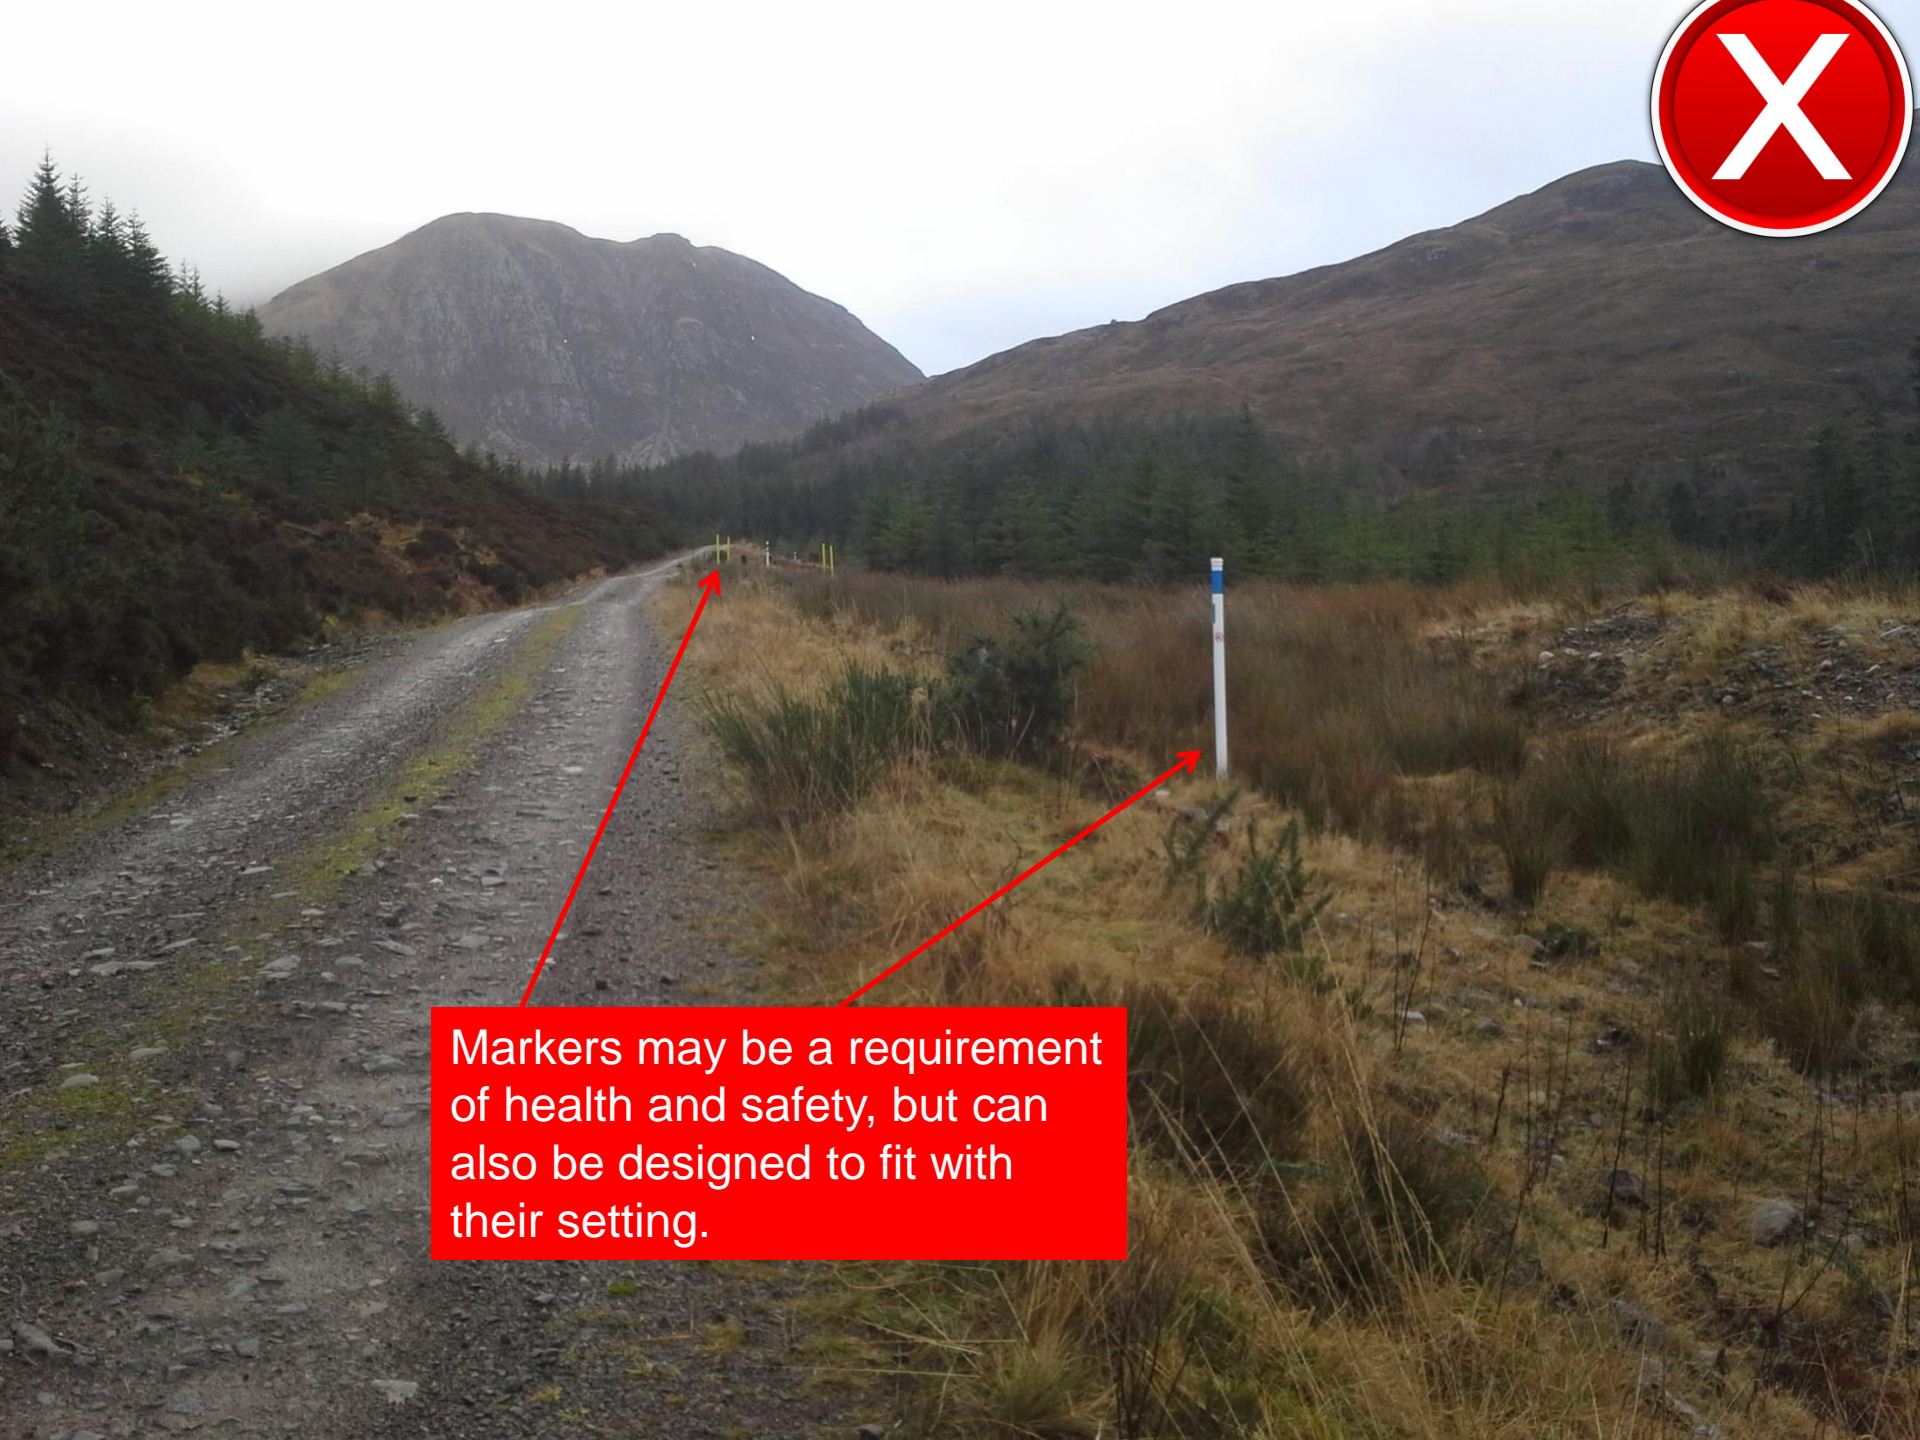
A gravel path leads through a mountainous landscape. On the right side of the path, there are several yellow markers and a white marker with a blue band. Two red arrows point from a text box to these markers. The background features large, rocky mountains under a cloudy sky.

Markers may be a requirement of health and safety, but can also be designed to fit with their setting.
