Good practice guide for minimising impacts on the natural heritage during construction.

This guide shows examples of good and poor practice examples for hydro construction.

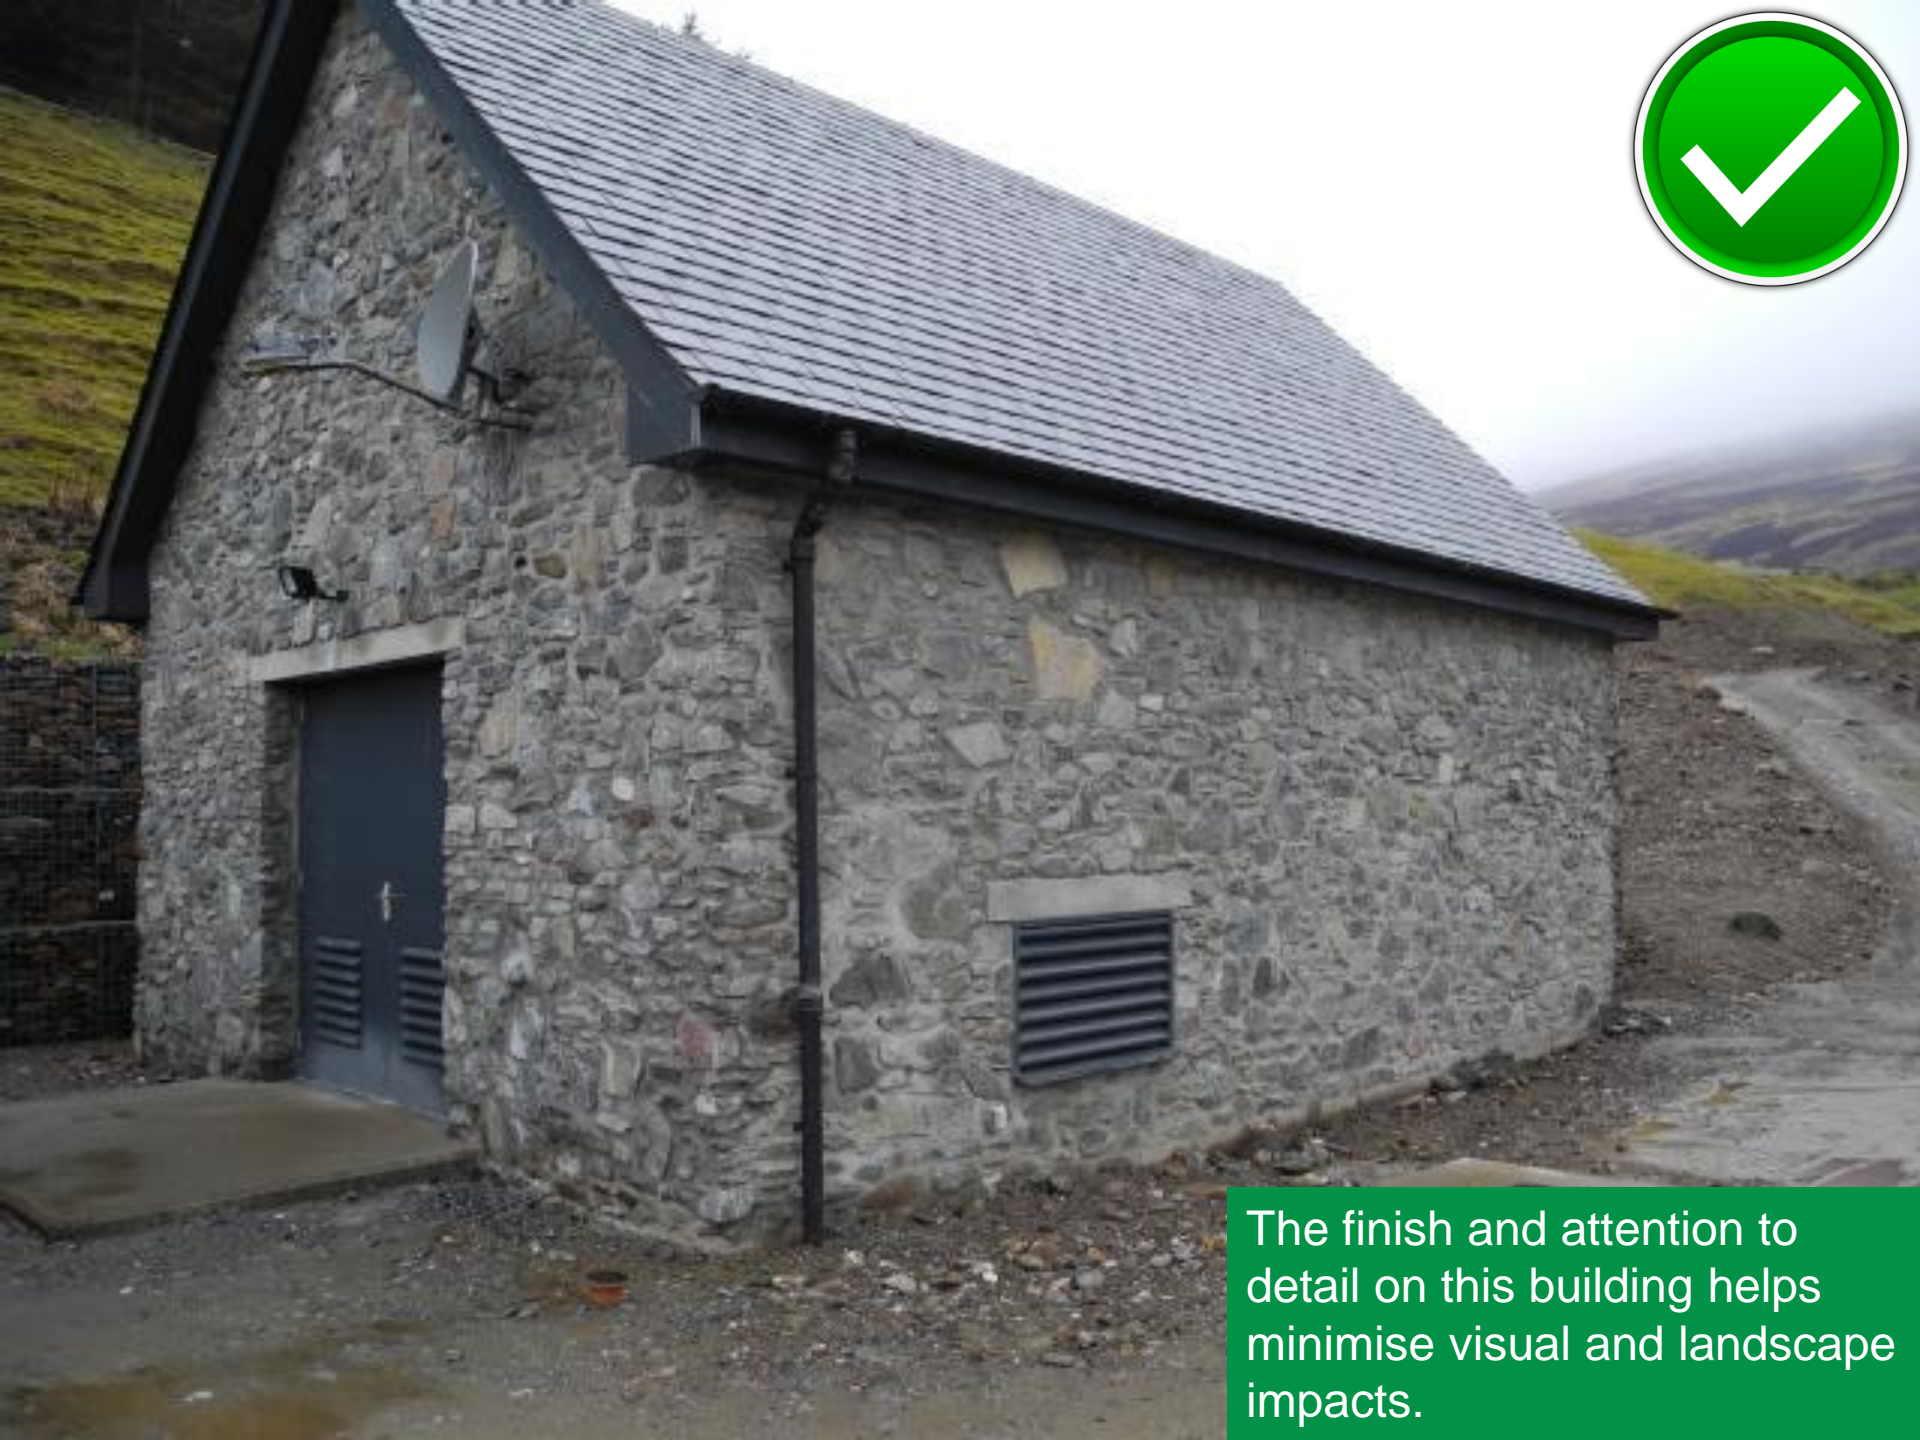
The finish and attention to detail on this building helps minimise visual and landscape impacts.

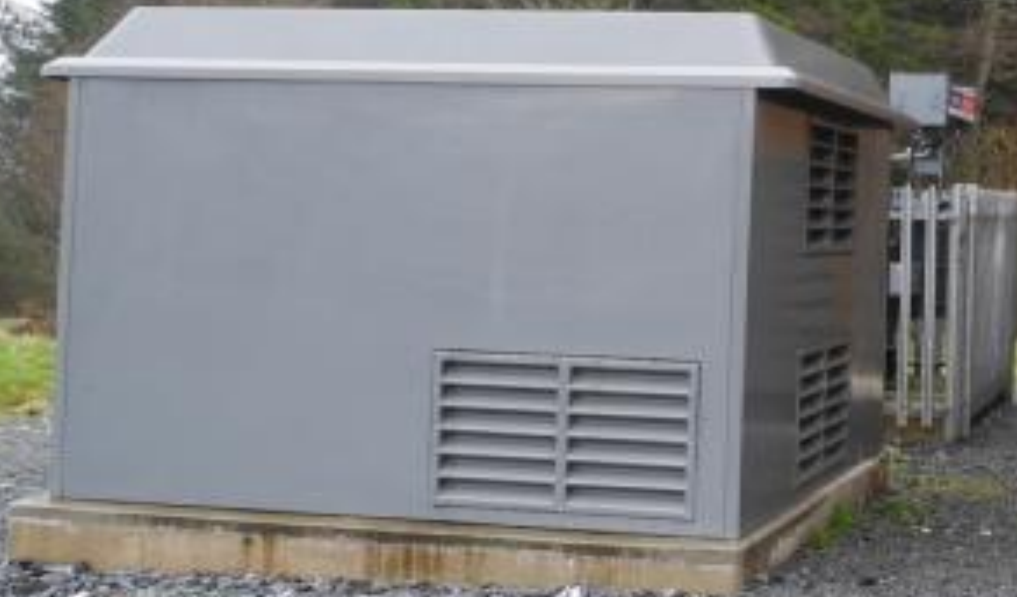
Ancillary components can detract from good turbine housing siting and design, especially if not considered fully at planning stage.

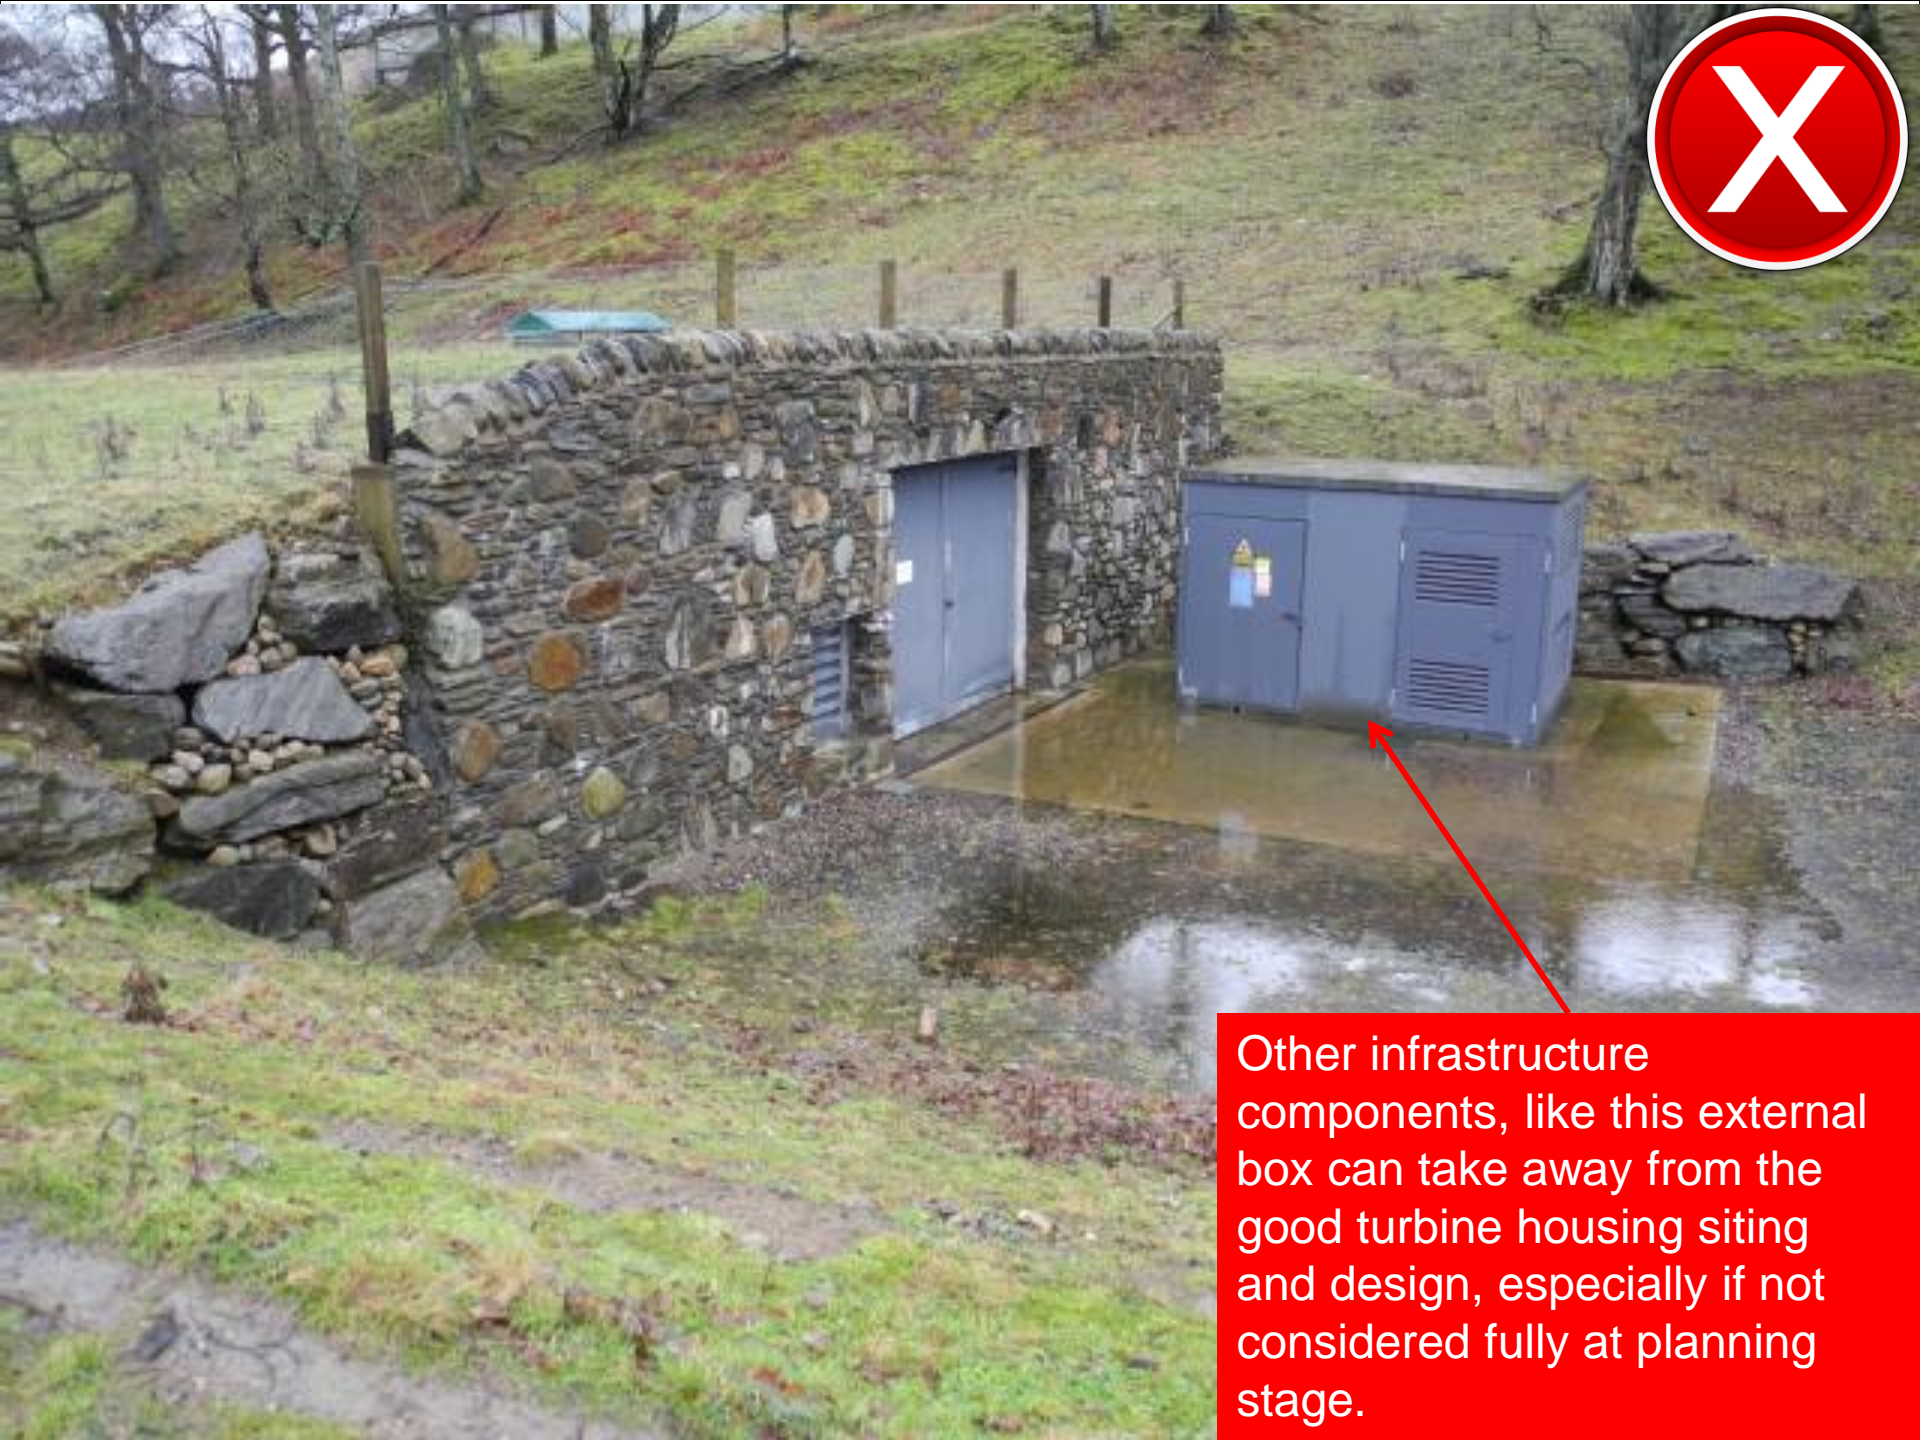
Other infrastructure components, like this external box can take away from the good turbine housing siting and design, especially if not considered fully at planning stage.

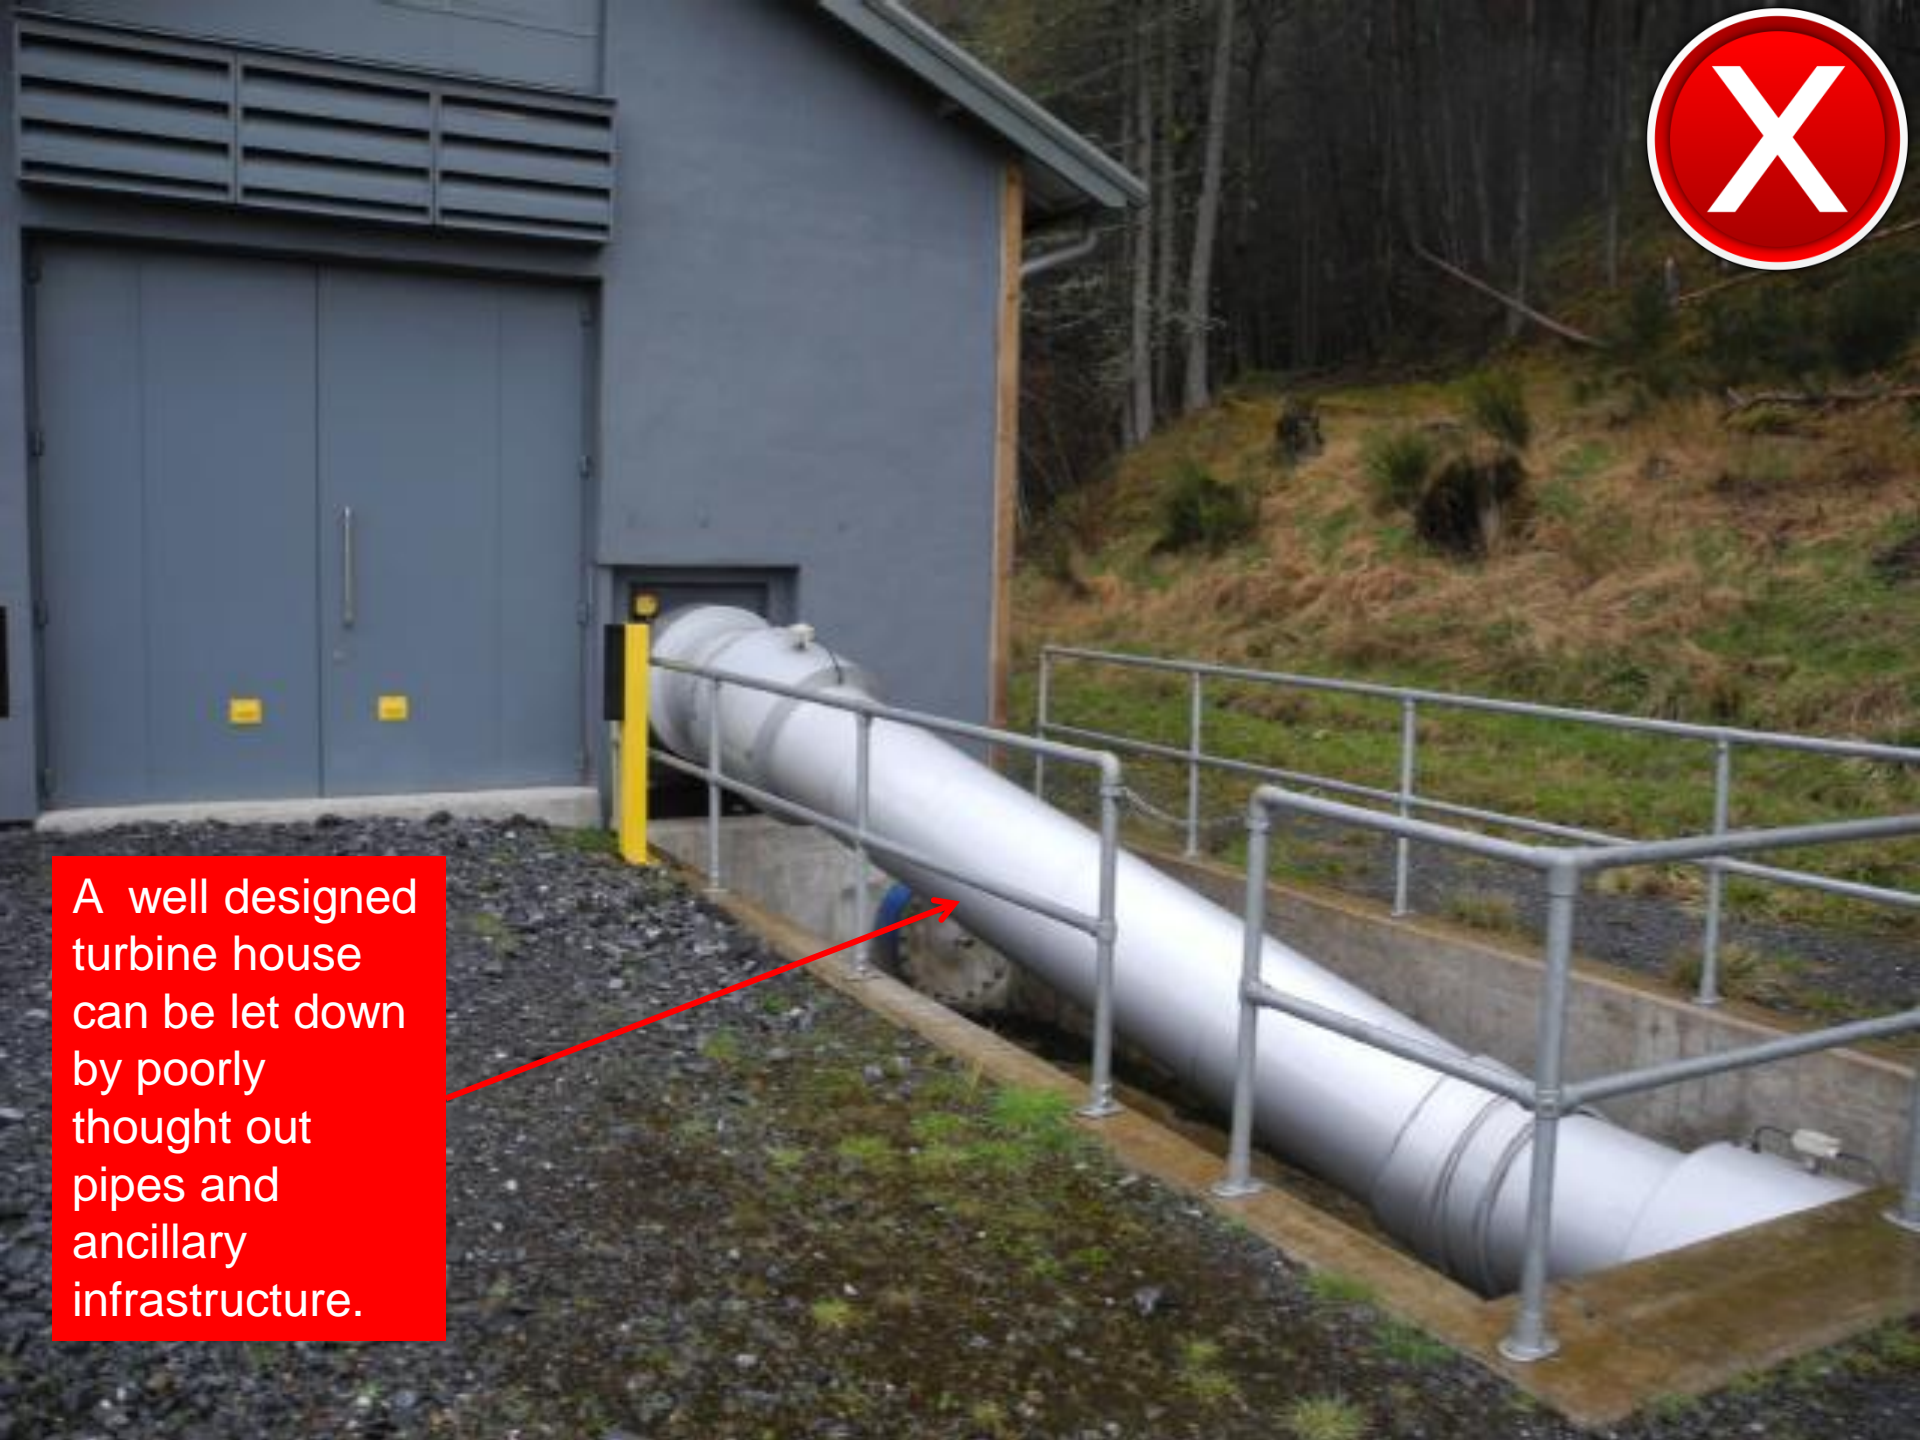
A well designed turbine house can be let down by poorly thought out pipes and ancillary infrastructure.

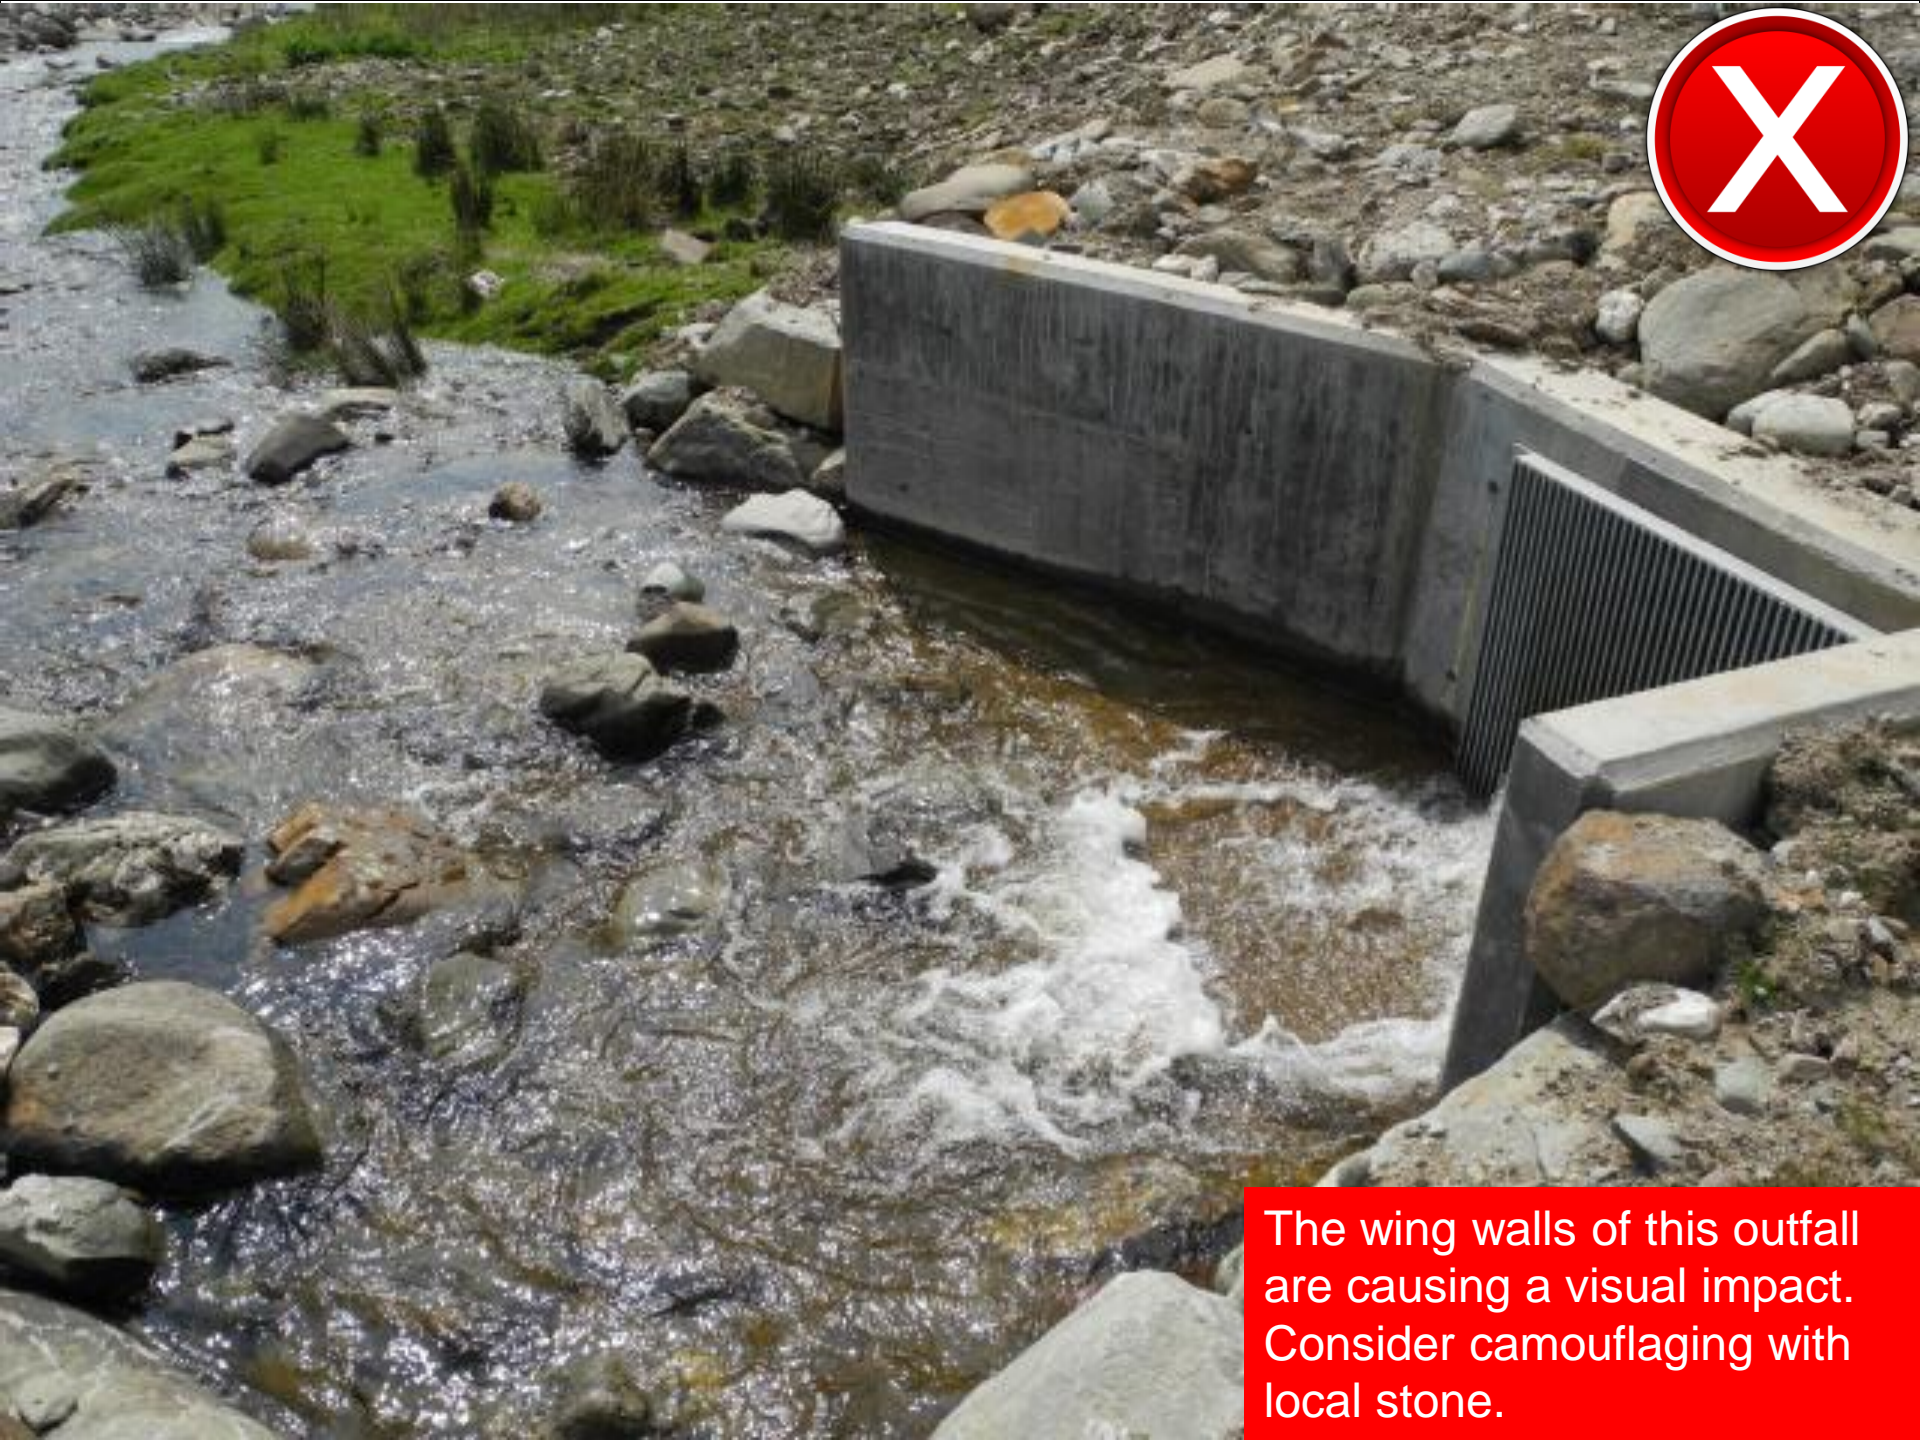
Hidden, low profile outfall with good practice wall and vegetation cover to hide infrastructure.

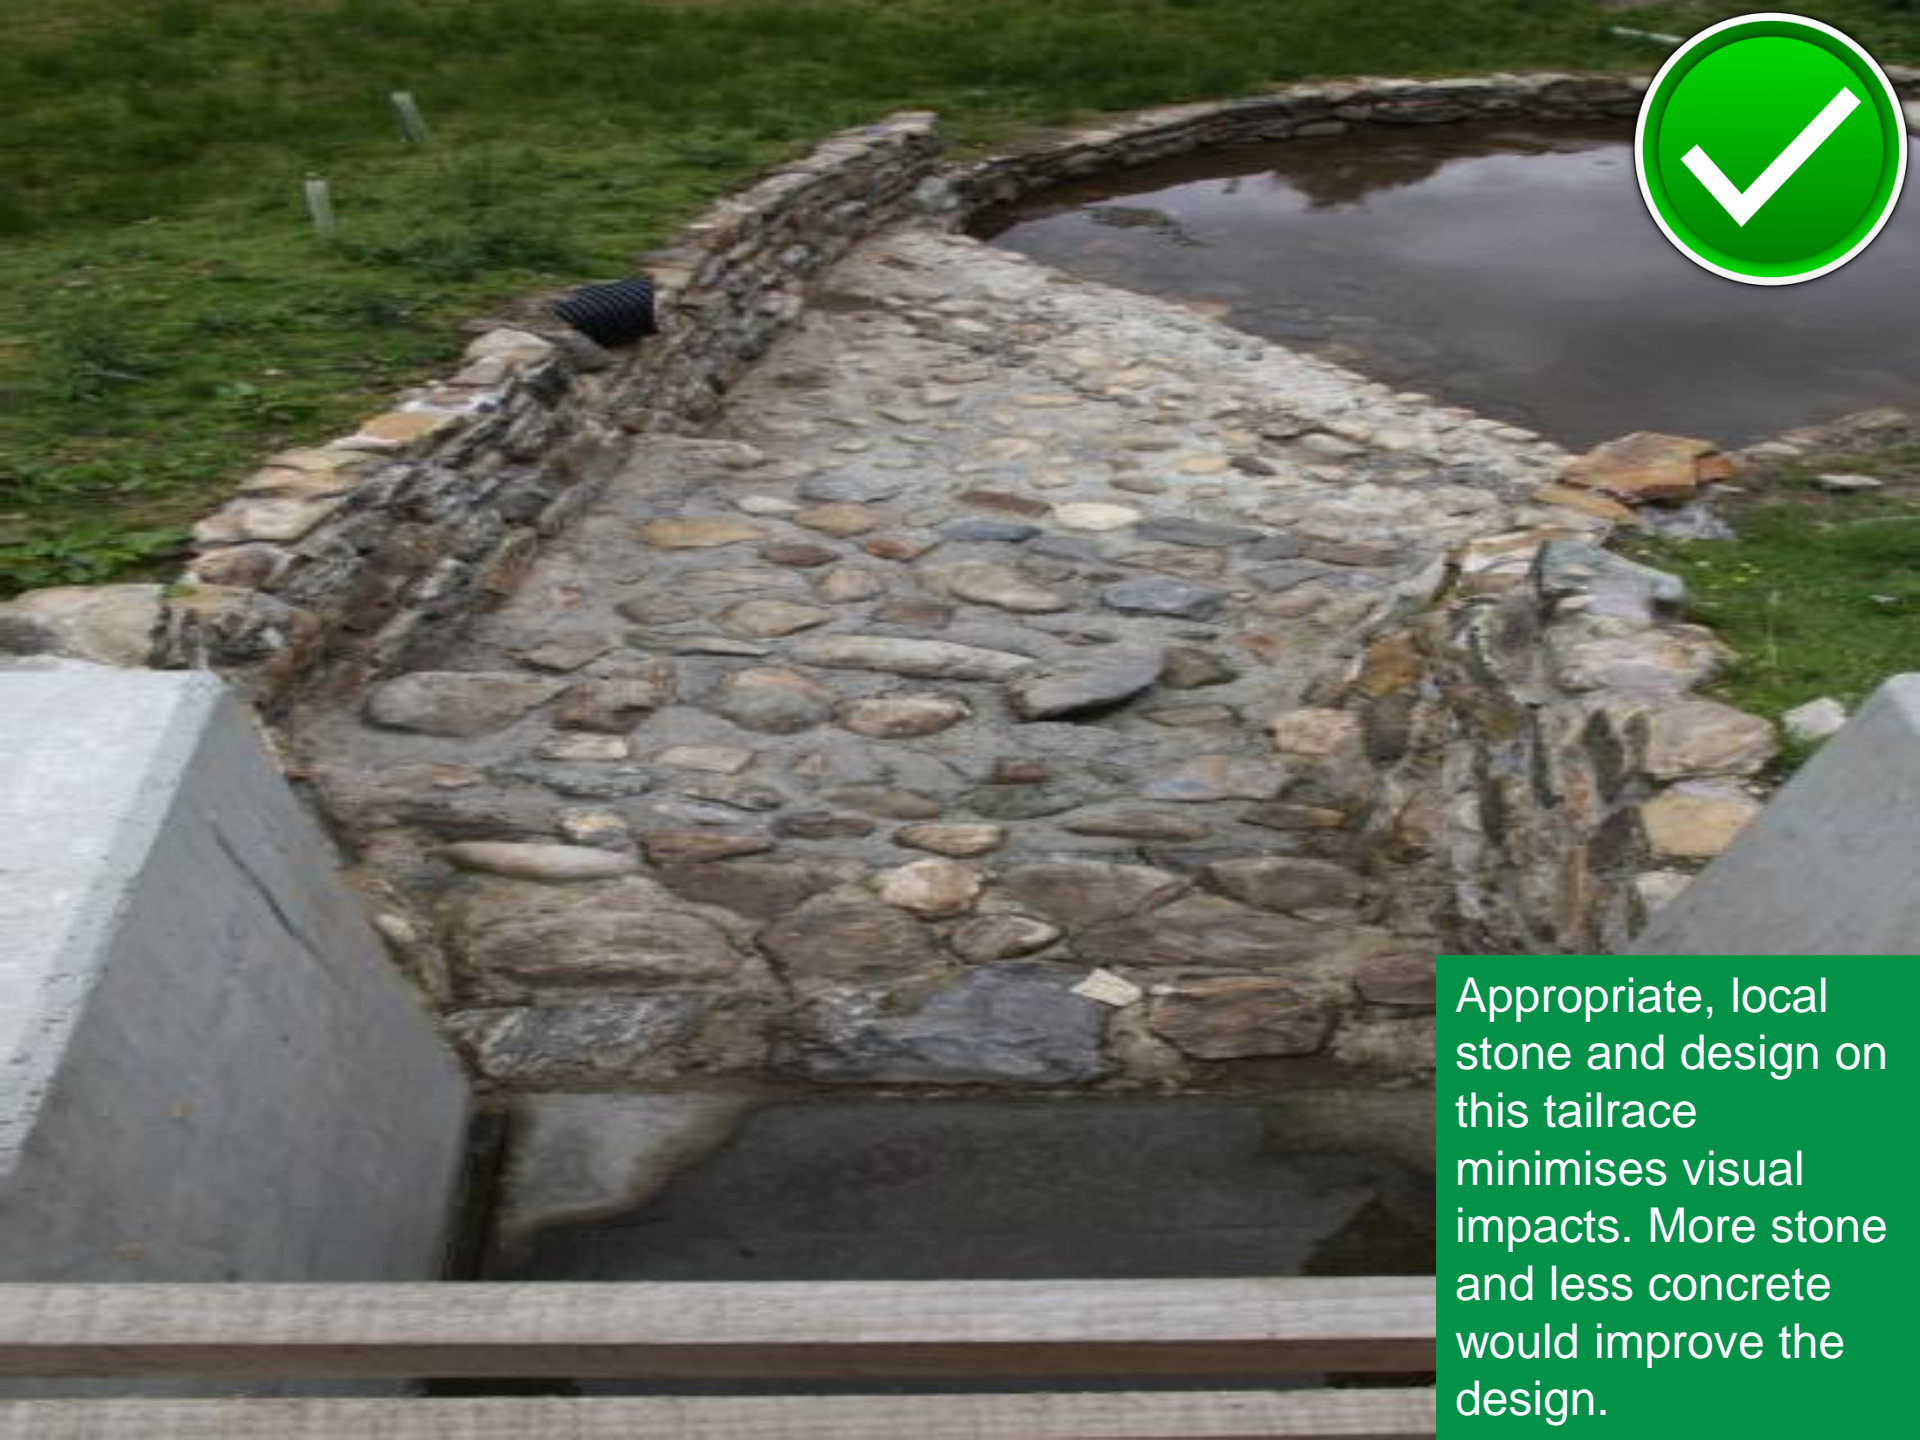
The outfall here is fairly natural in look, surrounded by vegetation.

The flow, however, could be slowed in order to minimise fish being attracted up the outfall.
